OCEANAGOLD

Managing the Hazards Associated with Open Stopes

Charles Gawith
OceanaGold Waihi Operations

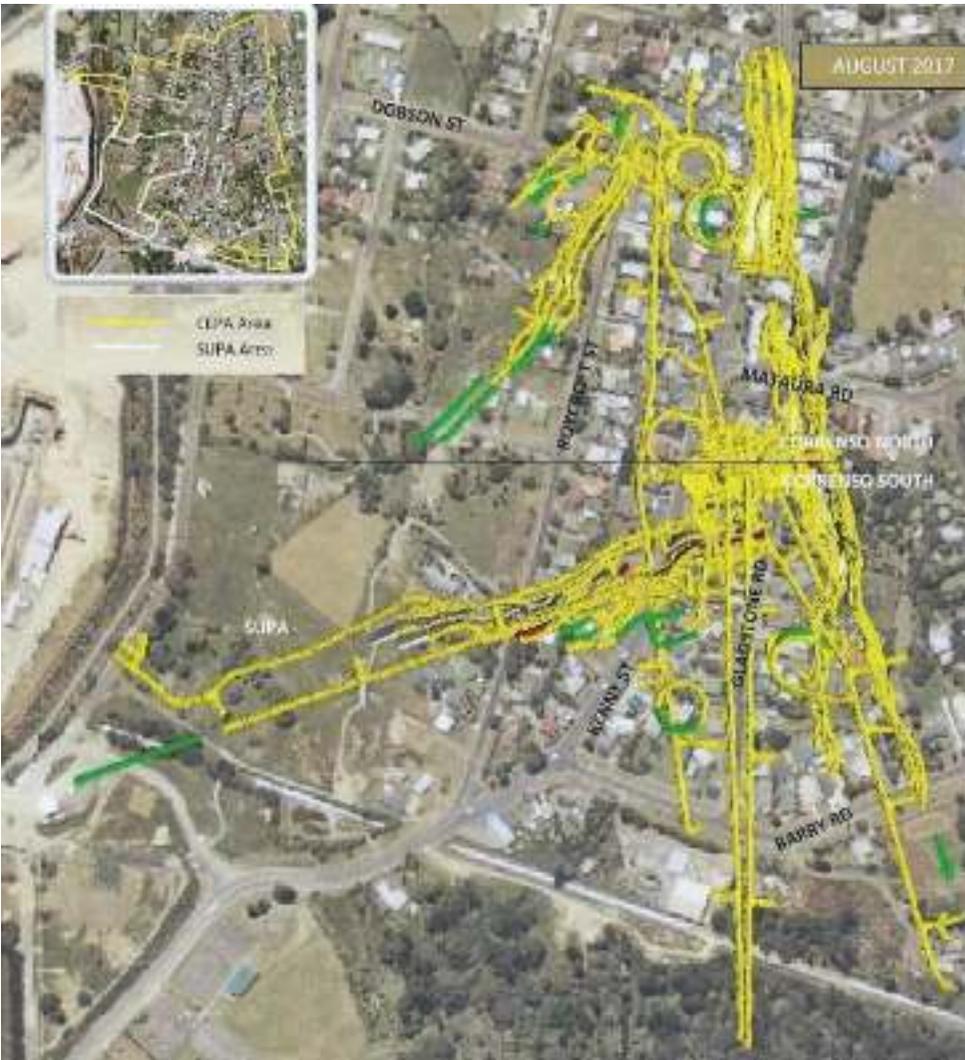
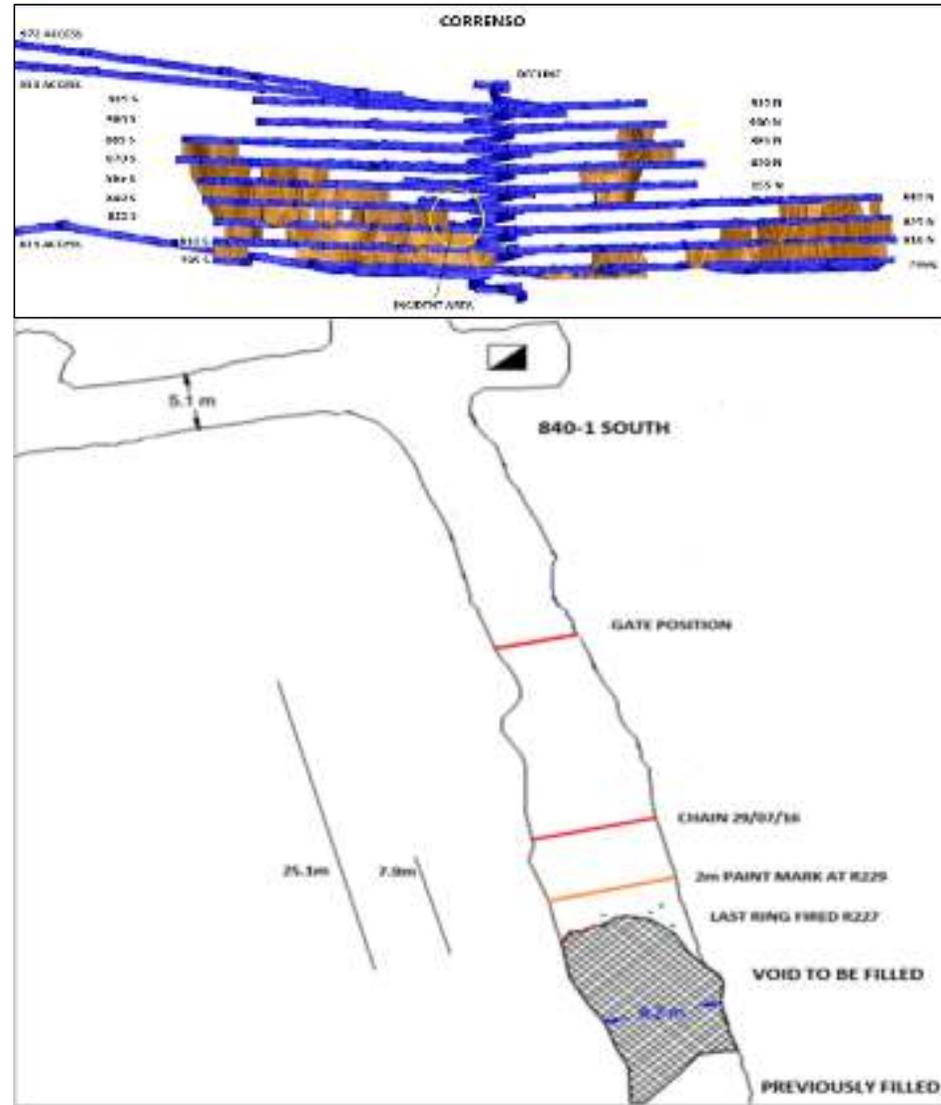
Location of the Incident

- **7:15am loader operator assigned task to commence backfilling operations at the 840-1-South**
- **Underground loader 122 was out of service so operator assisted charge-up crew until lunchtime.**
- **15:05pm loader operator proceeded underground in loader 123 to commence the backfilling task.**
- **15:40pm loader operator contacted remote operator on level below for confirmation that the appropriate barricades etc where in place as per procedure.**
- **Approximately 18:00pm remote operator discovered loader 123 upside down on the 825-1-South level and initiated emergency response.**

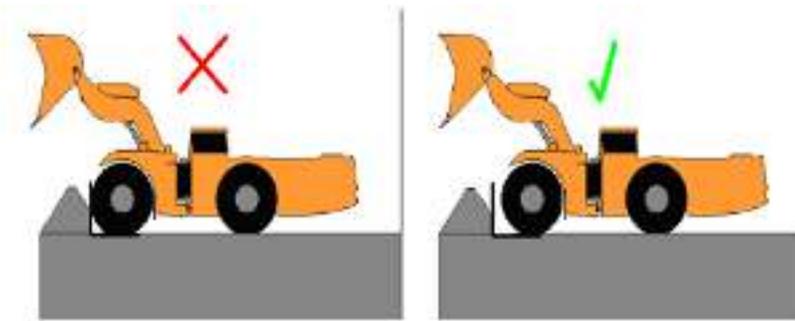
- Steel Stop Logs are generally not designed to stop a loader.

- Installing the Steel Stop Log has the same primary risk as the building of a waste bund. That is a loader drives towards an unprotected void with a bucket full of steel as opposed to a bucket full of rock!
- The increased complexity of installing the Steel Stop Log when compared to the rock bund construction was likely to lead to ad hoc modifications or on the fly hacks in the field.
- Steel Stop Logs and their associated chains require a significant amount of ongoing maintenance and checks. These multiple activities increase the risk associated with working around open stopes.
- Steel Stop Logs could give an operator a false sense of security as it will not stop their loader from entering a stope.

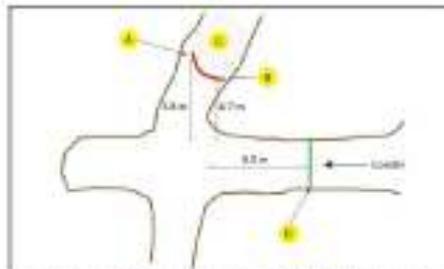
As the operator was tipping the load, the right hand side of the loader slumped and the operator exited the loader via the cab door. The loader kept moving forward under its own power and fell over the crest into the stope, coming to rest on the sill of one below. The operator was uninjured.

Level plan showing the direction the loader was travelling, as well as the brow pick-up (A), the edge of the open stope (B), the void (C) and the location of the restricted access sign (S) in the drive.

- Lack of adequate controls to manage the risks for mining activities near a void.

- No visual markers on the wall for the operator to position the bund safely.
- Reduced operator visibility:
 - the edge to an open stope was located on a bend
 - the loader was still articulated at the point of tipping (poor operator visibility)
 - there was limited lighting.
- The operator misjudged the location of the edge leading into the void.

- perform a formal team-based risk assessment to identify hazards and control measures before any work is commenced in the vicinity of an open stope or any other void. This should be in addition to lower level risk assessments (e.g. field level risk assessments, Task Hazard Analysis)
- install physical hard barriers in conjunction with lower level access controls (e.g. signage, demarcation). Hard barriers prevent workers and equipment accessing the edges of voids and should be:
 - designed and constructed at appropriate locations before open stopes or voids
 - where practicable, installed before creating a void
- use markers or spotlights for or during the construction of bunds when safe to do so.
