Union Hill Heritage Features Monitoring Plan

(Trio, & Correnso Mines)

February 2023

Document ID: WAI-200-PLN-02

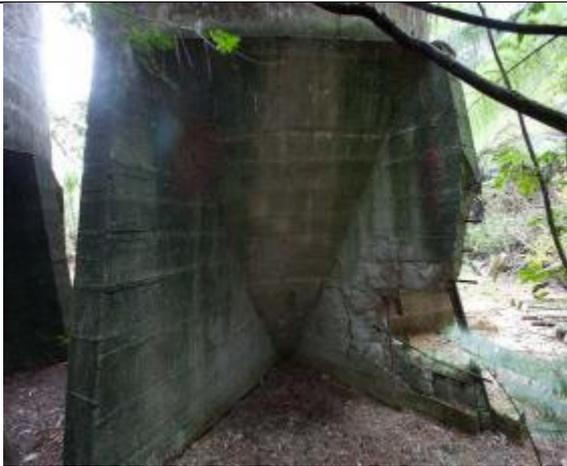
Extensometer fitted across the crack in the Tank 5 damaged tank leg buttress – real time monitoring

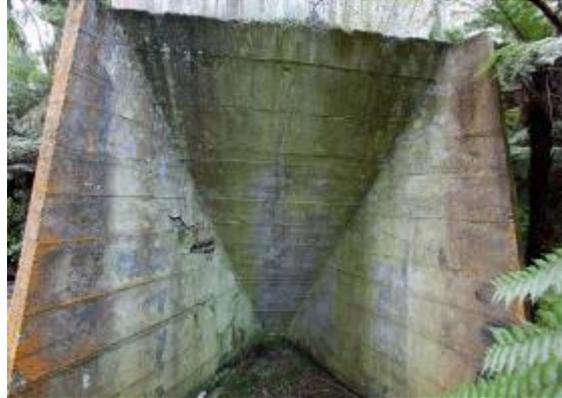
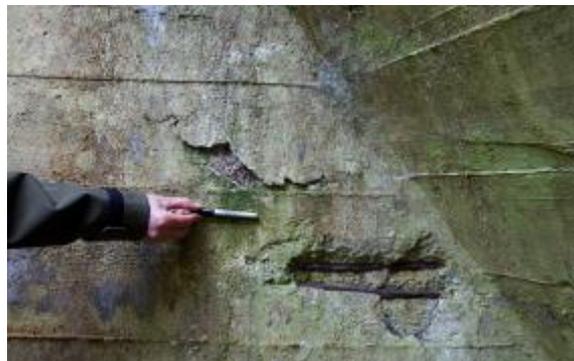
Visual Monitoring of existing spalling from continued corrosion of reinforcement in Tank

One South Leg

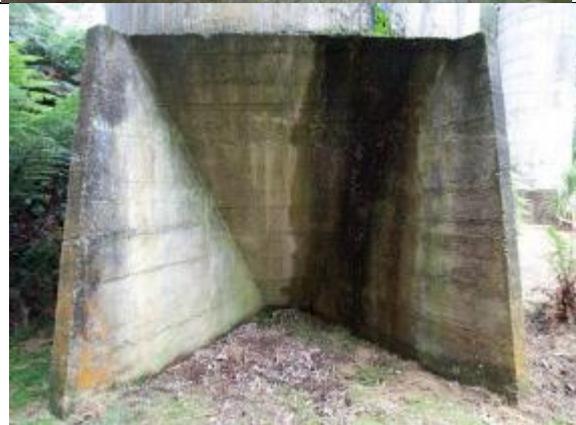
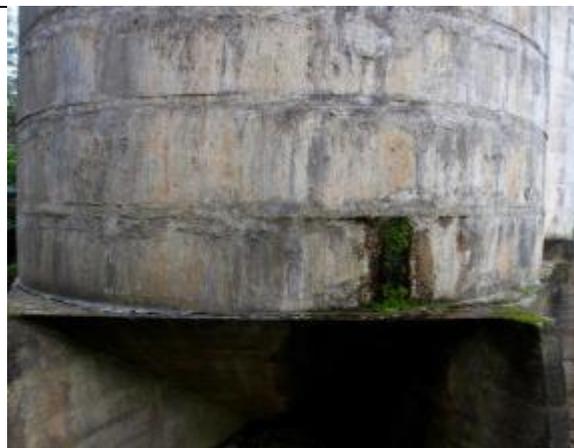
Visual monitoring of leakage from Tank 2 –
changes in flow / mould growth

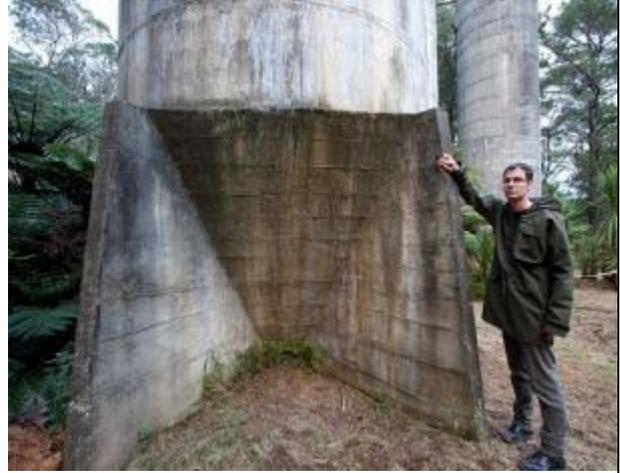
Vernier Calliper monitoring of pins installed across the existing crack in Tank 3 Leg

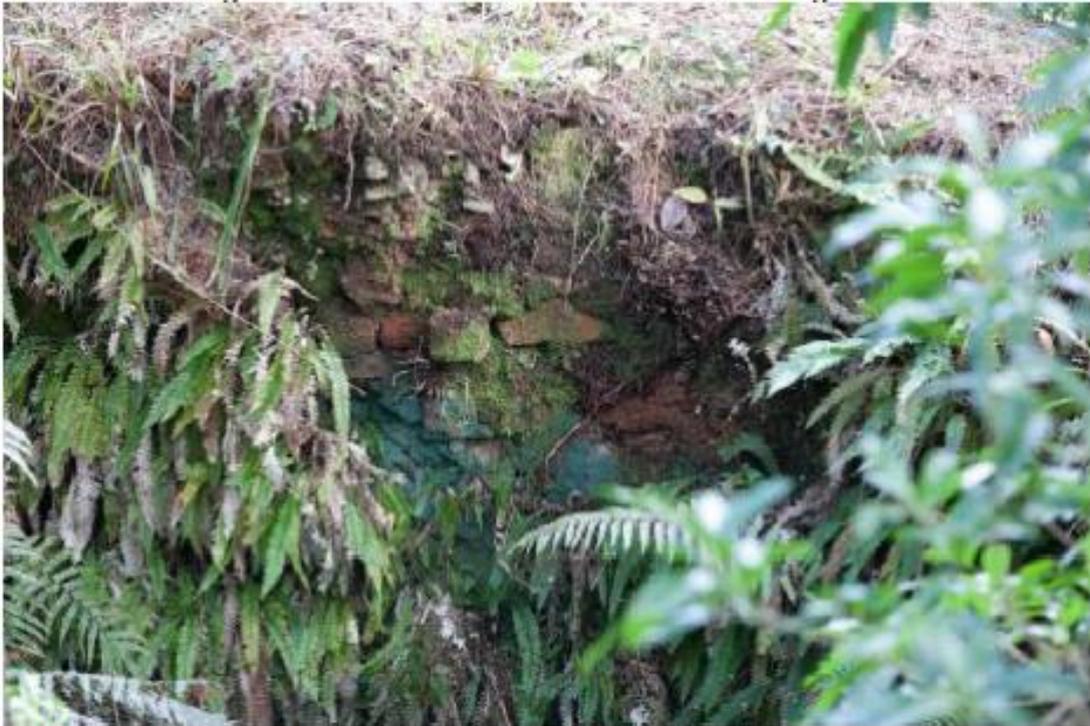
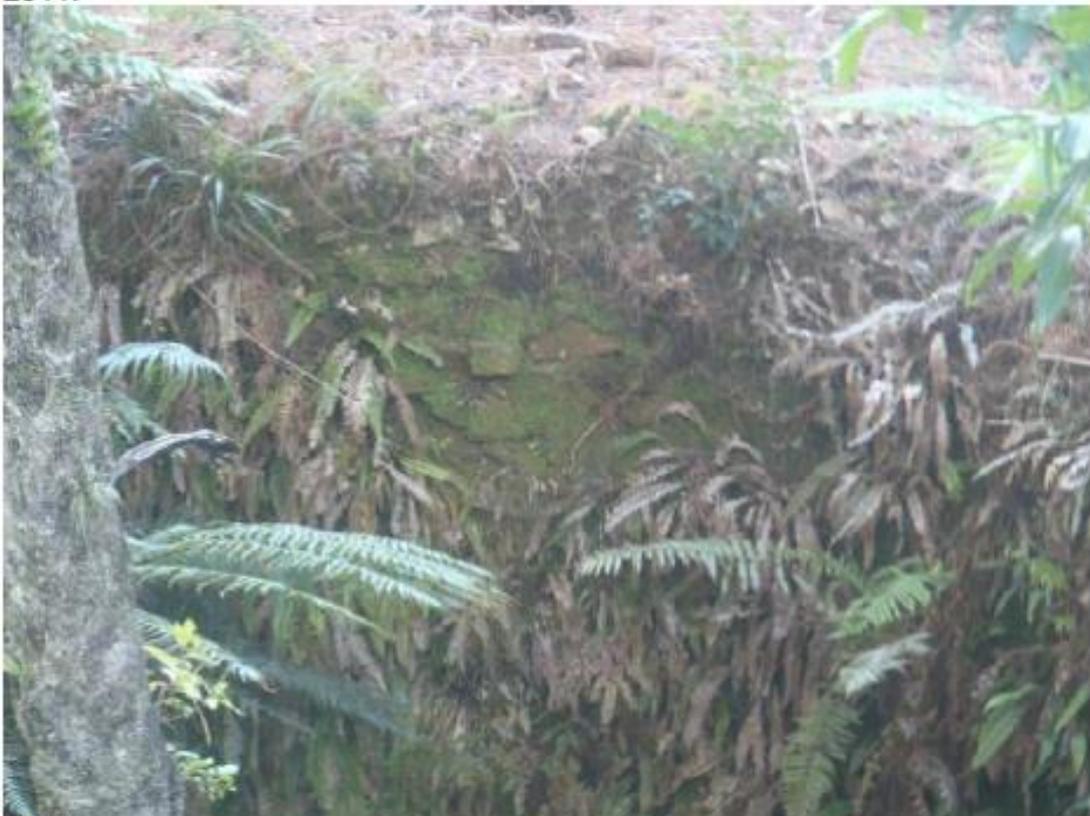
Kiln 9: Monitoring of area of loose brickwork without local vegetation behind.

Observations: Some trampling of earth above edge from monitoring. Localised browning of vegetation. No discernible visual change to ring structure.

Conclusion: No discernible change

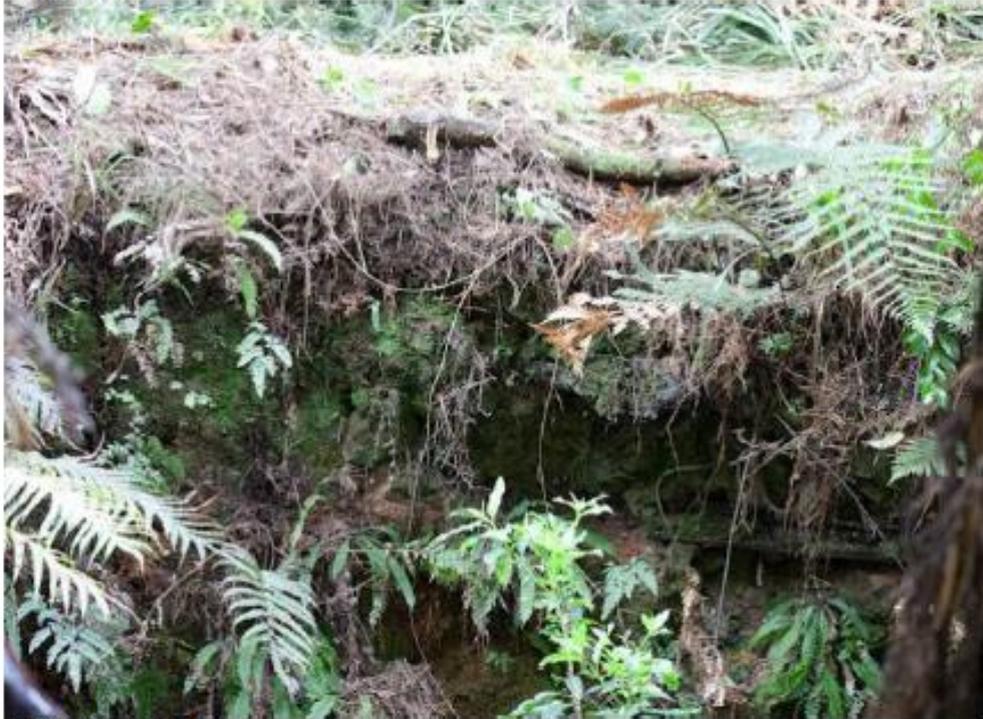
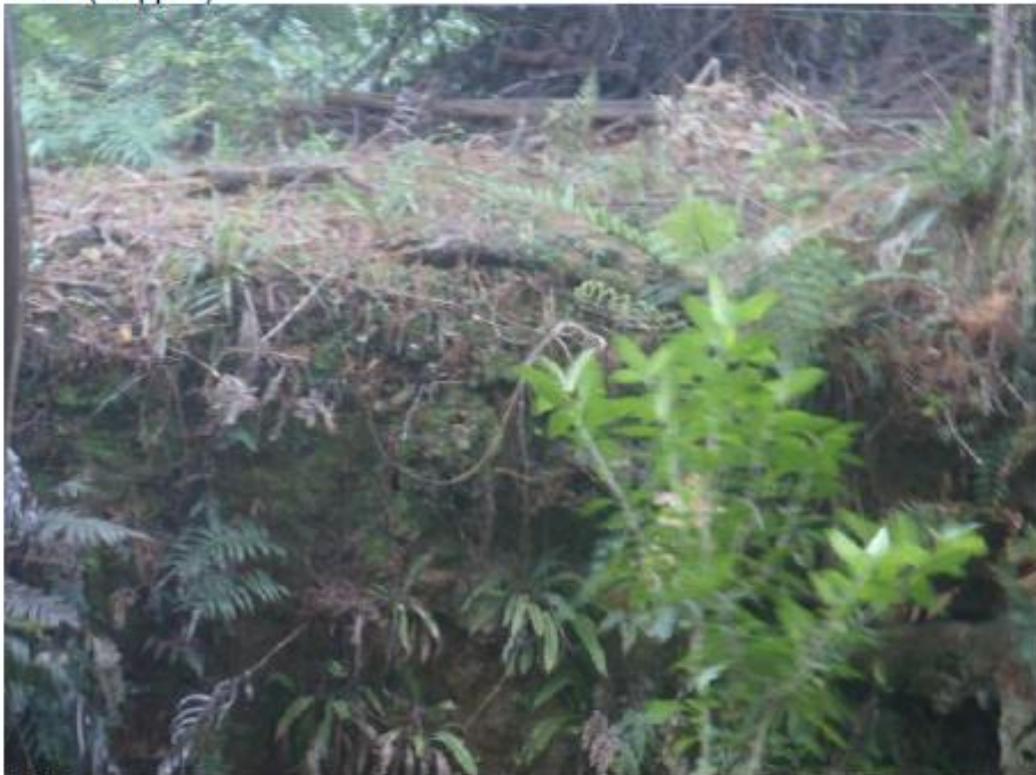
Kiln7 southern half: Monitoring of area of earth at risk of movement aided by vegetation.

Observations: Minor localised browning of vegetation. No discernible visual change to moss covered earth projections.

Conclusion: No discernible change

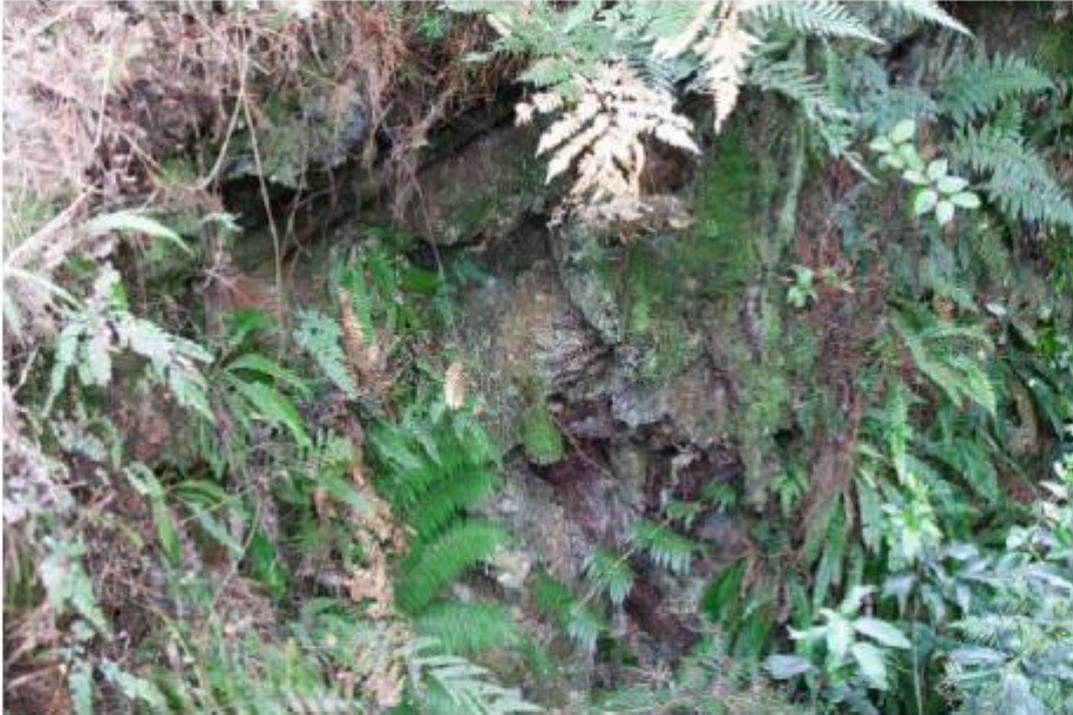
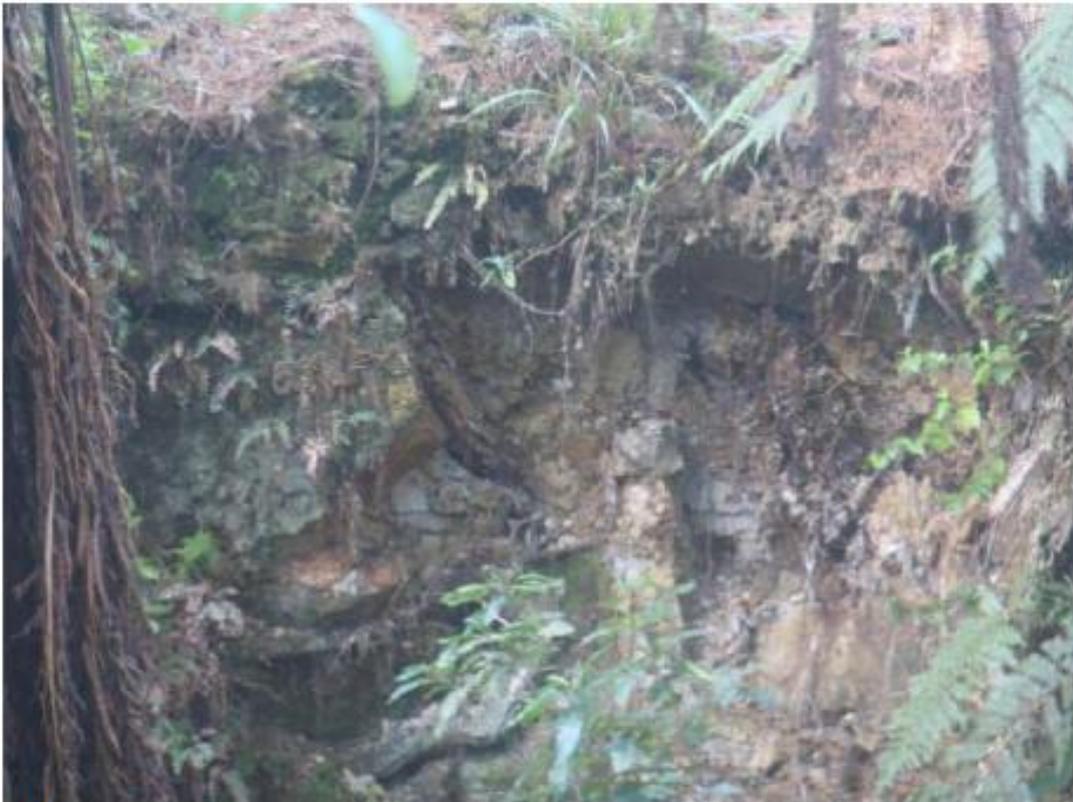
Kiln7 northern half: Monitoring of area of earth at risk of movement aided by vegetation.

Observations: Slip of loose fractured heavily weathered rock on right side of original condition survey. Slip is also apparent in 18 Jan 2011 photo (see over). Only minor erosion has occurred subsequently leaving the root behind more exposed.

Conclusion: Continue to monitor erosion. Good indicator of likely upper edge erosion where subject to weather. Sufficient loose and exposed to rain material still present to justify as indication area, although the south half of this indicator area is more representative of the current condition of the majority of kilns.

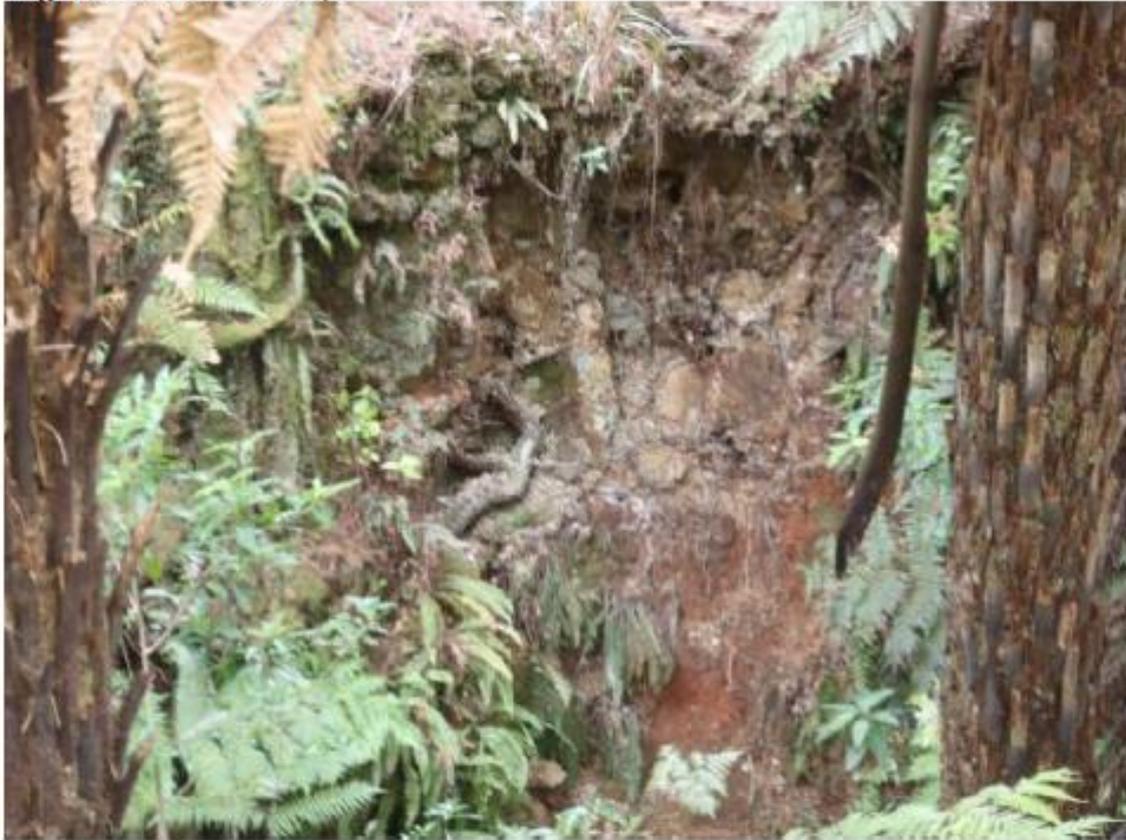
Kiln 7 18th January 2012: Showing small localised slip has occurred previously to original condition survey.

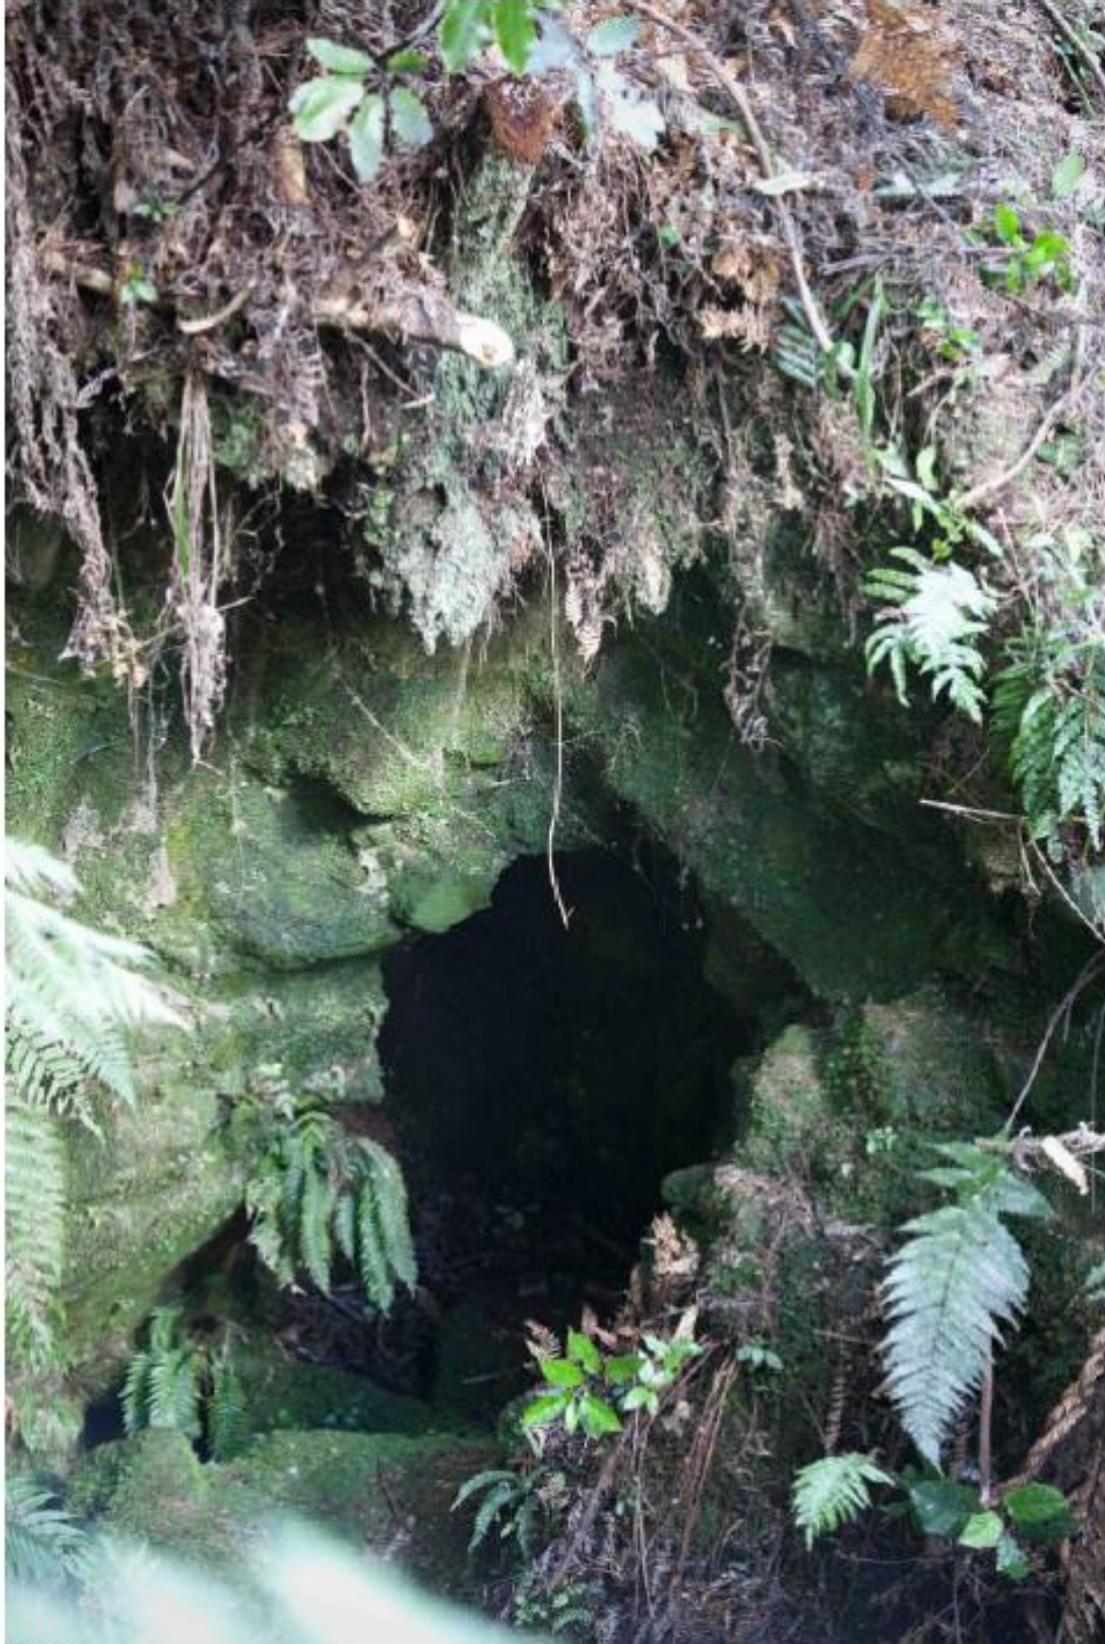
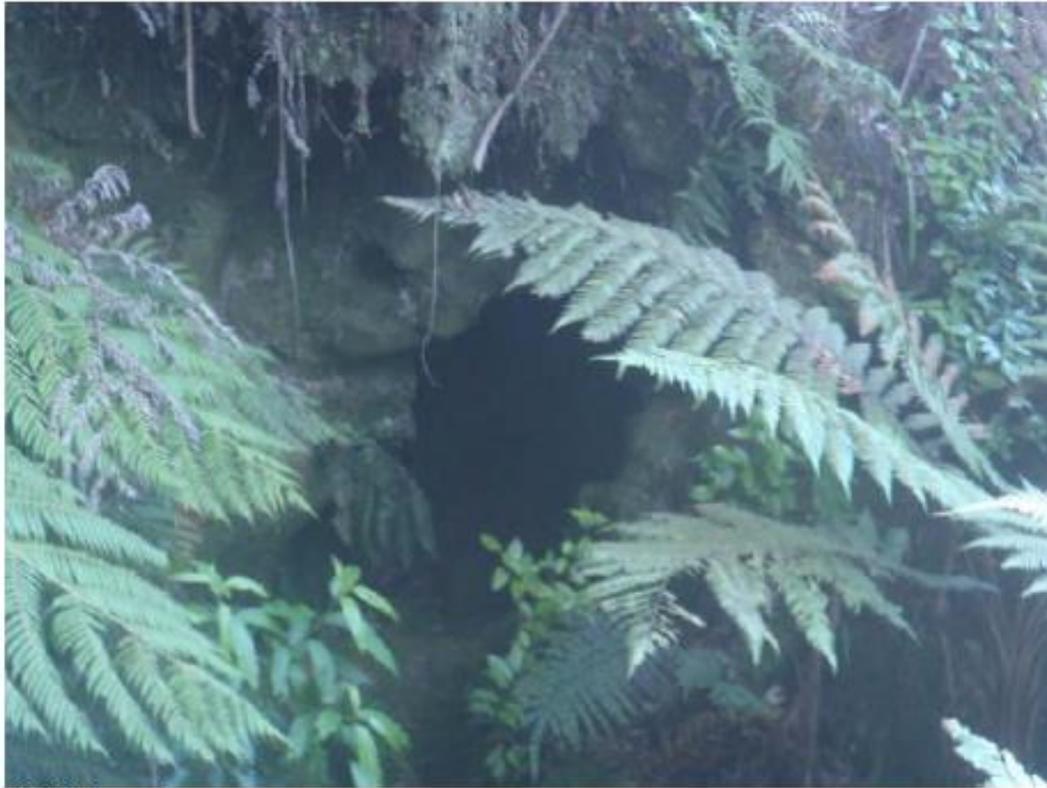
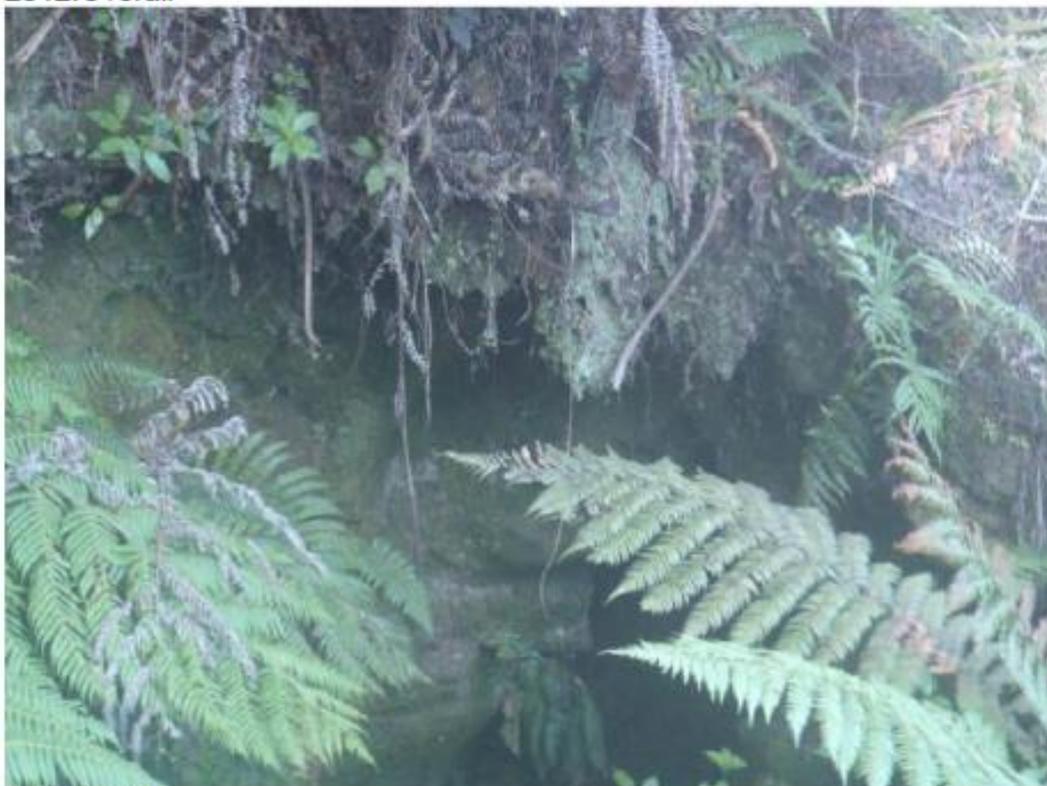
Kiln 5: Monitoring of one "indicator area" without signs of vegetation locally where the vent / loading area comes into the kiln.

Observations: Minor localised change to vegetation. No discernible visual change to moss covered earth/rock projections.

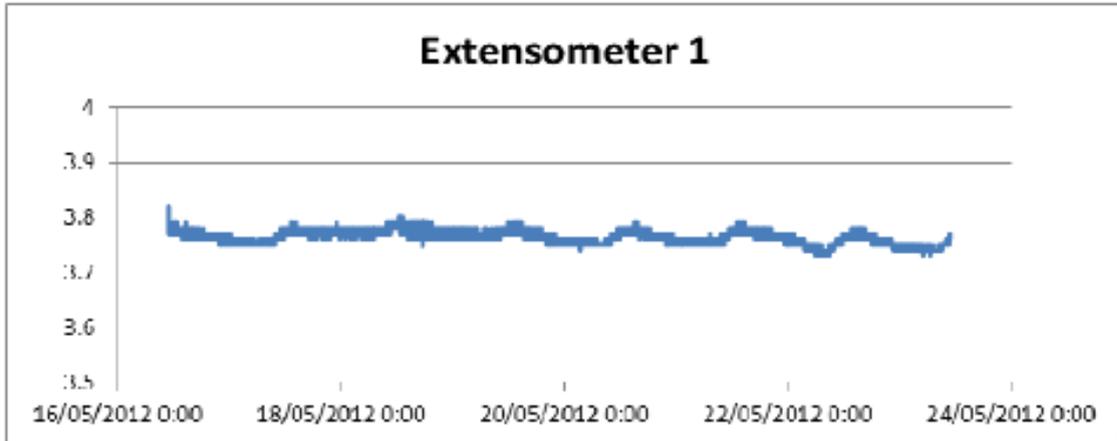
Kiln 10 North Extensometer: measures vertical ring displacement relative to the existing concrete block at the rim edge, and hence heave conditions surrounding the top rings.

The only noticeable change/trend is that there is a minor cyclical change related to the ground temperature. Movements are certainly negligible from a structural point of view (less than 0.05mm) and are cyclic rather than ratchetting ("walking").

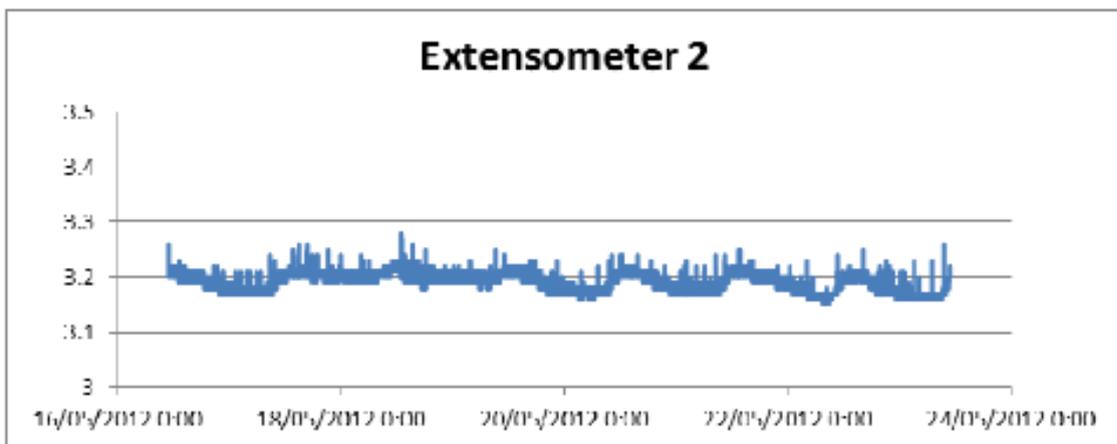
Kiln 10 West Extensometer measures actions from the roots of the tall tree adjacent to the ring. Aside from growth displacement this also could measure the effect of tree wind movement on the surrounding earth.

Again only slight temperature (daily) cyclic movements were discerned. No significant wind related movements were noted.

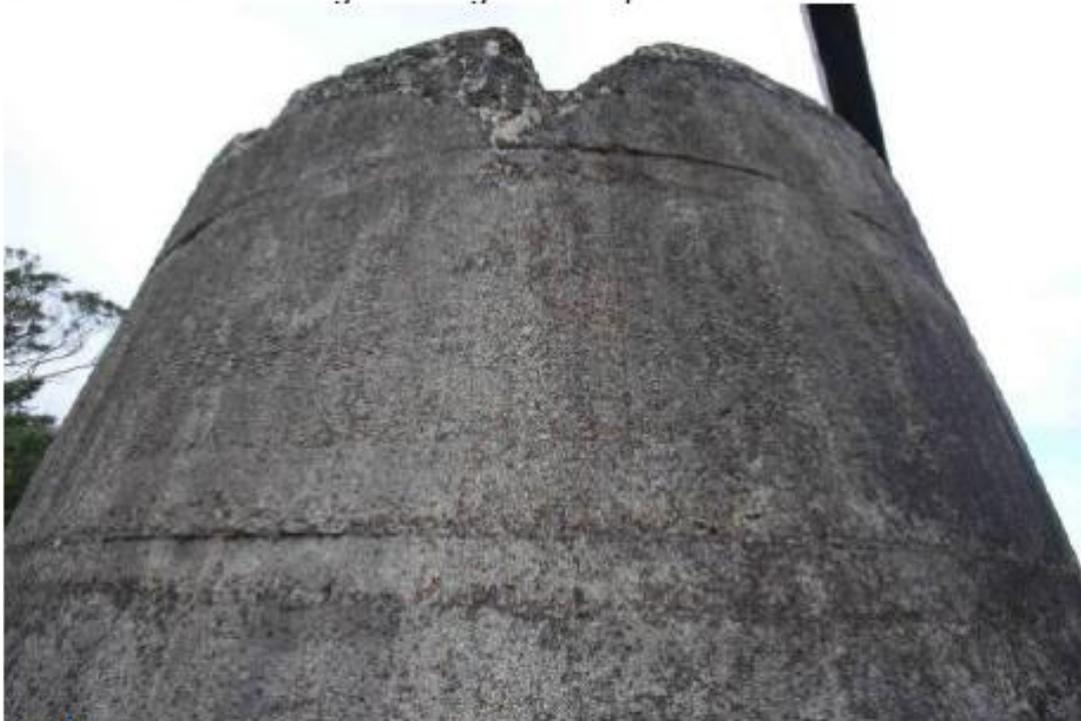
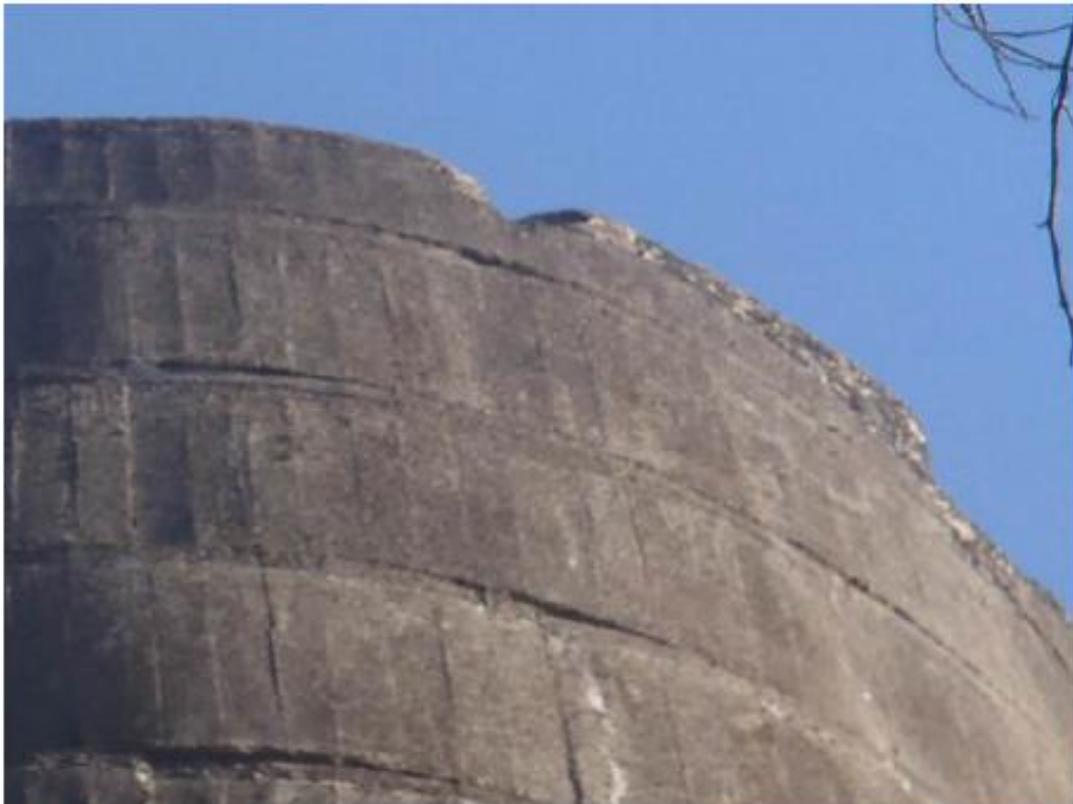
Tank 1: Visual monitoring of damage to the top rim

Observations: Difficult to photograph from below. No downward propagation of cracking evident.

Conclusion: No discernible change

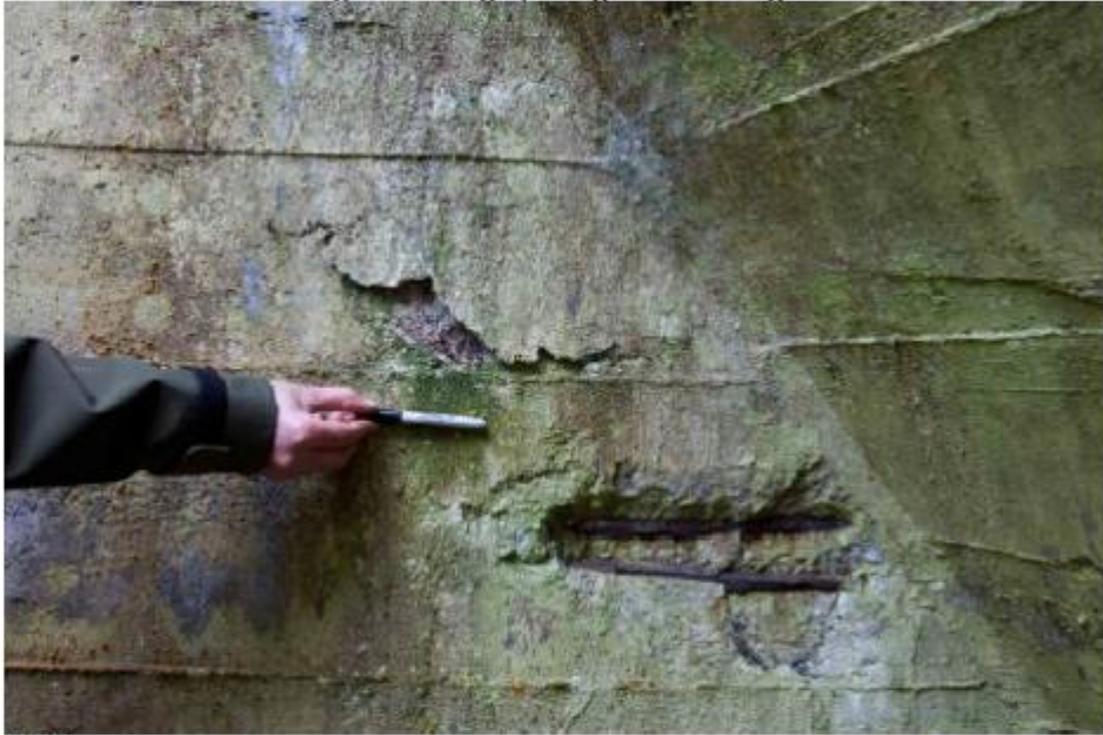
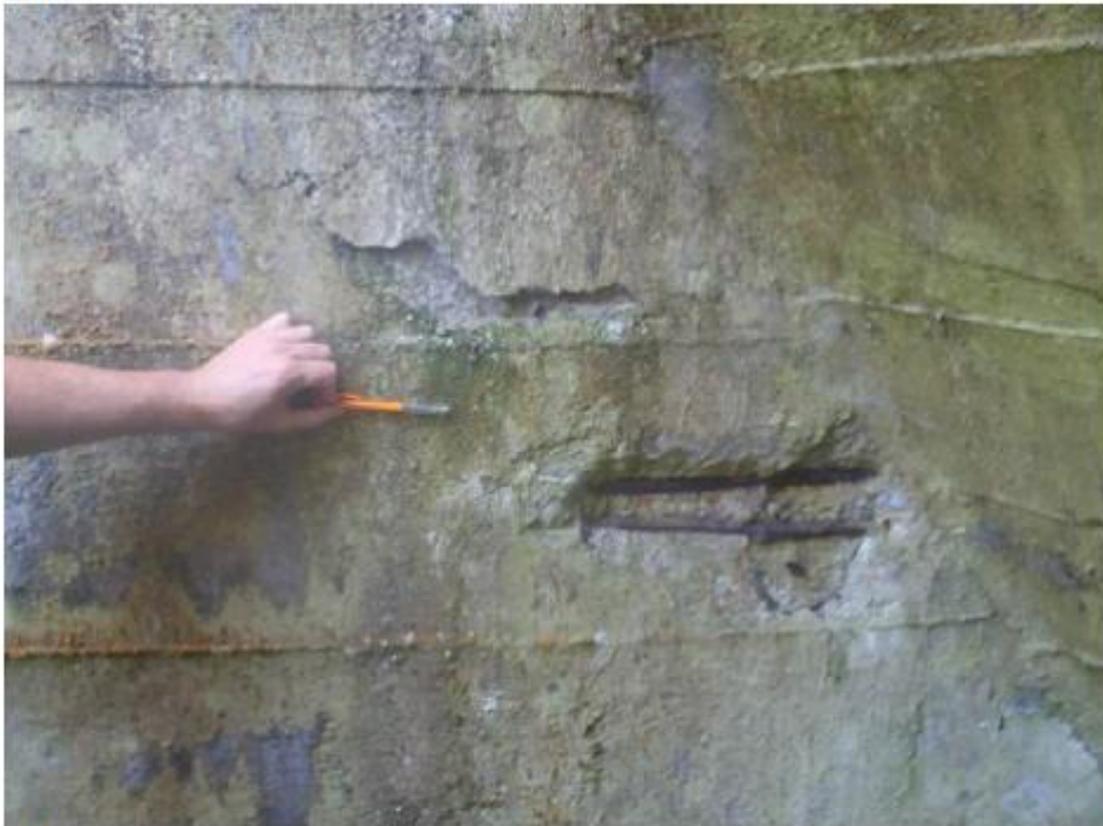
Tank 1: Visual monitoring of existing spalling on south leg

Observations: Loss of the bottom of the projecting spalled edge: likely from human intervention. Little distance that "flap" has moved outward.

Conclusion: Negligible outward movement from corrosion. Projecting thin concrete vulnerable to mechanical damage. Photo 16/12/11 shows same break.

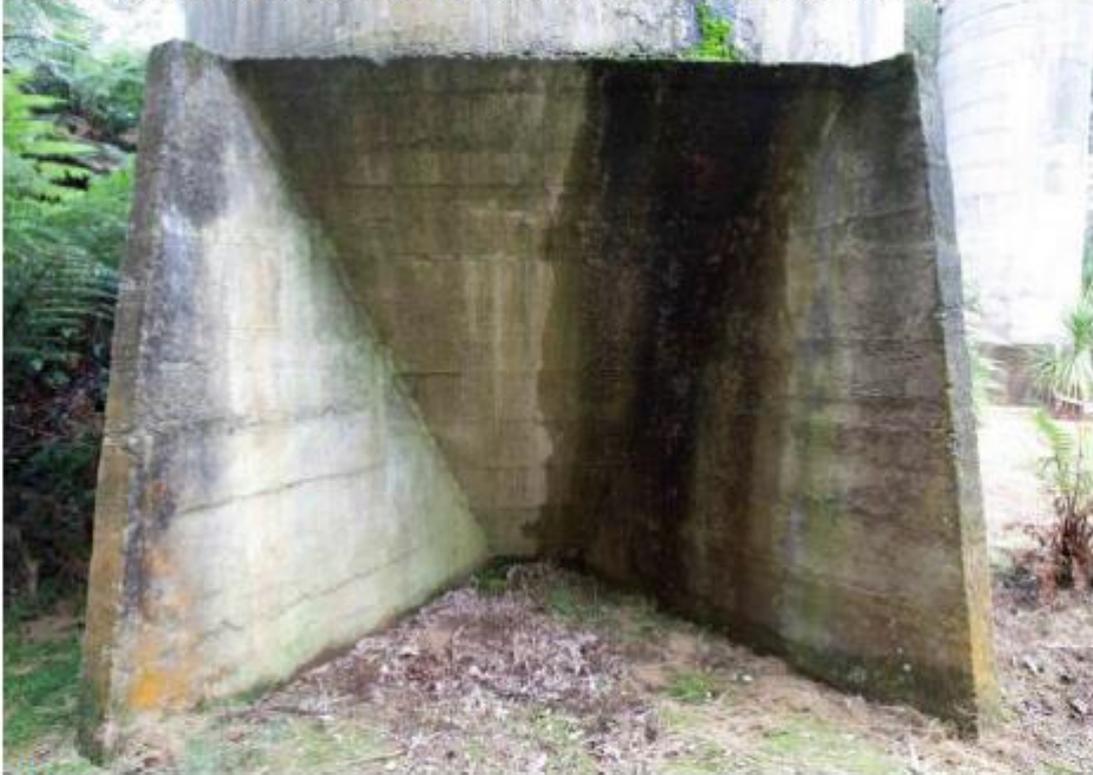
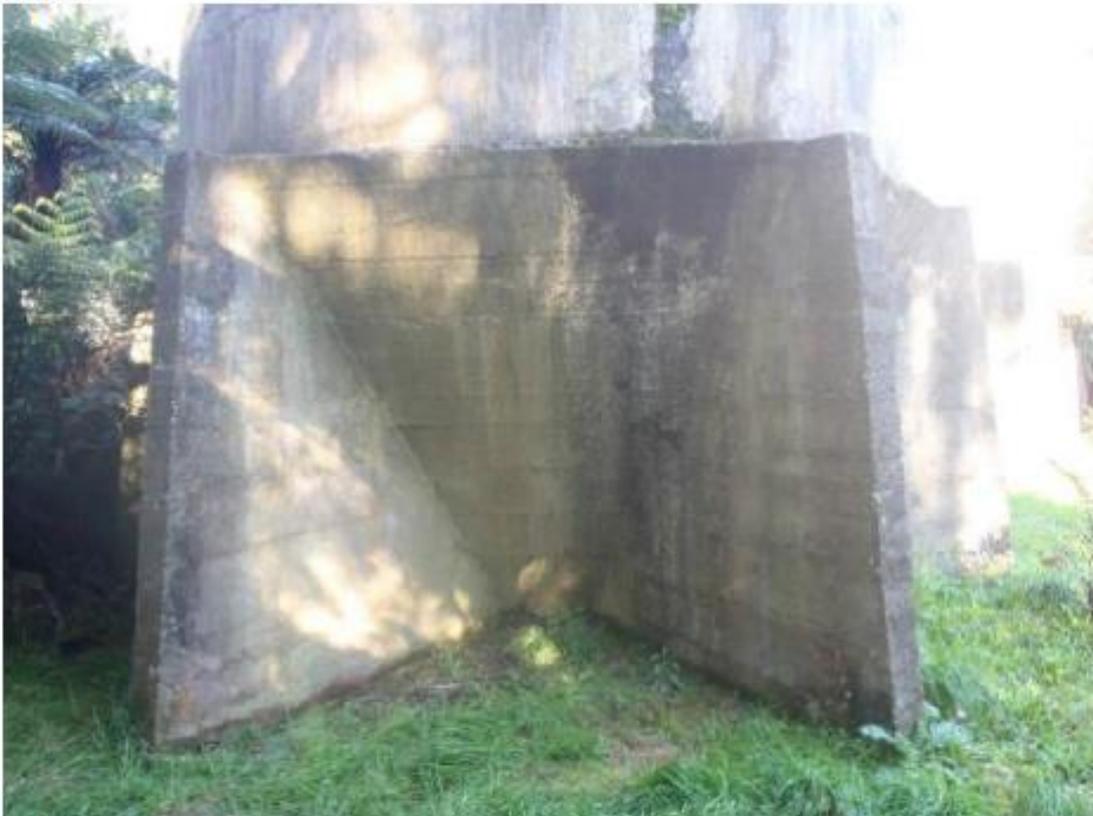
Tank 2: Visual monitoring of leakage – changes in flow/mould growth.

Observations: Leakage and moss growth follows weather pattern based on extent of external drying.

Conclusion: No discernible change

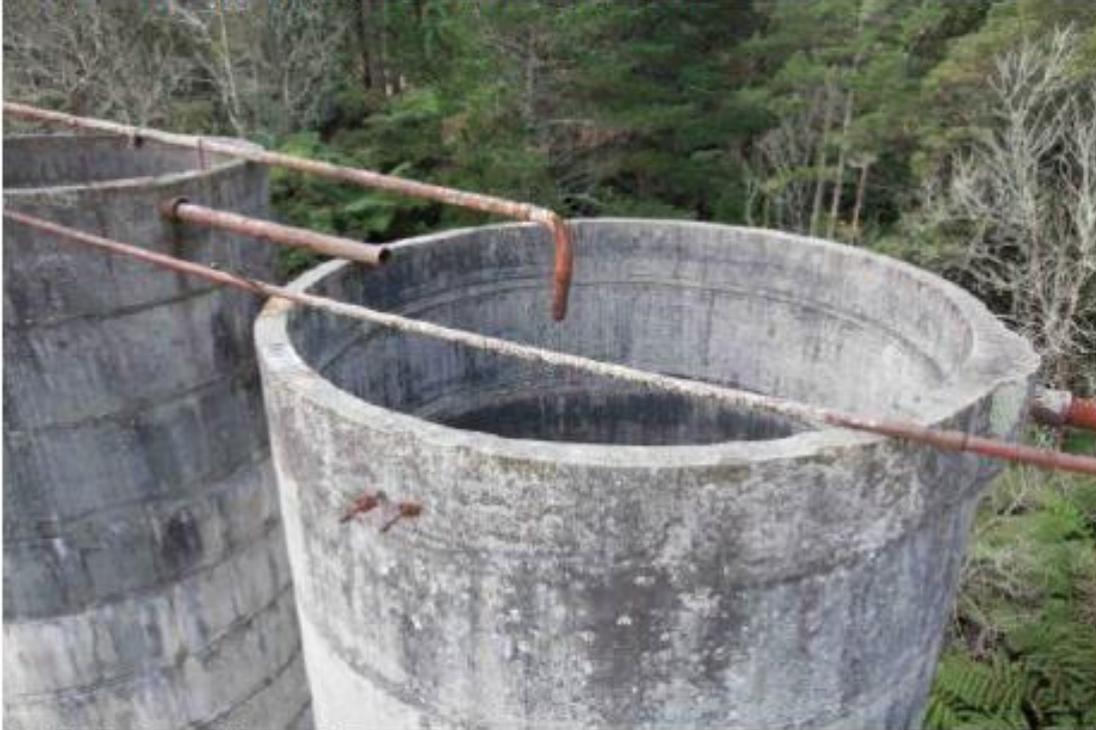
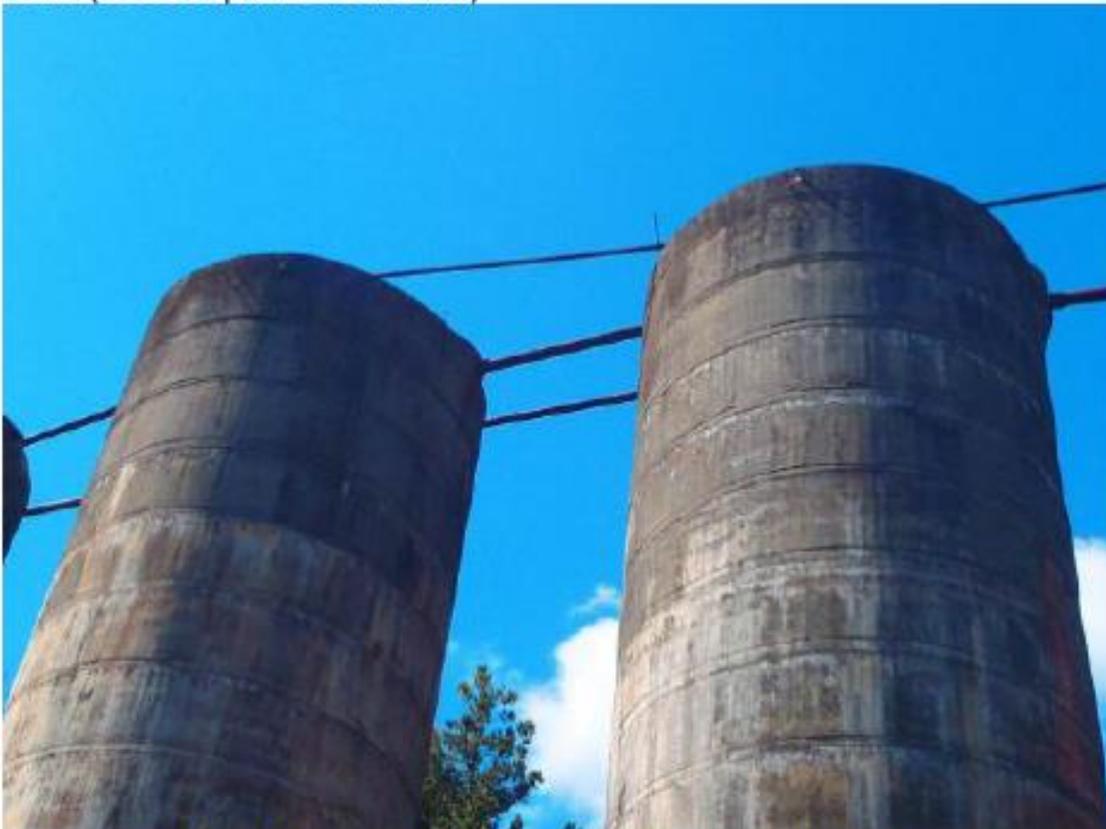
Visual monitoring of pipe positions on the top of the tanks.

Observations: No movement evident after close examination of series. Upward projecting small pipe not moved on unrestrained length.

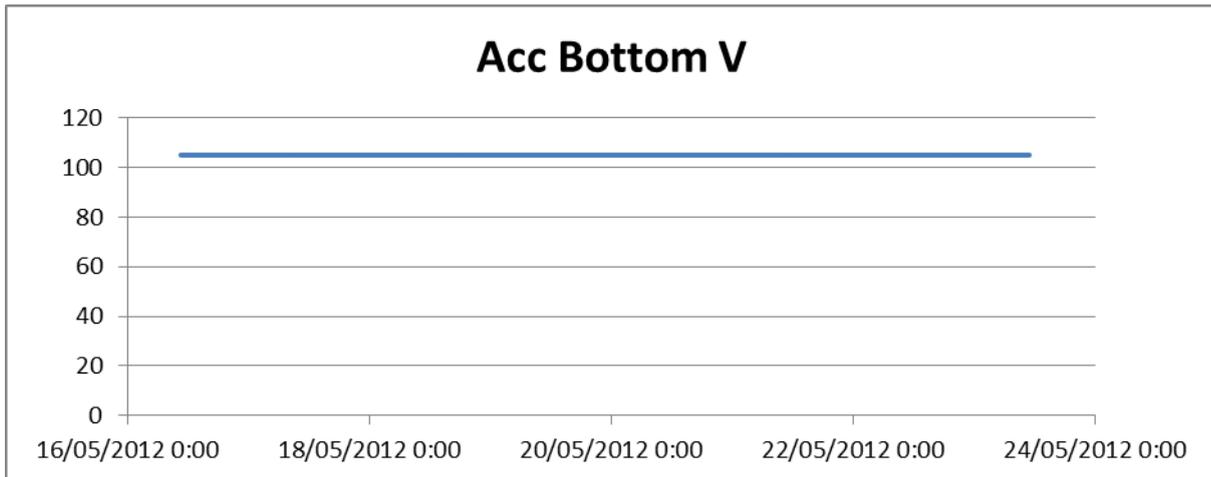
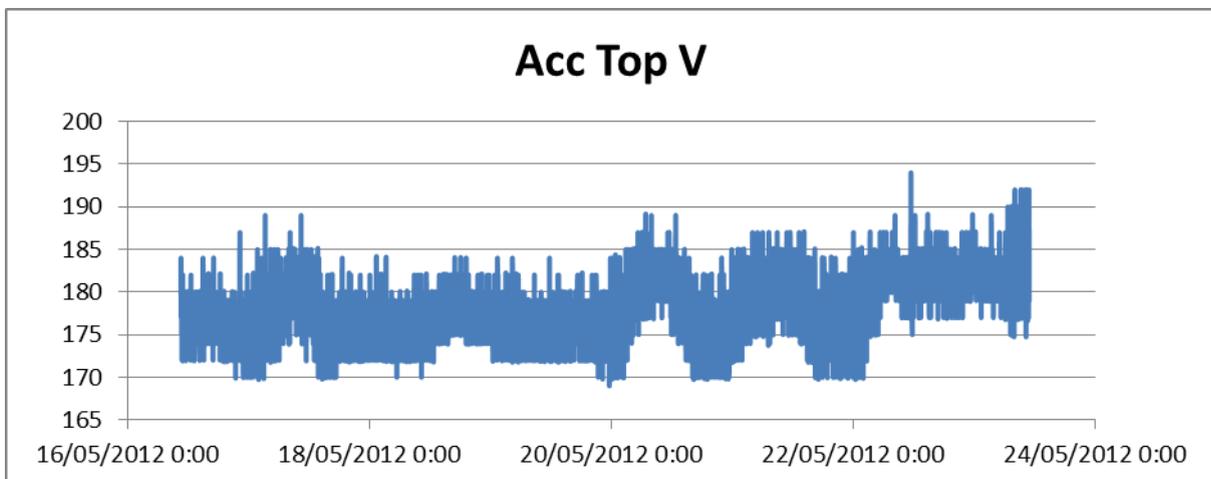
Tank 4: Accelerometers located at top and bottom of the tank.

The background peak vibration acceleration (measured at the bottom of the tank is almost constant) and similarly the response at the top at approximately twice this.

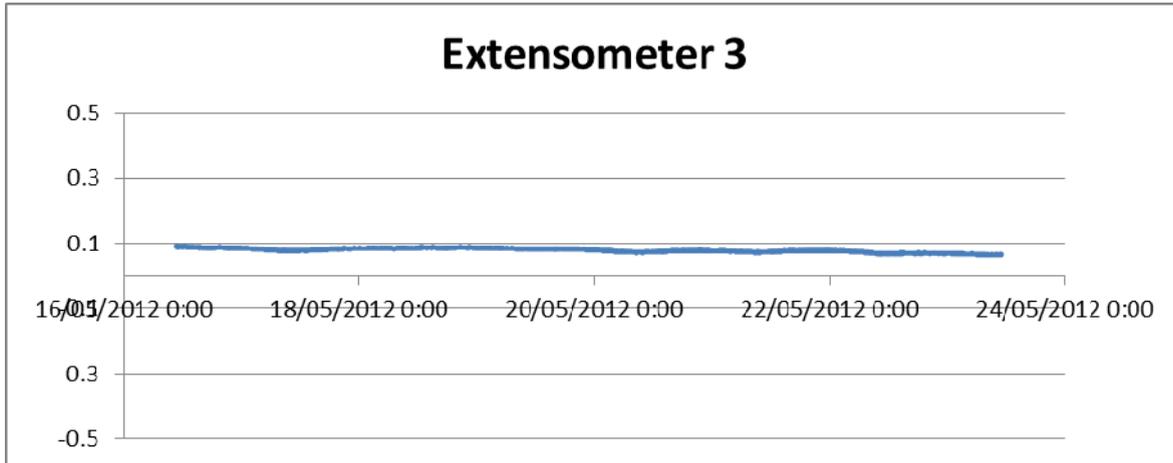
Tank 5: Extensometer fitted across the crack on the damaged (SE) buttress

There appears to be little pattern in minor movement responding to background vibration. No significant permanent trend in movement was detected from March to June.
