# Correnso Stability 2015 Annual Report

The purpose of the Waihi Gold (WG) Corrensen Surface Stability Annual Report is to comply with Condition 25 of Hauraki District Council (HDC) LUC 202.2012.

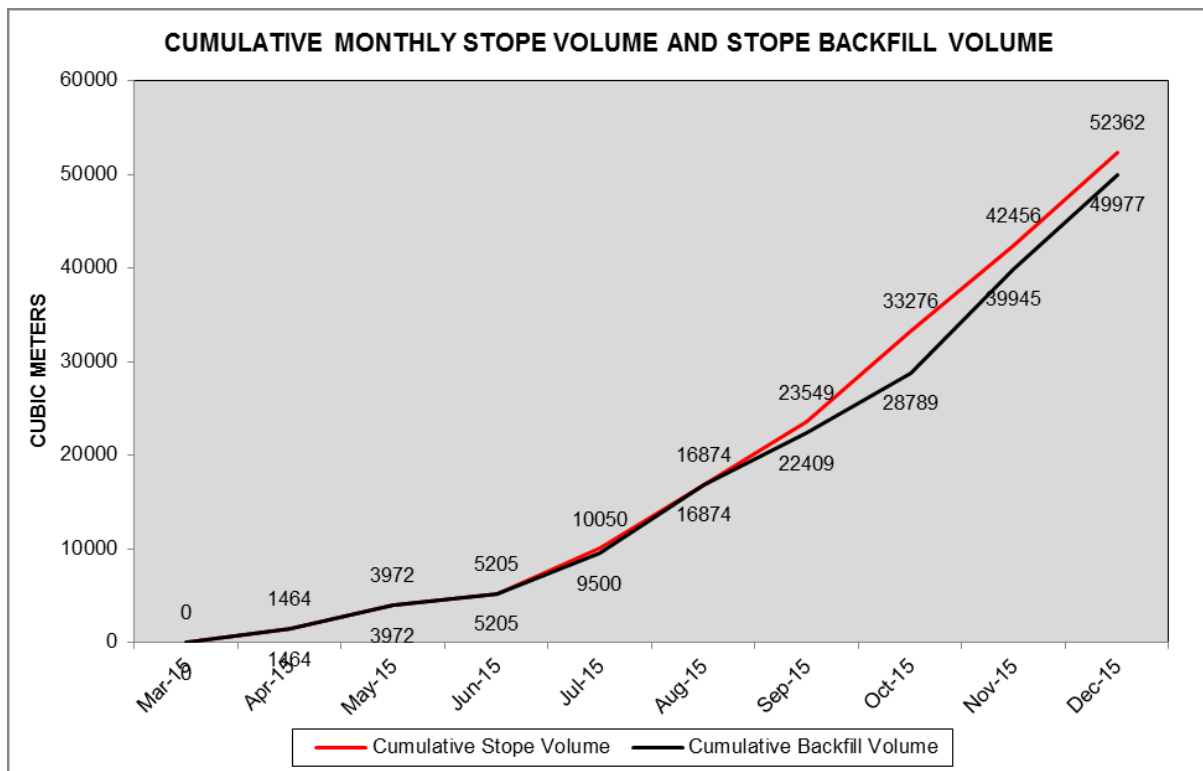
**Figure 1: Cumulative monthly stope voids and backfill volumes**

Minor stope extraction began in April 2015 during the development of the lowest drive at the 795 level (in the form of floor, wall and roof strips), with production stope blasting commencing in June 2015. Initially the smaller voids created were all backfilled during the same month. As the mine moved into full production, the production cycle meant some stopes are now in various states of backfill at the end of the month. By the end of the reporting period, 56,362m<sup>3</sup> of stope volume had been extracted, with 49,977m<sup>3</sup> backfilled (Figure 1) and mining had reached the 855 level.

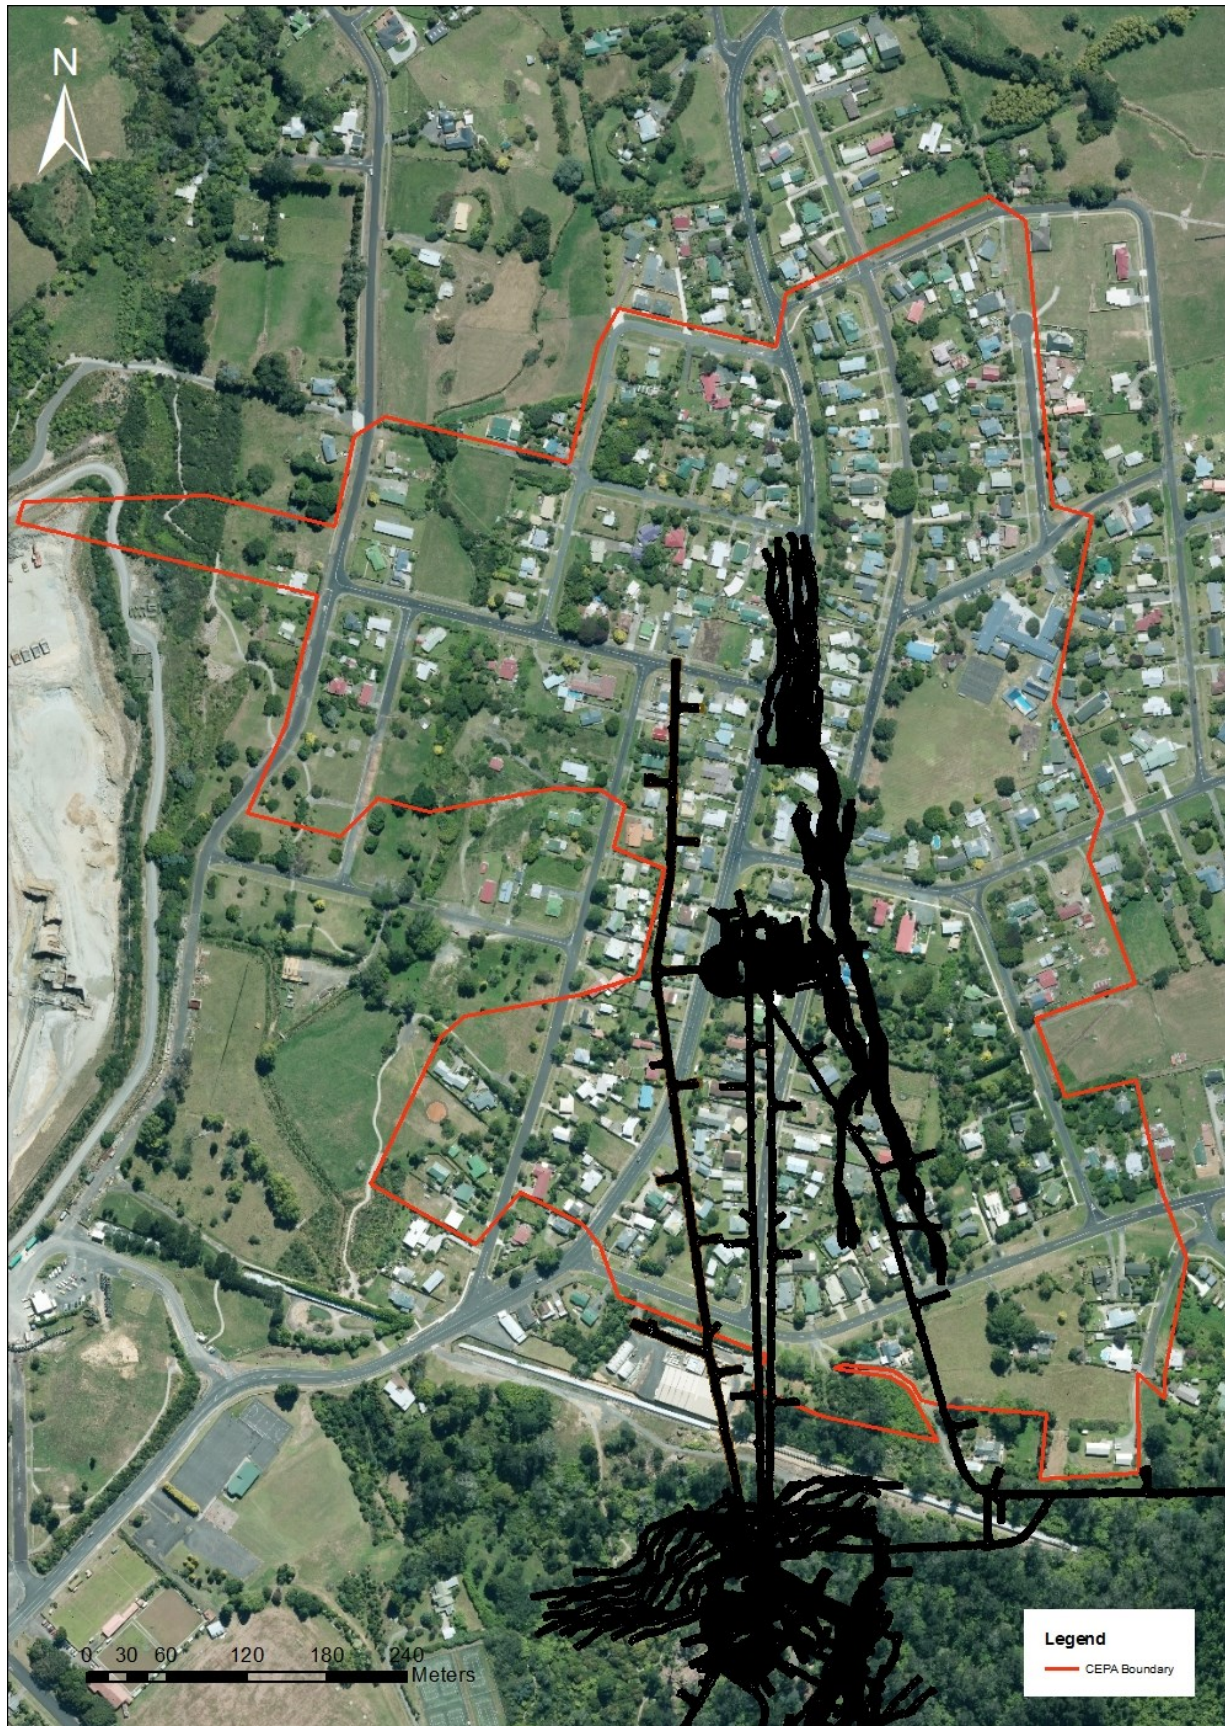
**Figure 6: Correnso Development – Plan View (with CEPA boundary)**

Figure 6 displays the current mine development overlying an aerial projection, with the CEPA boundary superimposed. Underground access to Correnso from Trio can be seen entering the south end of the CEPA boundary, with all subsequent Correnso works entirely within the consent boundary.

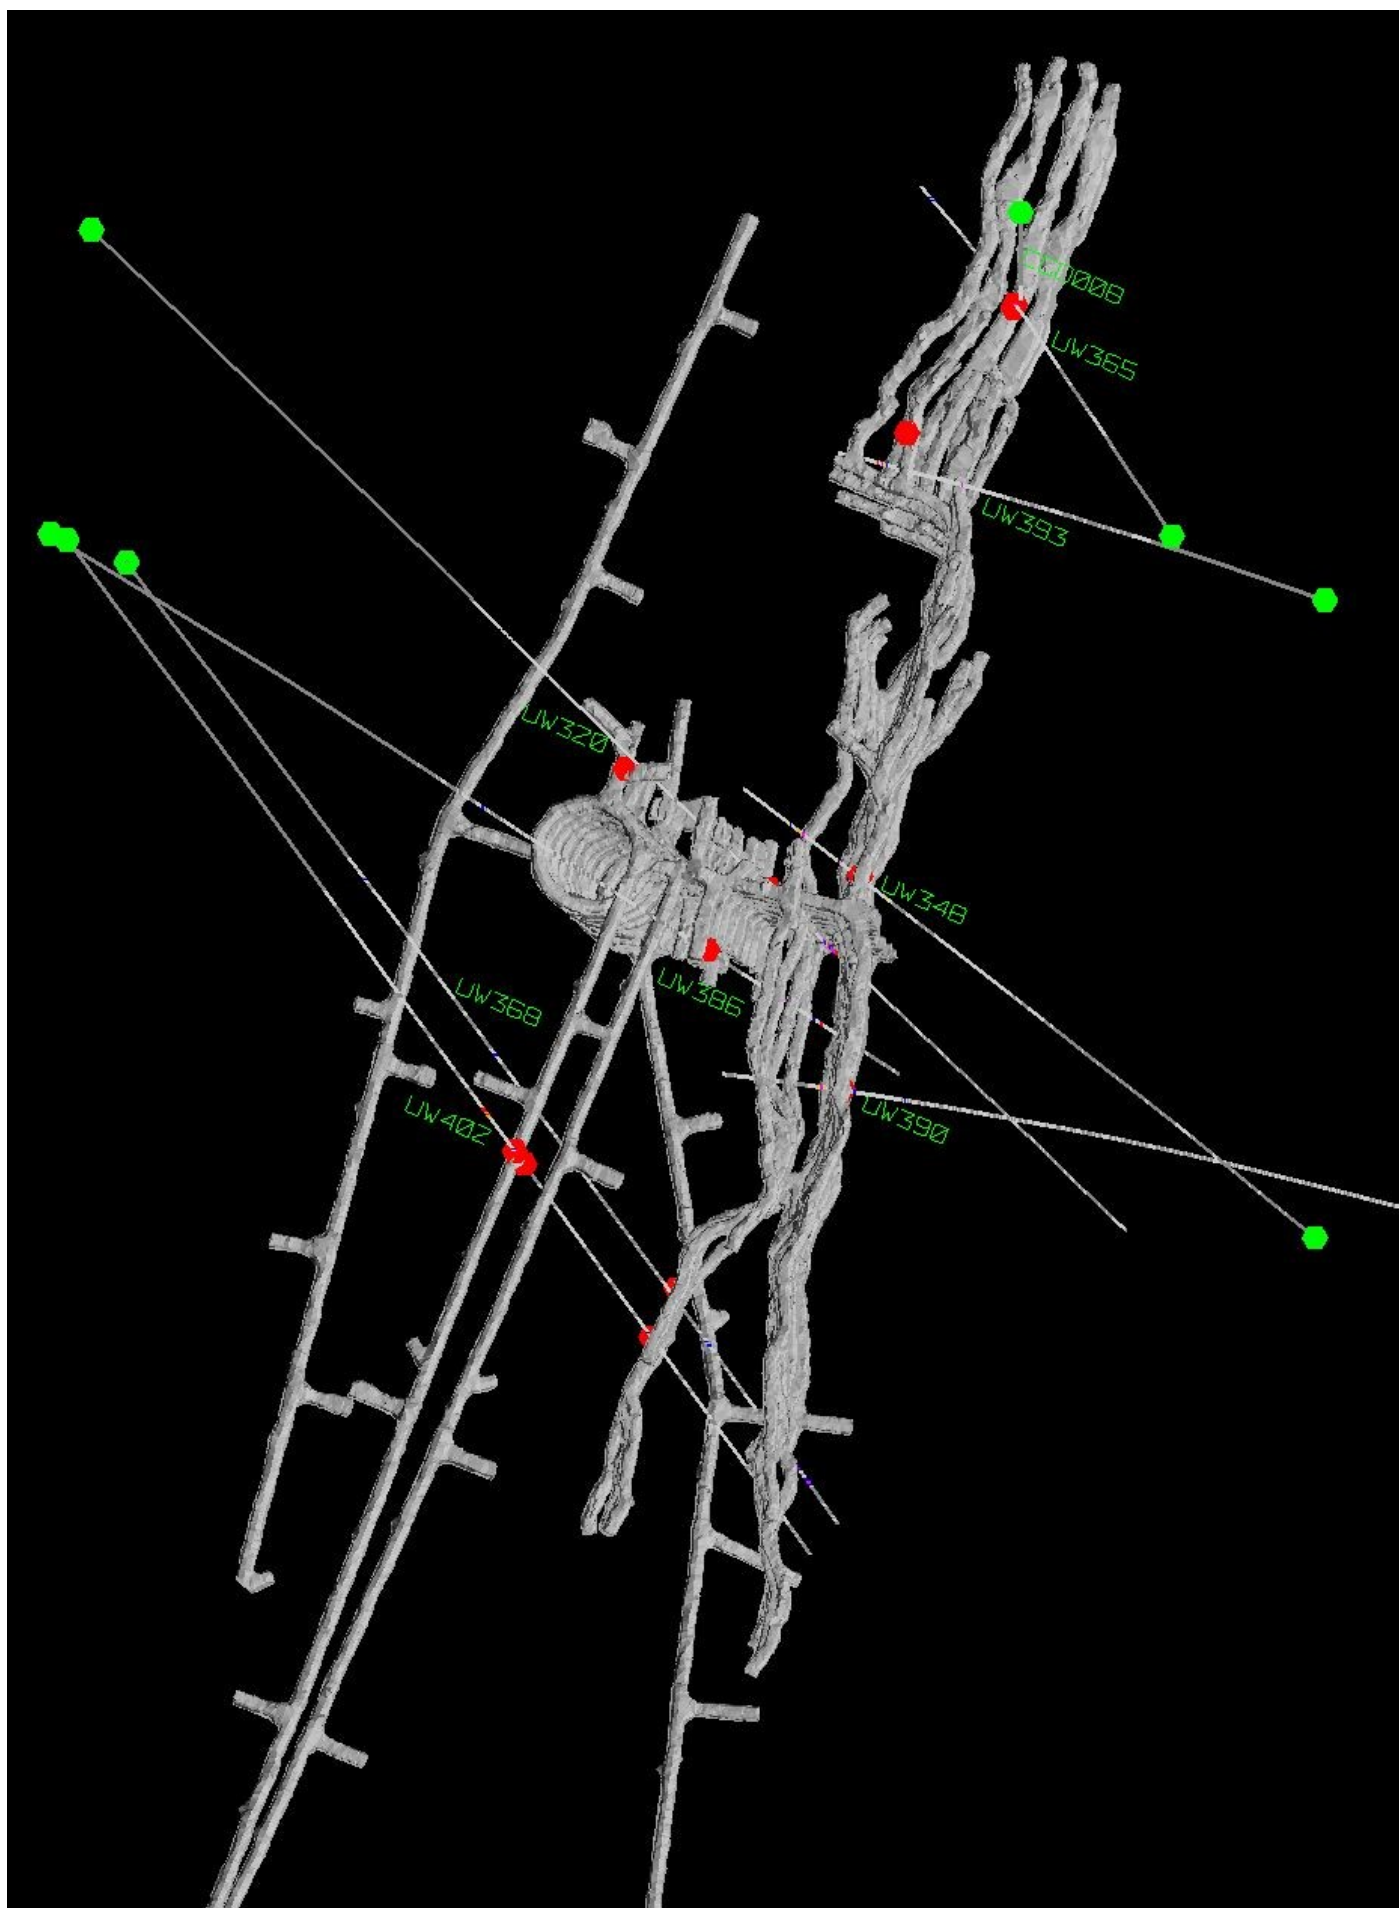
Hole ID	Level	Drive	E	N	mRL	Date intersected	Pickup	Grouting status	Comments
<b>CGD008</b>	810	C4-FW	396488.5	643473.4	821.4	13/06/2015	Estimated	Not grouted	Hole dry - no evidence of being a water conduit at this level: no Fe staining
<b>UW320</b>	912	ACC	396432.0	643265.1	917.8	13/04/2015	Surveyed	Not grouted	Hole dry
<b>UW348</b>	900	C1-N	396520.5	643263.4	907.6	14/12/2015	Estimated	Grouted	Trickling water which ceased within a day - grouted 16/12/2015
<b>UW365</b>	810	C4-FW	396488.4	643474.8	821.4	9/06/2015	Estimated	Not grouted	Hole dry
<b>UW368</b>	825	C7-S	396515.3	643114.2	833.1	26/08/2015	Surveyed	Grouted	Minor flow - hole re-grouted 16/12/2015
<b>UW386</b>	915	ORE PASS	396482.3	643218.5	914.9	4/02/2015	Surveyed	Not grouted	Hole dry - now in ore pass
<b>UW390</b>	840	C1-S	396541.4	643199.0	844.1	25/03/2015	Surveyed	Not grouted	Hole dry - no evidence of being a water conduit at this level: no Fe staining

<b>UW393</b>	840	C4-HW	396472.9	643416.3	851.4	16/08/2015	Estimated	Not grouted	Hole dry
<b>UW402</b>	953	CDD	396449.3	643126.9	930.5	17/12/2014	Surveyed	Grouted	Hole was producing minimal water for only a few hours
<b>UW402</b>	855	C7-S	396515.0	643092.4	864.6	18/10/2015	Surveyed	Not grouted	Dry - second time intersecting hole with development - was grouted on the 953

Overleaf is an oblique view looking north-west of Correnso development with surface drillholes intersected and their pierce points. (Green points are the drillhole collars in view while the red points are where the drillholes intersect development.)
