Correnso/SUPA Stability 2016 Annual Report

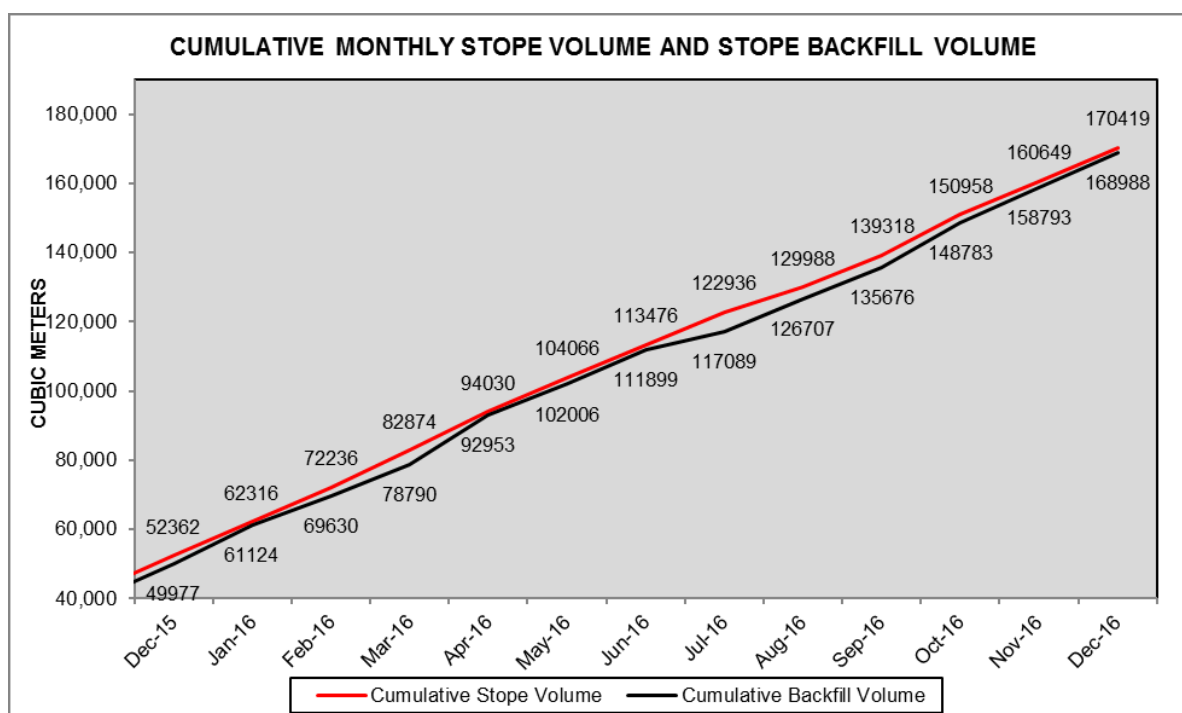
Figure 1: Cumulative monthly stope voids and backfill volumes 2016

Stope extraction began in mid 2015, with production continuing throughout 2016. At any one time, multiple stopes are in various states of the production cycle (drilling, blasted stocks, bogging, and backfilling). This means that some stopes may have open voids at the end of the month. By the end of the reporting period, 170,419m³ of stope volume had been extracted, with 168,988m³ backfilled (Figure 1) and mining had reached the 915 level.

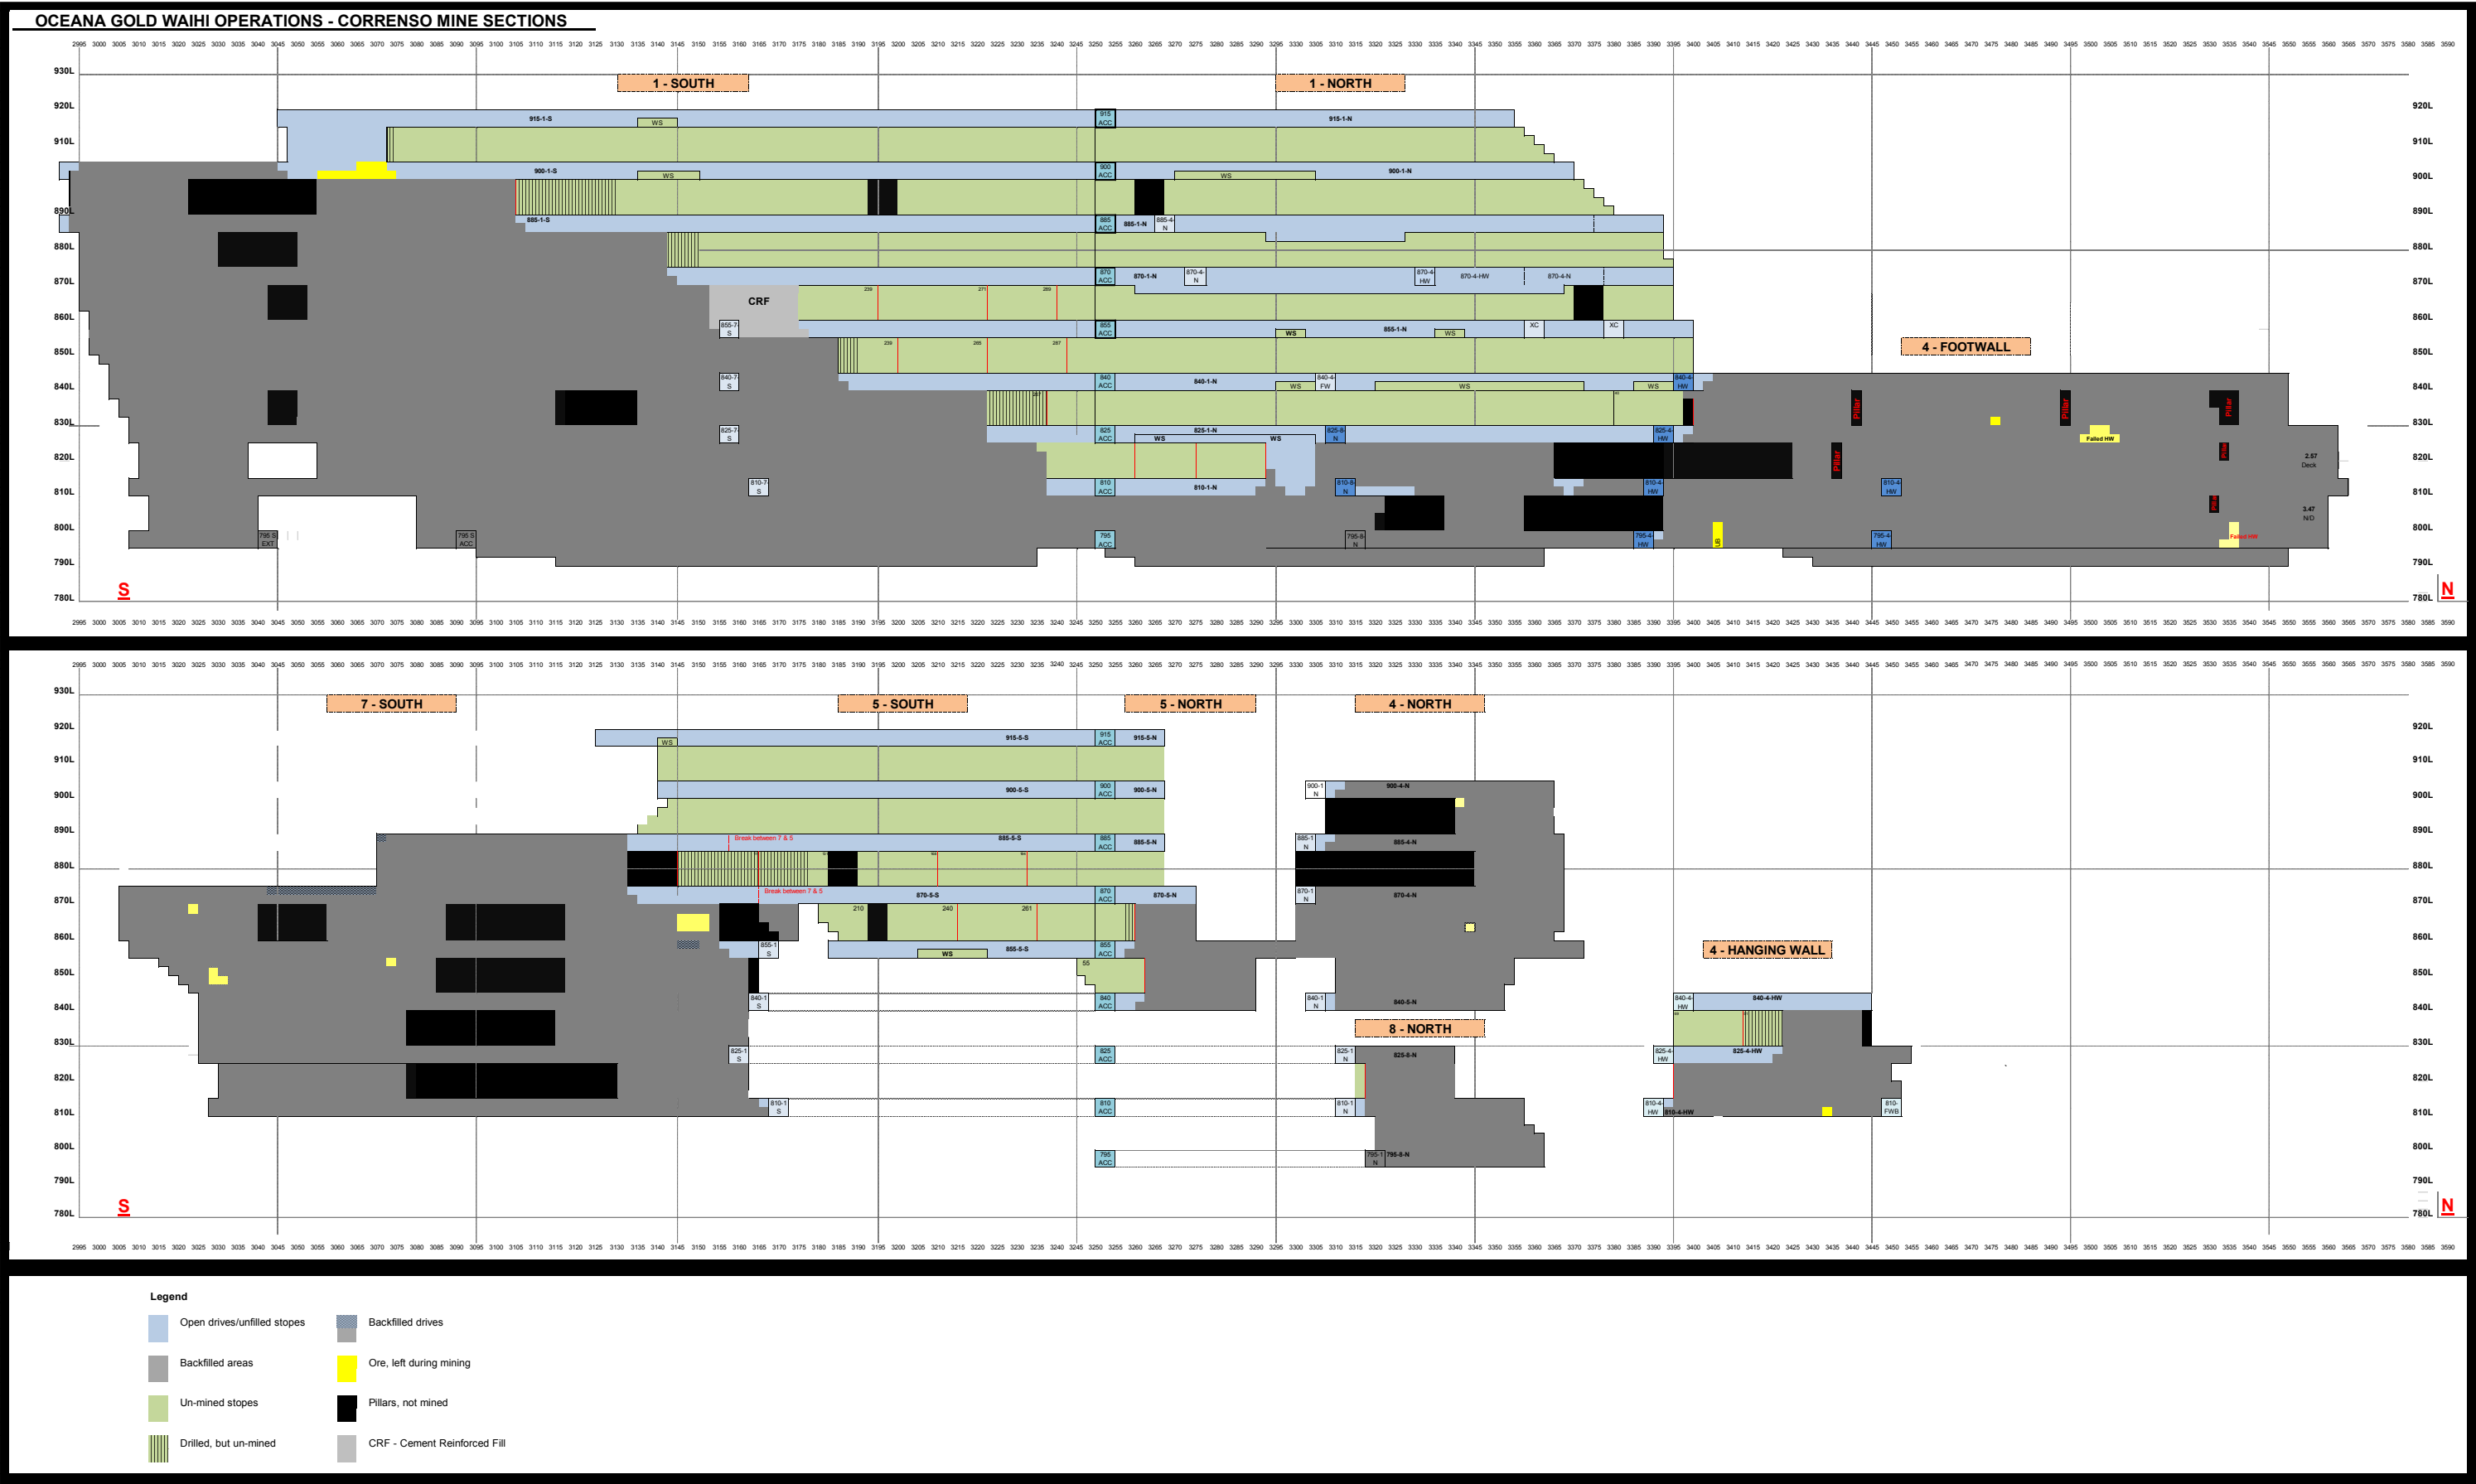
Figure 2: Schematic Long Section of Correnso Veins

While most of the mine development is along the main vein, mining of minor offshoot 'splay' veins occurs when viable. These are in various states of extraction (Figure 2) and are annotated in Figure 4.

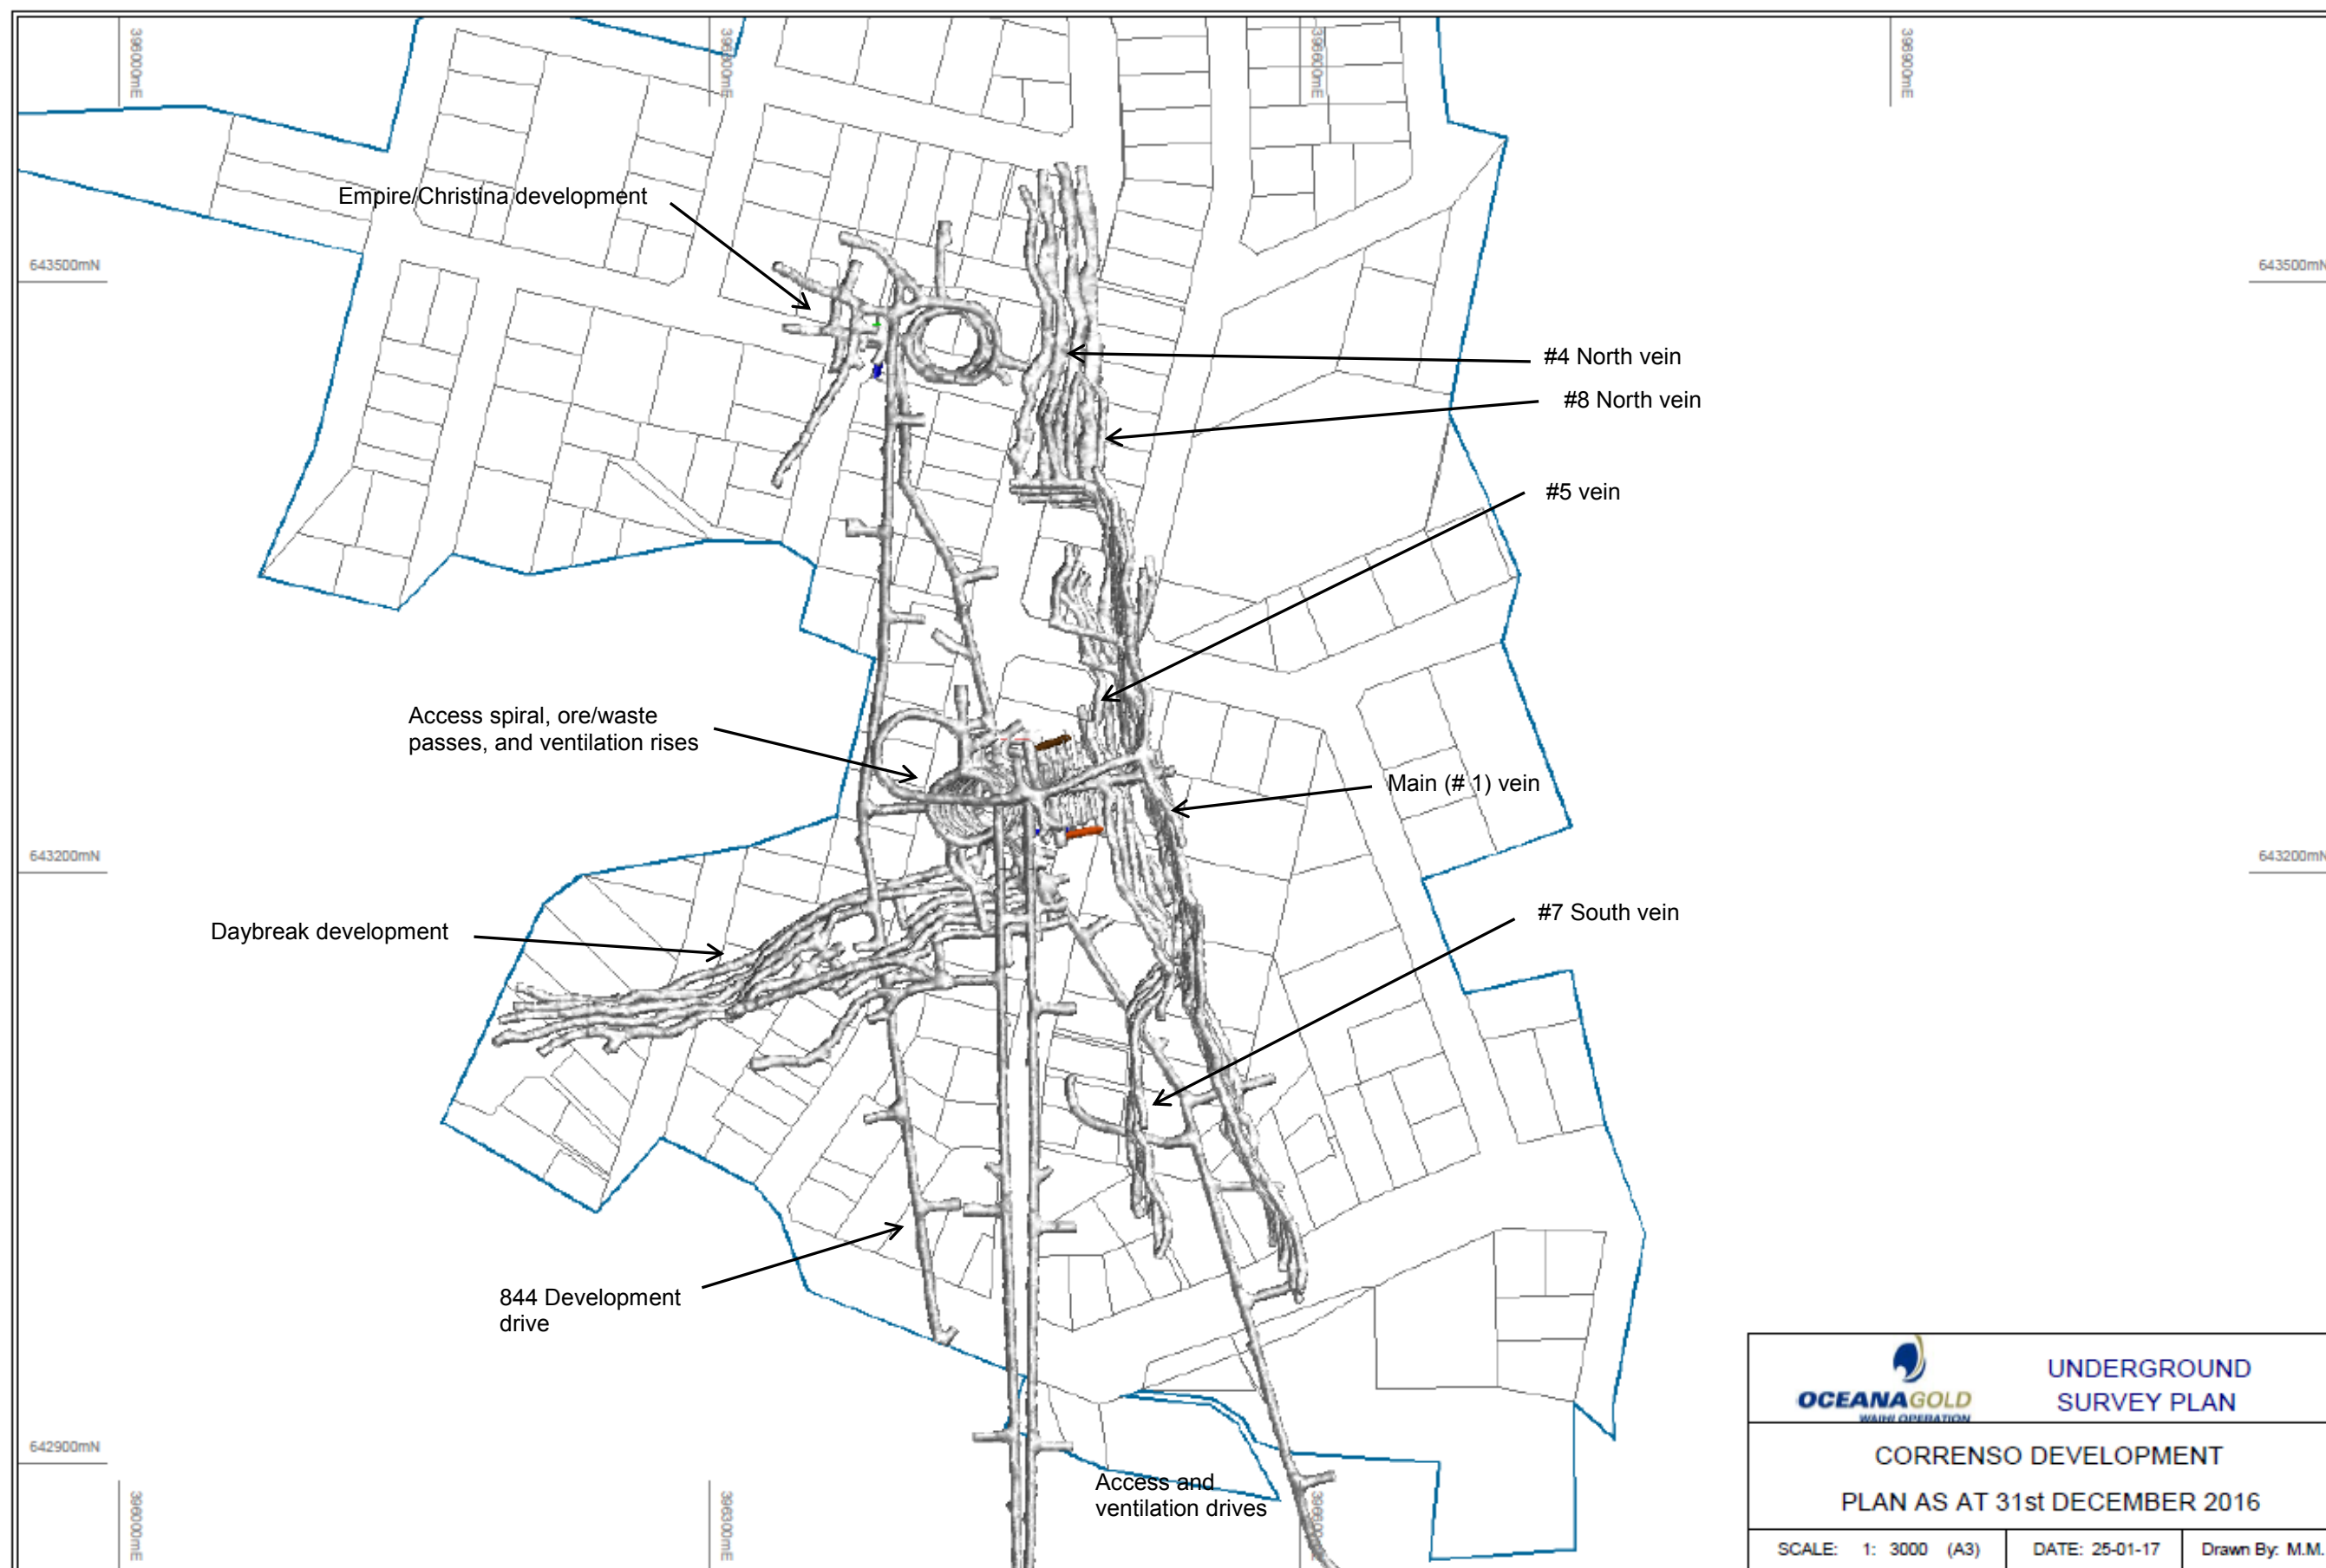
Figure 4: Correnso Development – Plan View (overlying property boundaries)

Figures 4 and 5 indicate development progress in Correnso as at 31 December 2016. As noted earlier, the SUPA boundary had not been crossed at year end.

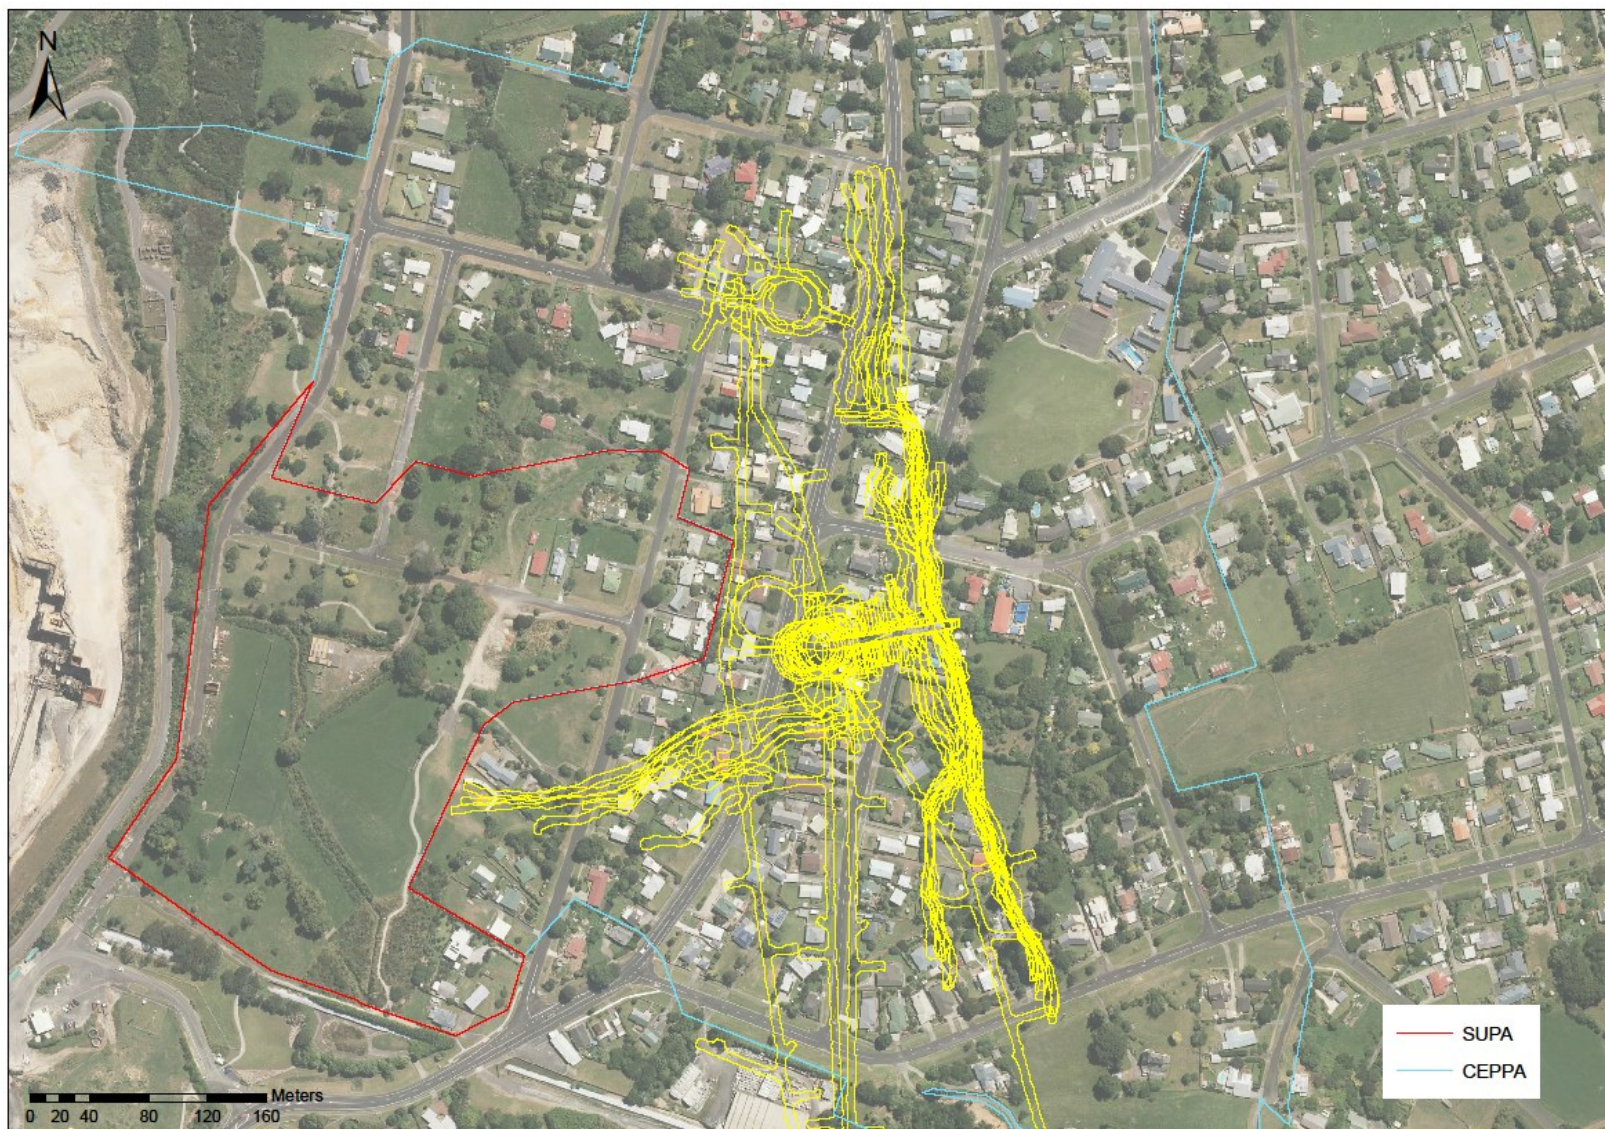
Figure 6: Correnso Development – Plan View (with CEPA and SUPA boundaries)

Figure 6 displays the current mine development overlying an aerial projection, with the CEPPA and SUPA boundaries superimposed. All current Correnso works are entirely within the CEPPA consent boundary, and the SUPA boundary was not crossed during the year.

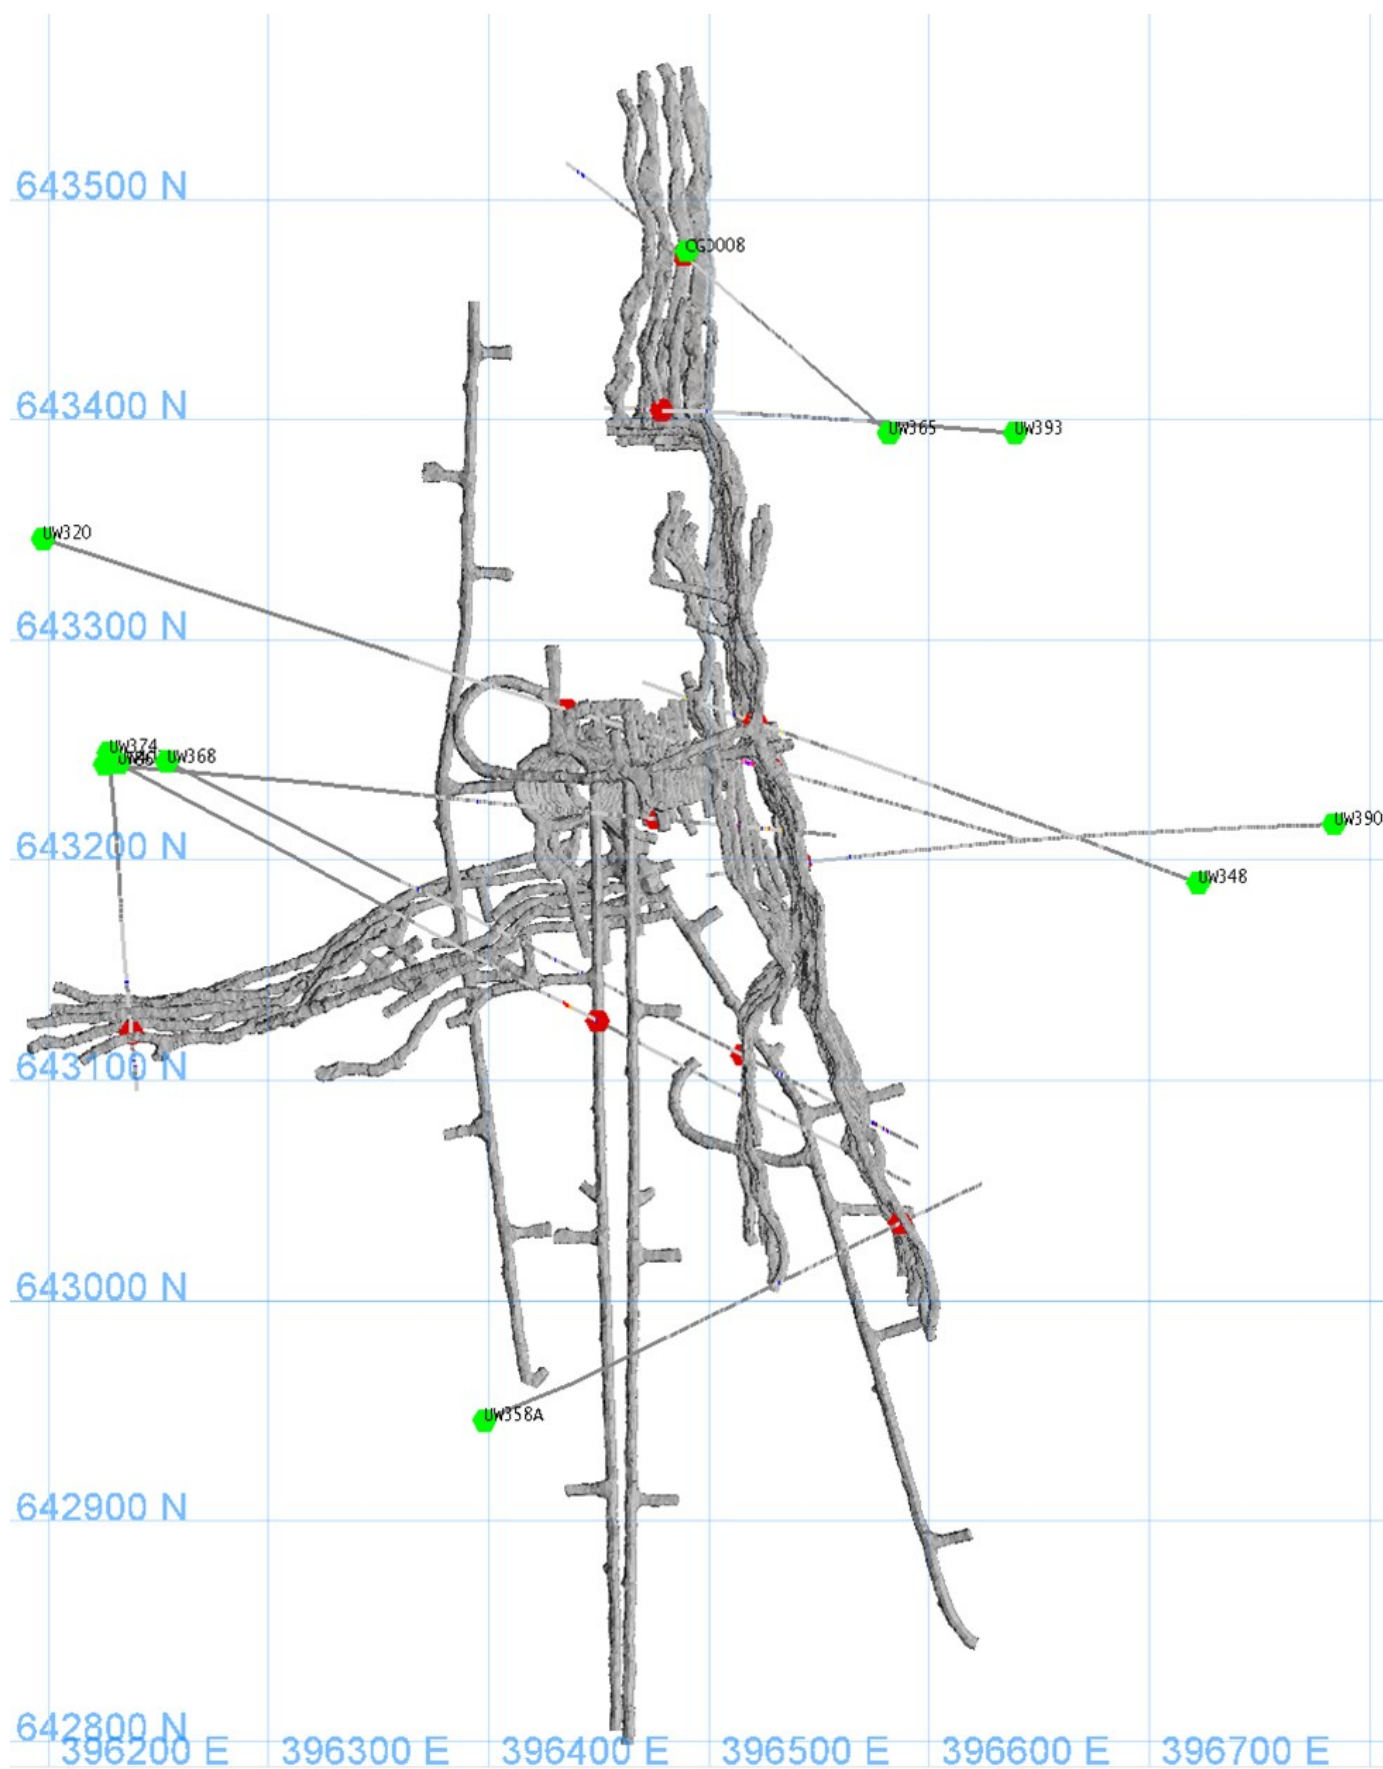
Hole ID	Level	Drive	E	N	mRL	Date intersected	Pickup	Grouting status	Comments
CGD008	810	C4-FW	396488.5	643473.4	821.4	13/06/2015	Estimated	Not grouted	Hole dry - no evidence of being a water conduit at this level: no Fe staining
UW320	912	ACC	396432.0	643265.1	917.8	13/04/2015	Surveyed	Not grouted	Hole dry
UW348	900	C1-N	396520.5	643263.4	907.6	14/12/2015	Estimated	Grouted	Trickling water which ceased within a day - grouted 16/12/2015
UW 358A	900	C1-S	396586.7	643035.2	910.6	27/07/2016	Estimated	Grouted	Low flow, originally grouted within 12 hours, re-grouted after 36 hours. Surrounding split sets grouted as were acting as a conduit. Flow was approximately 1ltr/min.
UW365	810	C4-FW	396488.4	643474.8	821.4	9/06/2015	Estimated	Not grouted	Hole dry
UW368	825	C7-S	396515.3	643114.2	833.1	26/08/2015	Surveyed	Grouted	Minor flow - hole re-grouted 16/12/2015
UW386	915	ORE PASS	396482.3	643218.5	914.9	4/02/2015	Surveyed	Not grouted	Hole dry - now in ore pass

UW390	840	C1-S	396541.4	643199.0	844.1	25/03/2015	Surveyed	Not grouted	Hole dry - no evidence of being a water conduit at this level: no Fe staining
UW393	840	C4-HW	396472.9	643416.3	851.4	16/08/2015	Estimated	Not grouted	Hole dry
UW402	953	CDD	396449.3	643126.9	930.5	17/12/2014	Surveyed	Grouted	Hole was producing minimal water for only a few hours
UW402	855	C7-S	396515.0	643092.4	864.6	18/10/2015	Surveyed	Not grouted	Dry - second time intersecting hole with development - was grouted on the 953
UW374	860	DB-HWW	396237.7	643120.7	871.9	16/12/2016	Surveyed	Not grouted	Hole was dry, no indication of previous water – i.e. no Fe staining, etc.

Overleaf is plan view of Correnso and Daybreak development with surface drillholes intersected and their pierce points (no surface holes have yet been intersected by Empire development). Green points indicate the drillhole collars in view while the red points indicate the approximate intersection point of surface drillholes with development.
