Geotechnical Study Martha Open Pit  
Phase 4  
(PSM)

**PROJECT MARTHA**  
**GEOTECHNICAL STUDY MARTHA OPEN PIT PHASE 4**

**PSM125-282R Rev 2      MAY 2018**

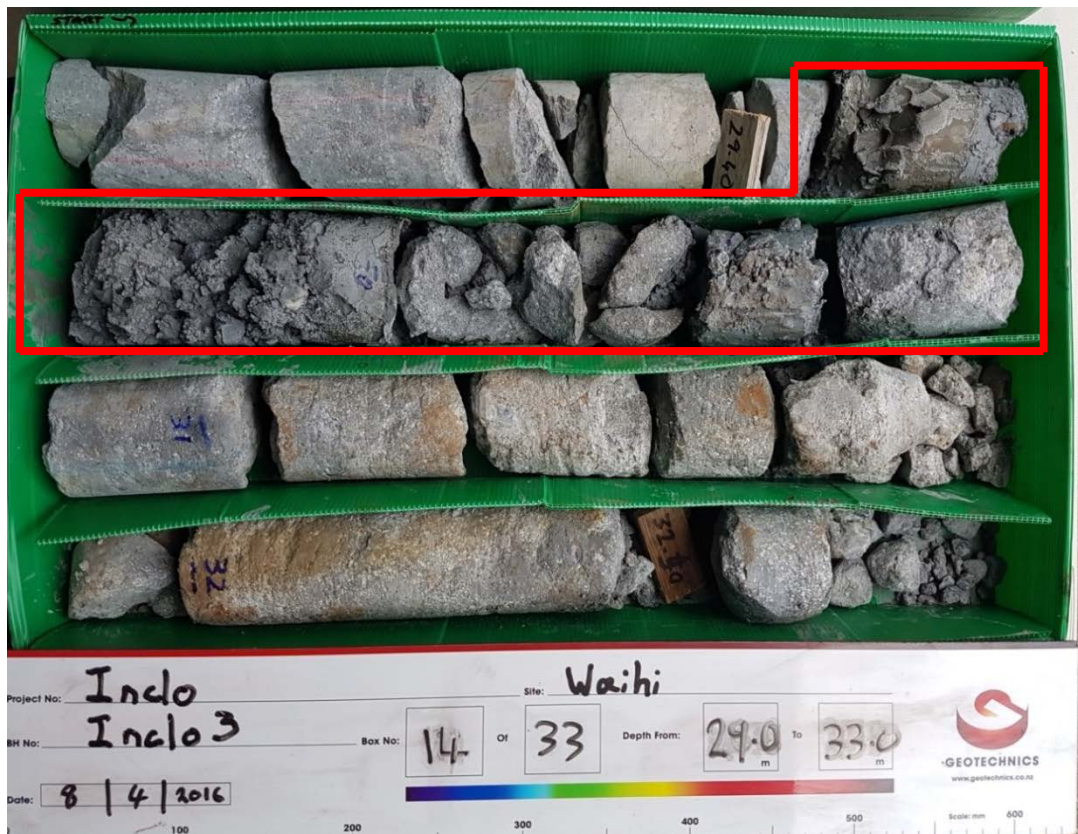
PLATE 1

Core photo of fault in INCLO\_003, highlighted in red.  
 Note 0.9m of core loss over interval

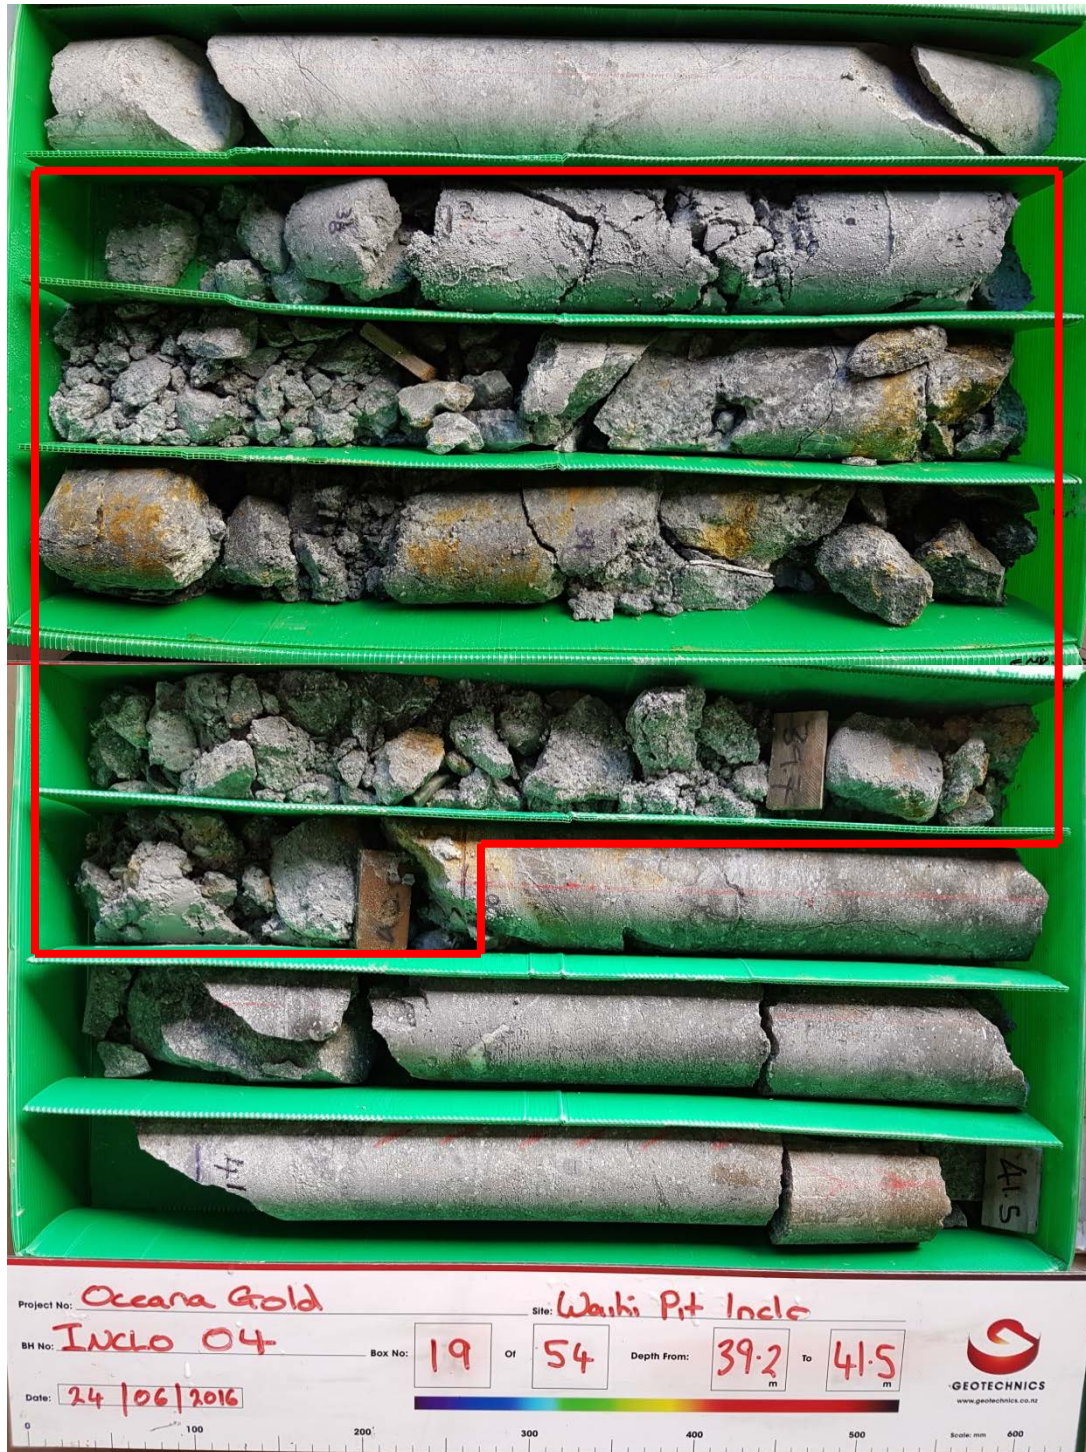
PLATE 2

Core photo of fault in INCLO\_004, highlighted in red.  
 Note 0.2m of core loss over interval
