# Correnso/SUPA/MDDP Stability 2017 Annual Report

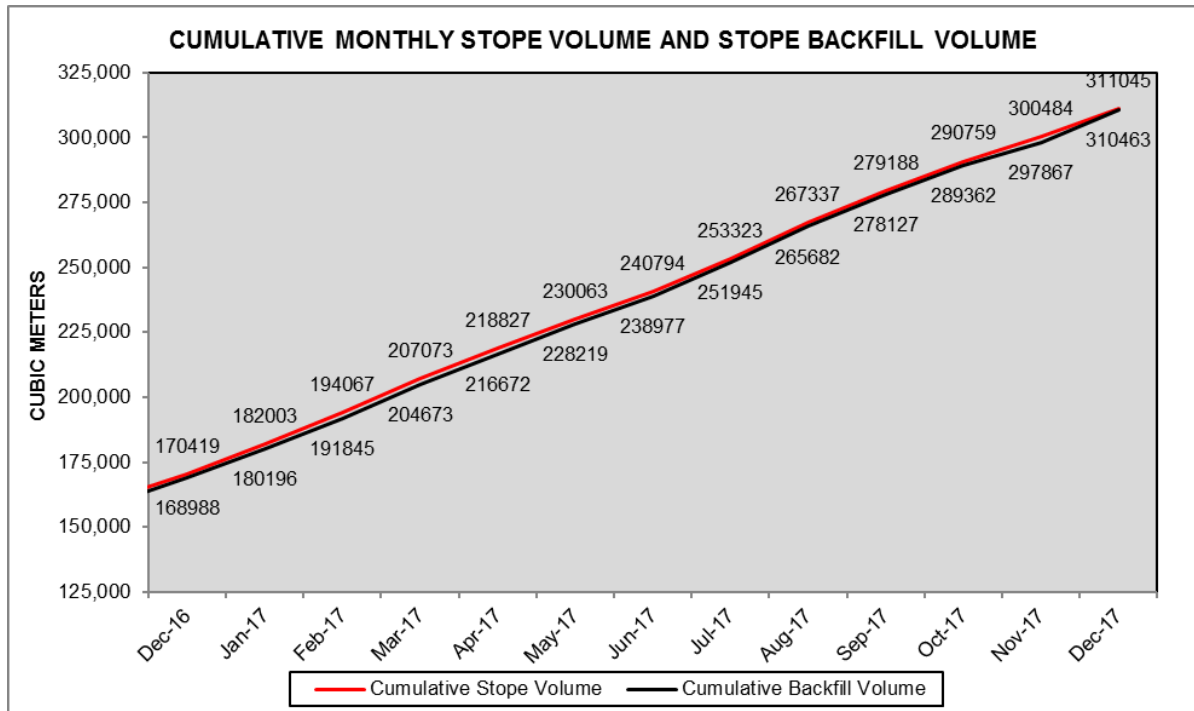
Stope extraction began in mid-2015, with production continuing throughout 2016 and 2017. At any one time, multiple stopes are in various states of the production cycle (drilling, blasted stocks, bogging, and backfilling). This means that some stopes may have open voids at the end of the month. By the end of the reporting period, 311,045m<sup>3</sup> of stope volume had been extracted, with 31,046m<sup>3</sup> backfilled (Figure 1) and mining had reached the 915 level.

**Figure 1: Cumulative monthly stope voids and backfill volumes 2017**

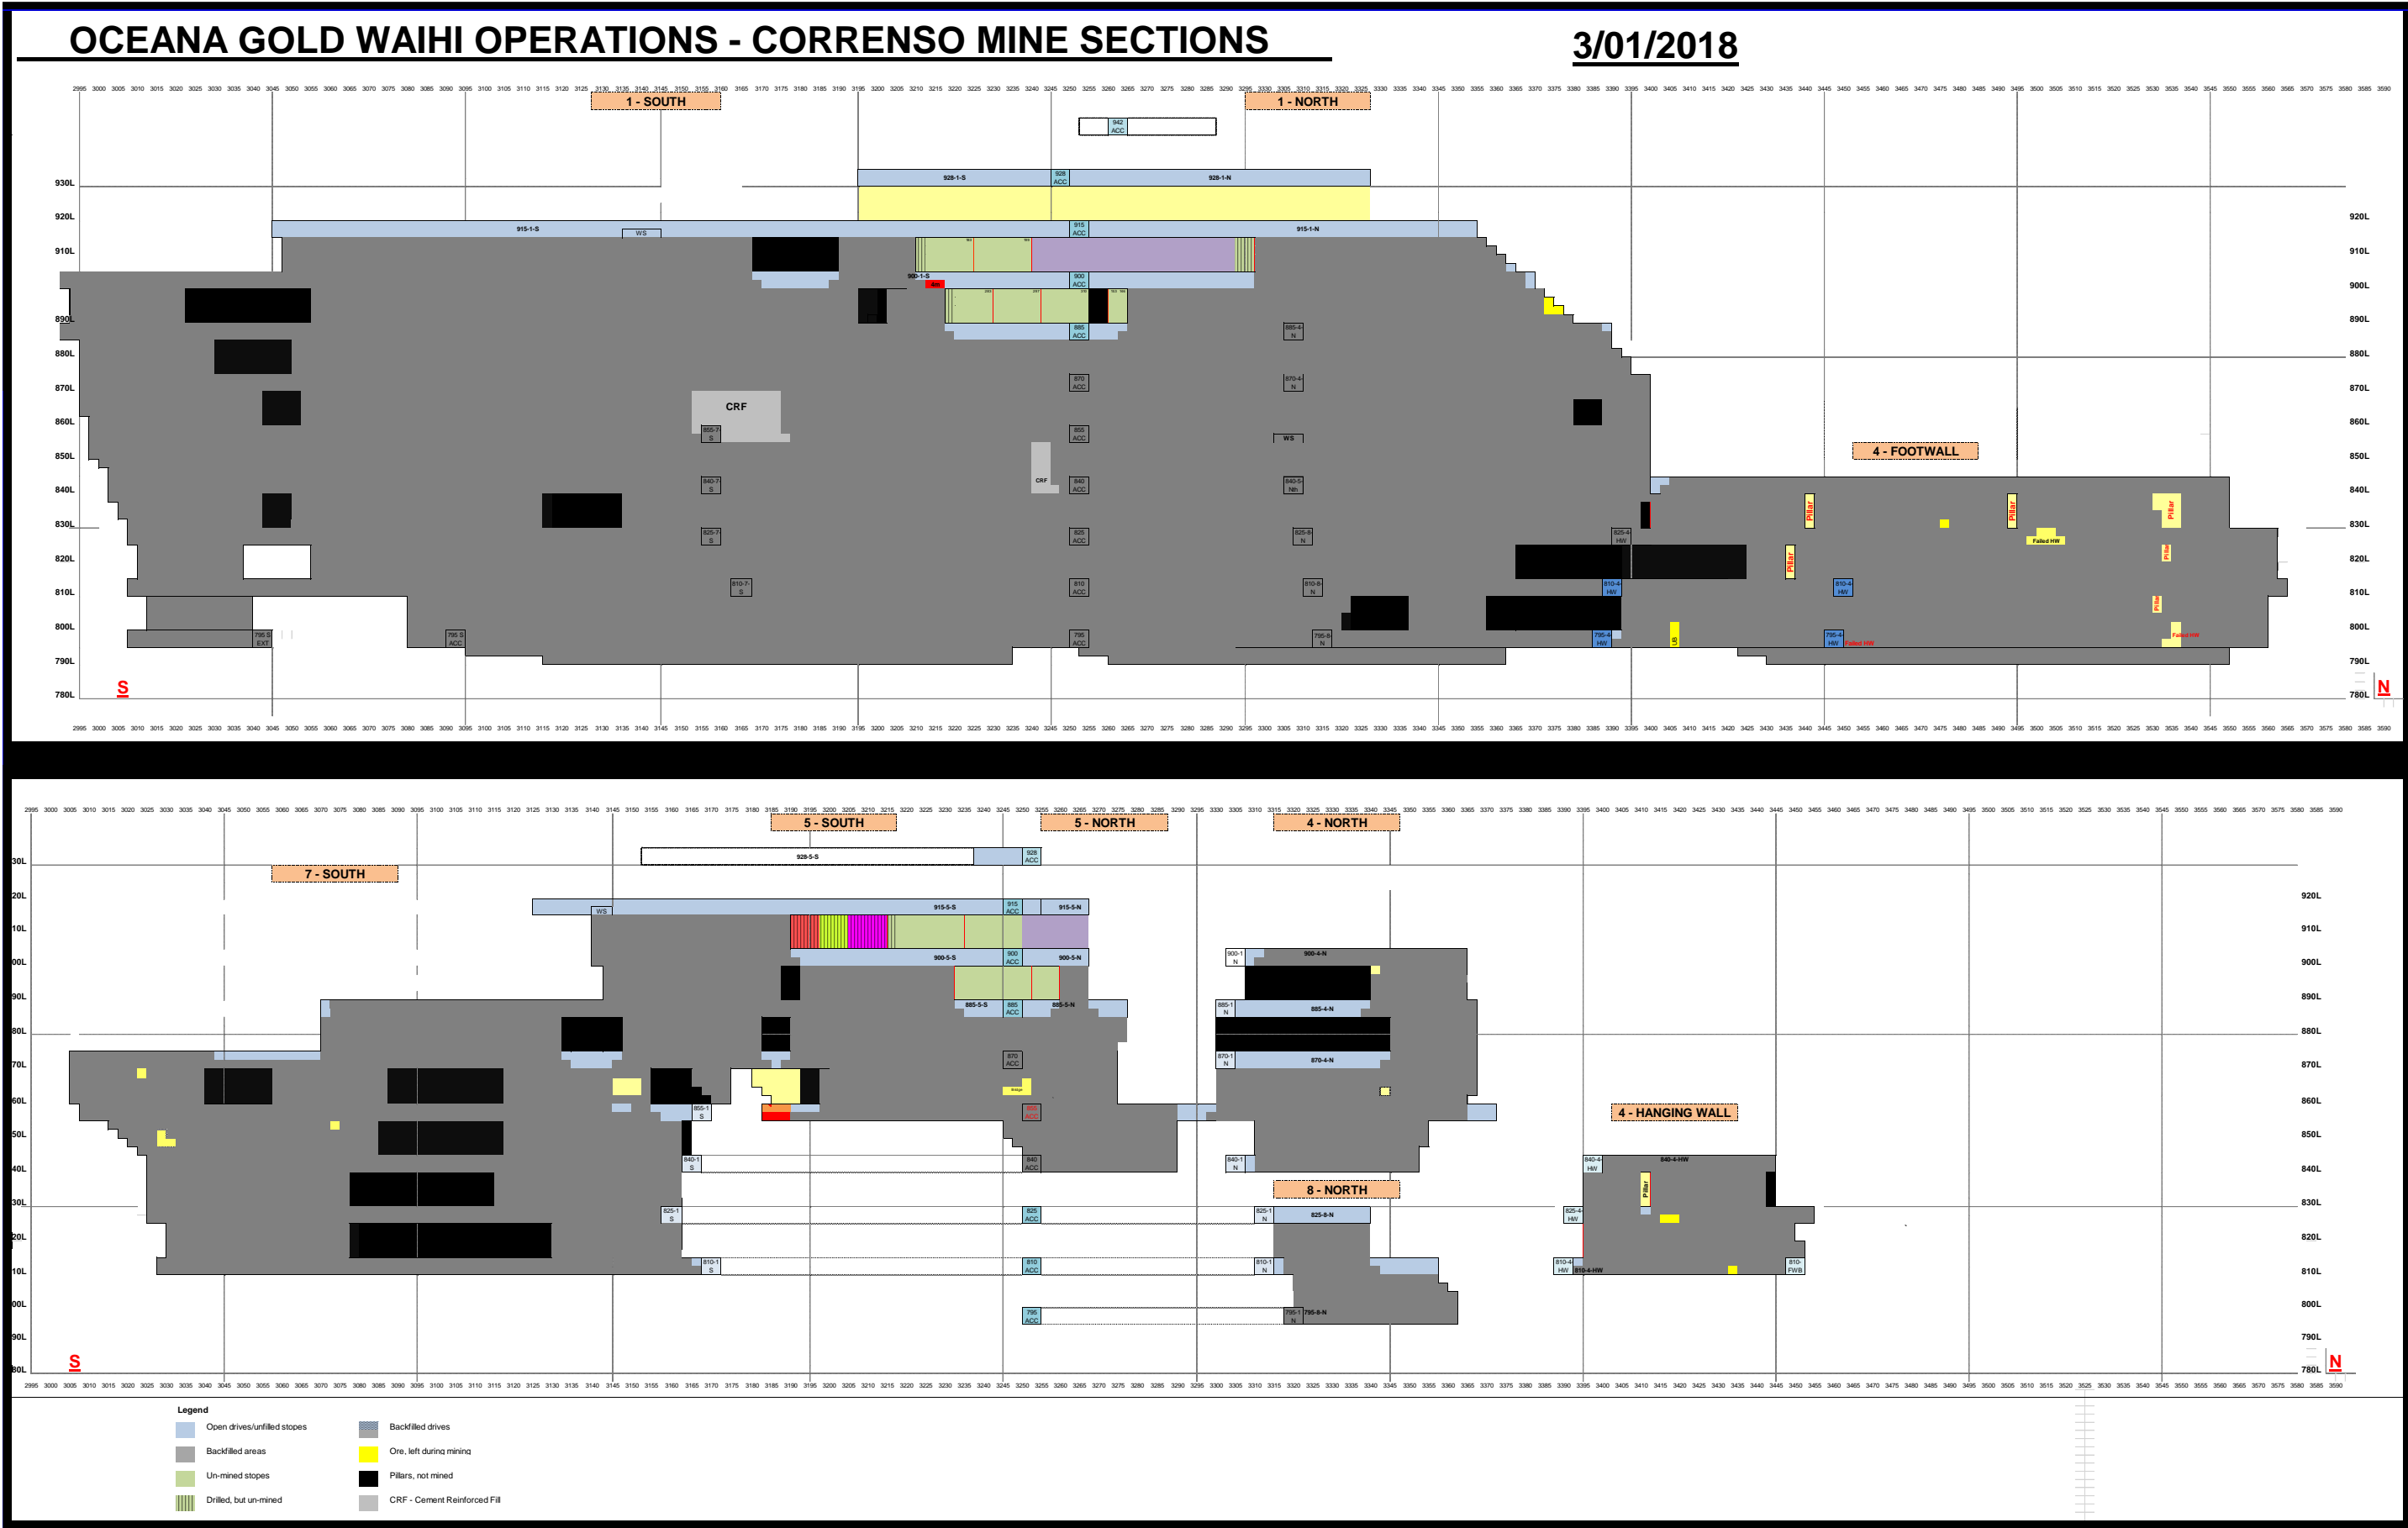
Figure 2: Schematic Long Section of Correnso Veins

Mining during 2017 extracted the lower levels of Correnso which are now backfilled and closed off. (Figure 2). The upper levels of Correnso have overall steeper to sub-vertical vein orientations in relatively good ground conditions. Very few problematic areas have been encountered apart from areas of converging veins where both veins are extracted. These has been successfully managed through appropriate mine sequencing, additional reinforcement and prioritising back-filling.

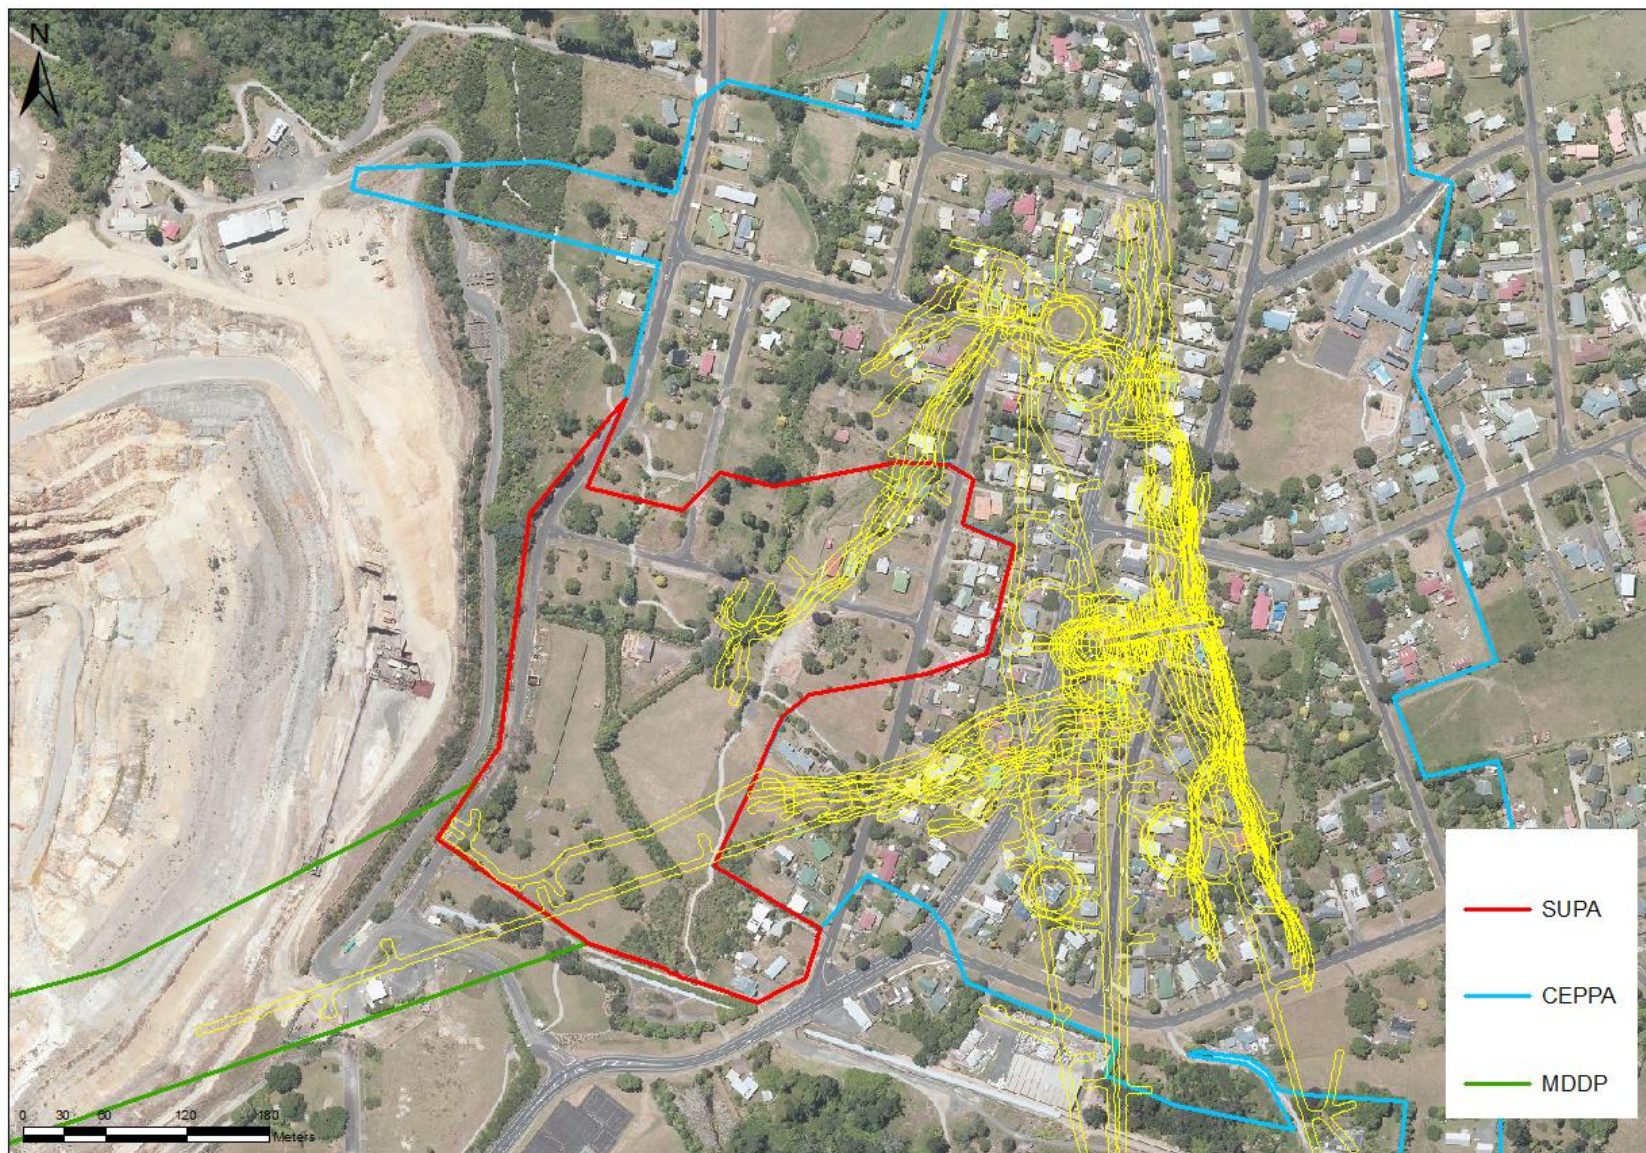
Figure 8 displays the current mine development overlying an aerial projection, with the consent boundaries superimposed. All current works are entirely within the consent boundaries.

Figure 8: Correnso Development – Plan View (with CEPA, SUPA & MDDP boundaries)

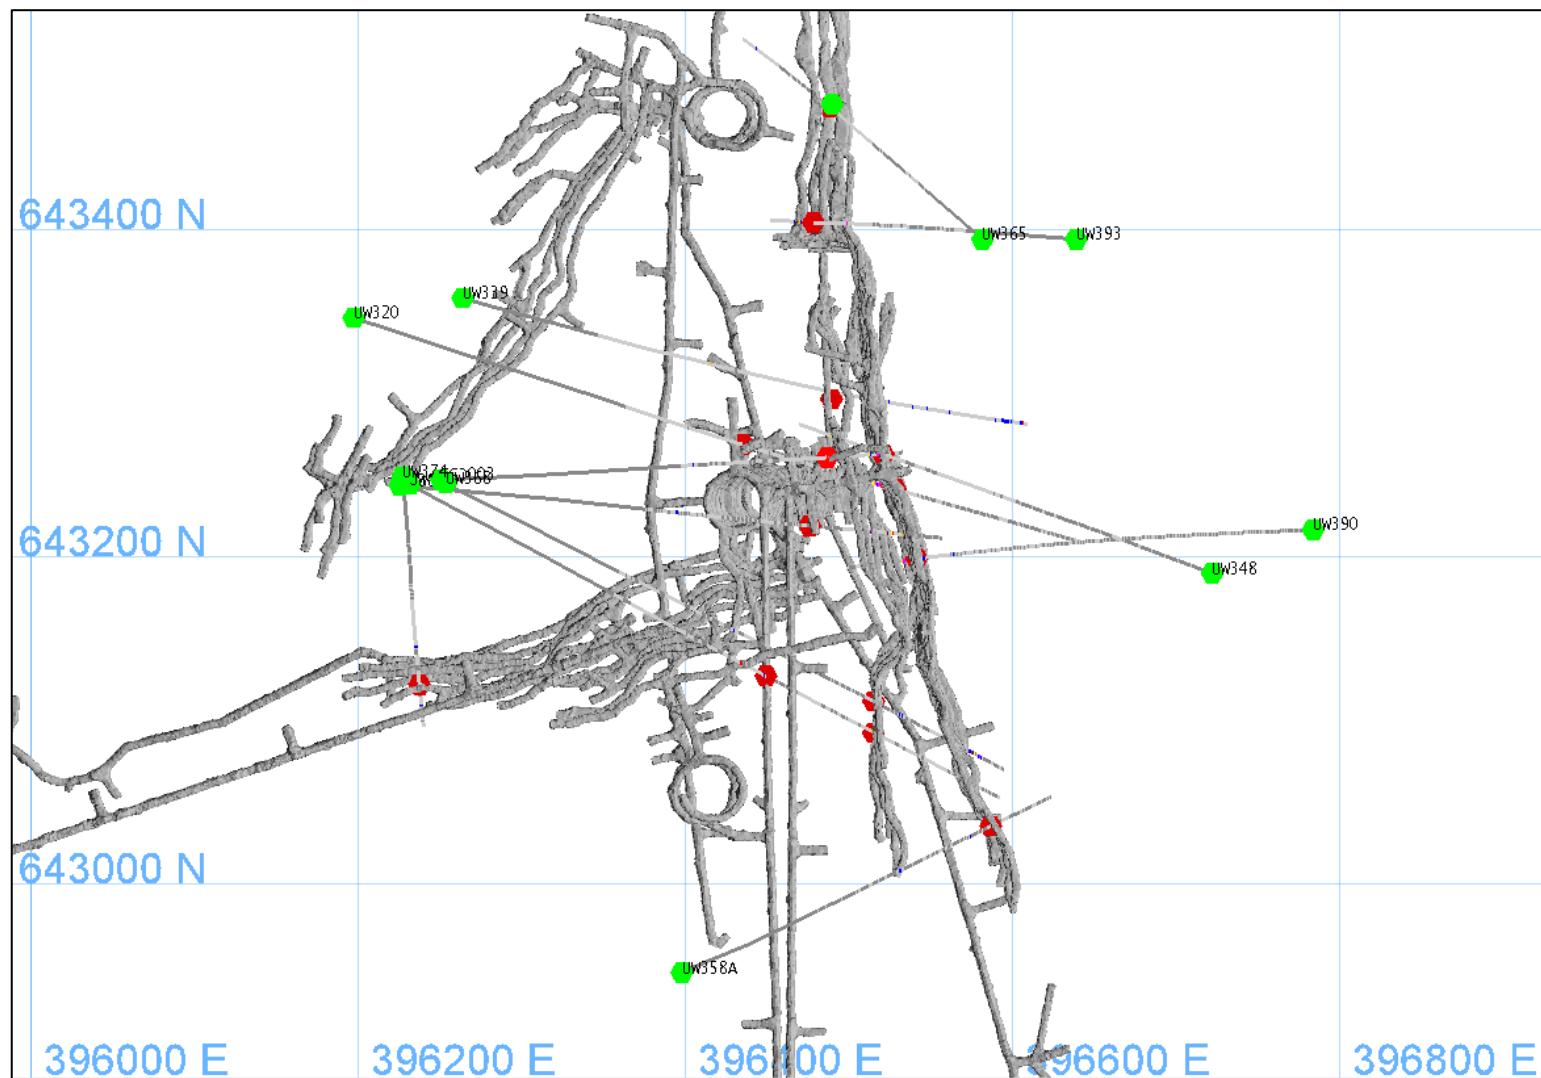
- f) Interception of surface-drilled holes with water flows, and their treatment  
There were no surface drillholes intercepted with any significant water-flows during 2017 (refer Appendix B).

Below is a plan view section showing development on Correnso, Daybreak and Empire mine areas. Surface drillholes which intersect development, along with their pierce points, are shown; green points indicate the drillhole collars in the view while the red points indicate the approximate intersection point of surface drillholes with development (no surface holes have yet been intersected by Empire development).
