Martha Shallow and Deep Aquifer Report

Document Reference: WAI-200-REP-011-001

MARTHA SHALLOW AND DEEP AQUIFER REPORT 2019

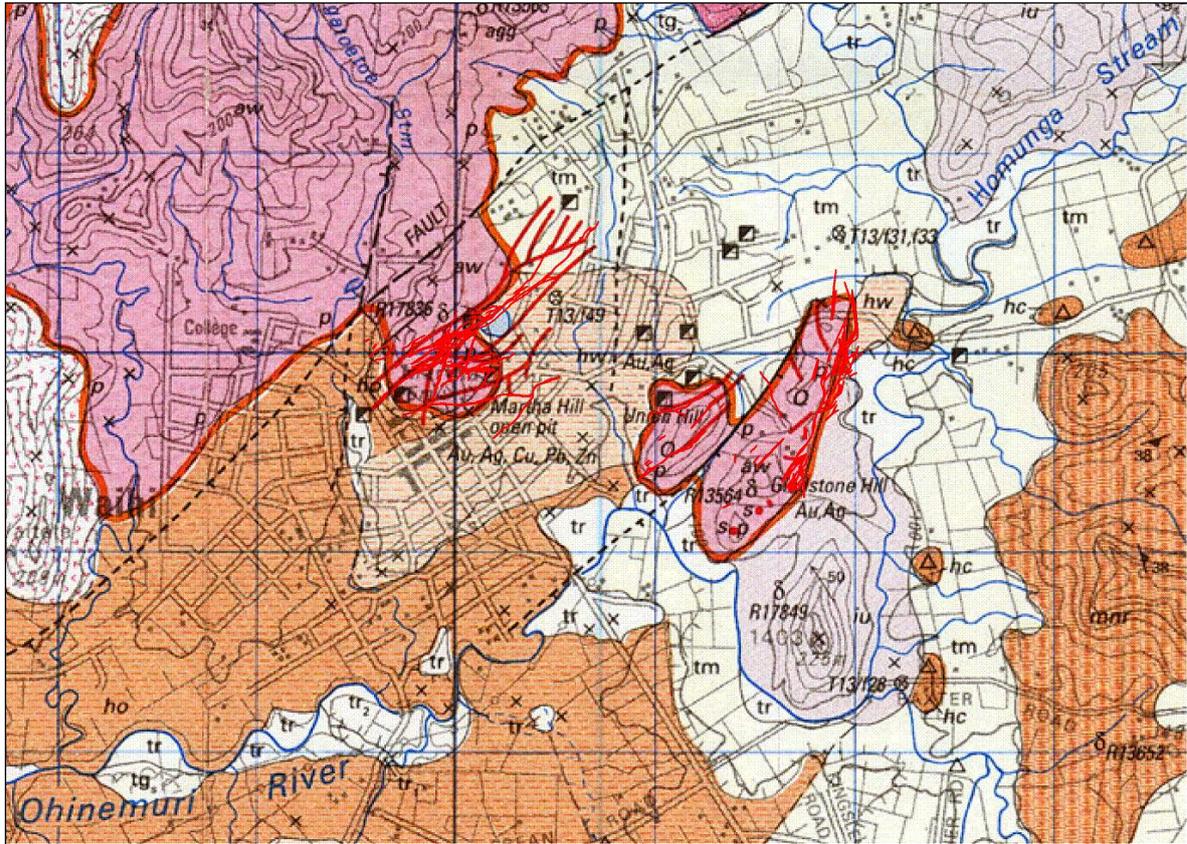
Figure 1(a) Geology Map of Waihi showing distribution of andesite (aw), younger volcanics (ho & hw) and alluvium (tm & tr). The Martha and Favona vein systems (Gladstone Hill area) are defined as fine red lines (derived by exploration and mining surveys).

The mineralised vein deposits of the Martha, Favona, Trio and Correnso zones are hosted by altered andesitic lava flows, breccias and tuffs (Figure 1a). The host andesites of Miocene age extend to depths greater than 600m and are extensively modified in places by weathering and hydrothermal alteration. Paleo-weathering and hydrothermal alteration have created an extensive low-permeability clay-rich cap within the upper part of the andesite sequence. This cap generally separates the andesites hydrogeologically from a younger overlying sequence of rhyolitic ignimbrite flows and alluvial boulder beds and prevents the younger volcanic deposits from being fully dewatered. Exposure of the altered andesite in the southern wall of the Martha Pit indicates that the weathered clay cap may extend up to 30 metres in thickness. Dewatering of the andesites is considered to contribute little to the development of settlement around the mine site due to the stiffness of these rocks.

The uppermost layer of alluvium is discontinuous beneath Waihi township (Figure 1a) and is located in areas where old streams and river channels are cut into the top of the ignimbrites, rhyolitic tephra and andesite. Alluvial deposits are extensive east of Waihi where they are associated with the drainage systems of the Ohinemuri River catchment. Groundwater in the alluvial formation (and the upper weathered contact of the younger volcanics) is monitored to depths of less than 10m.

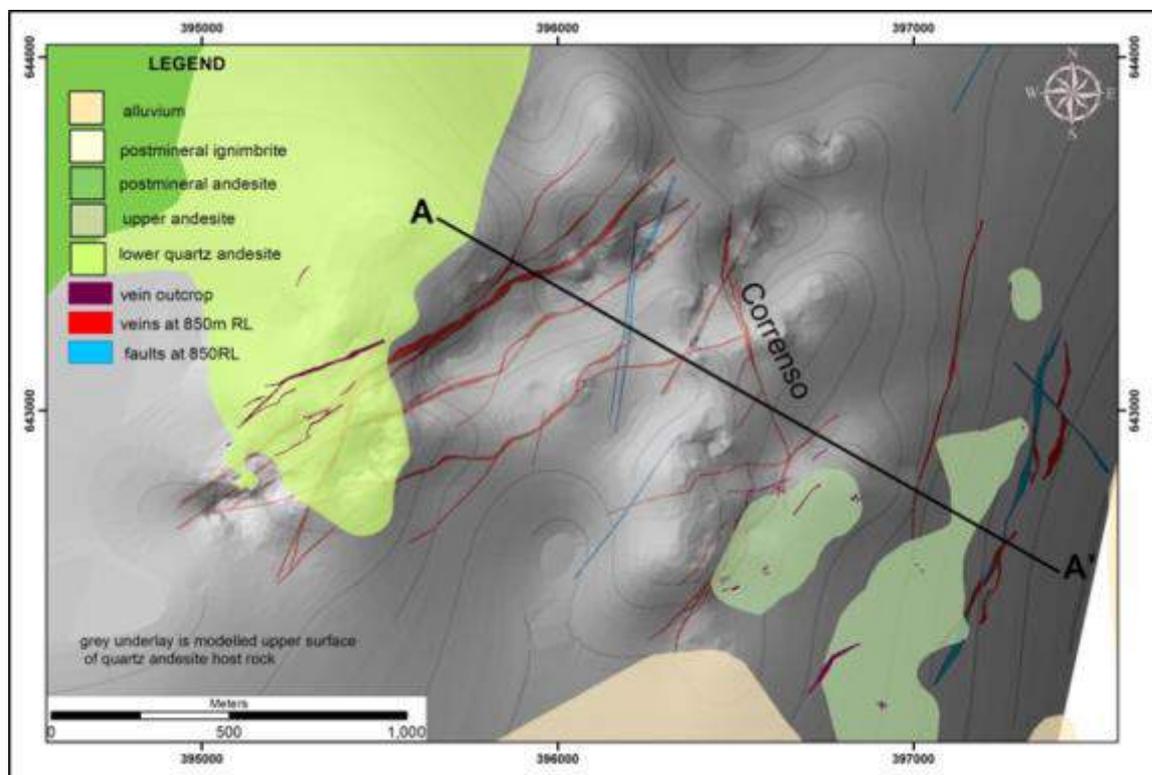
Figure 1(b) Veins and faults from around Martha & Favona mines, showing projected Correnso (J Hobbins, OGNZL Exploration Dept.).

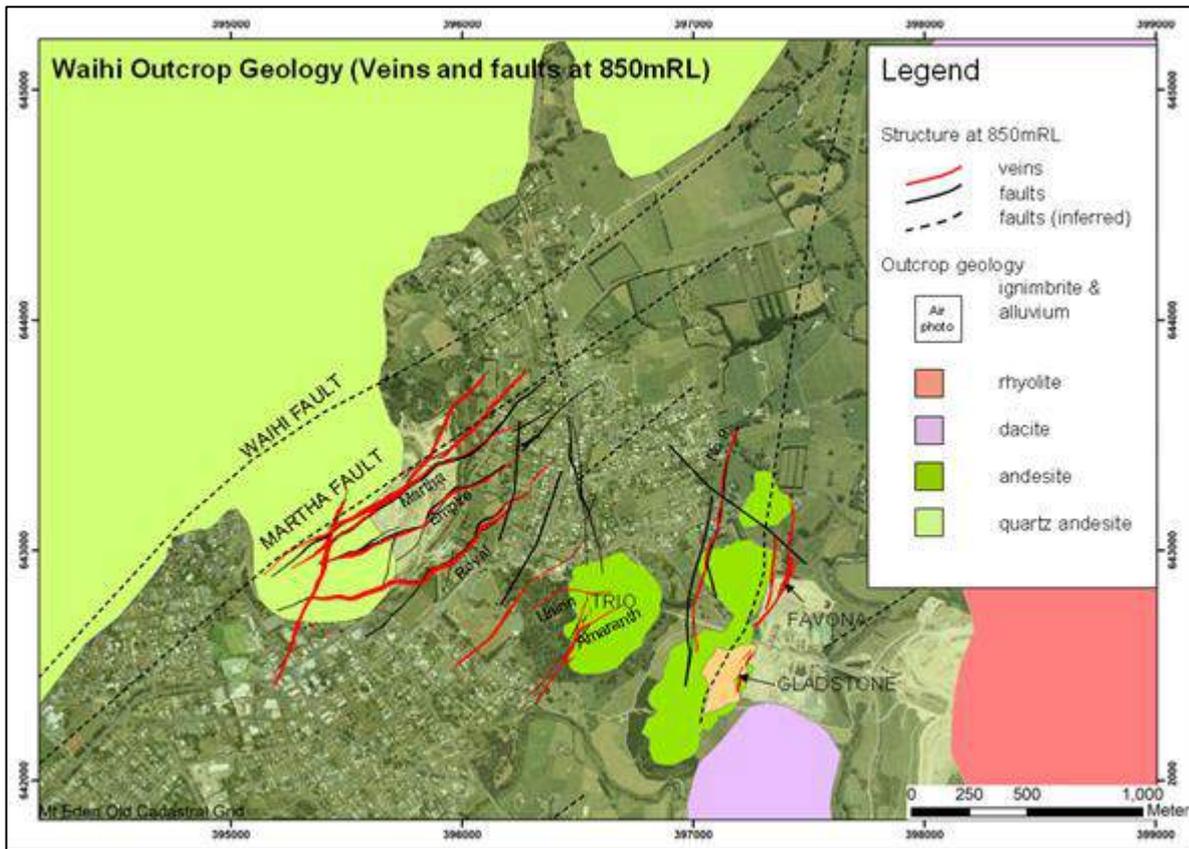
Figure 1(c) Faults and geology at 850 m RL showing main structural elements

Groundwater levels in the andesite are controlled in the vicinity of the Martha Pit by old underground mine workings and shafts as well as the structural controls of faults and veins in the area. The old mine workings extend mainly in a SW-NE orientation following the Martha lode (Figure 1b). The historical mine workings act as effective conduits allowing groundwater inflow of water from an area surrounding the current mine pit. Investigation drilling at Union Hill has identified similar water levels in permeable vein systems to those in the historical workings, with water levels at higher elevations in less permeable ground. This pattern of groundwater depressurisation is consistent through the older andesites in the vicinity of Martha Mine (Figure 1c).

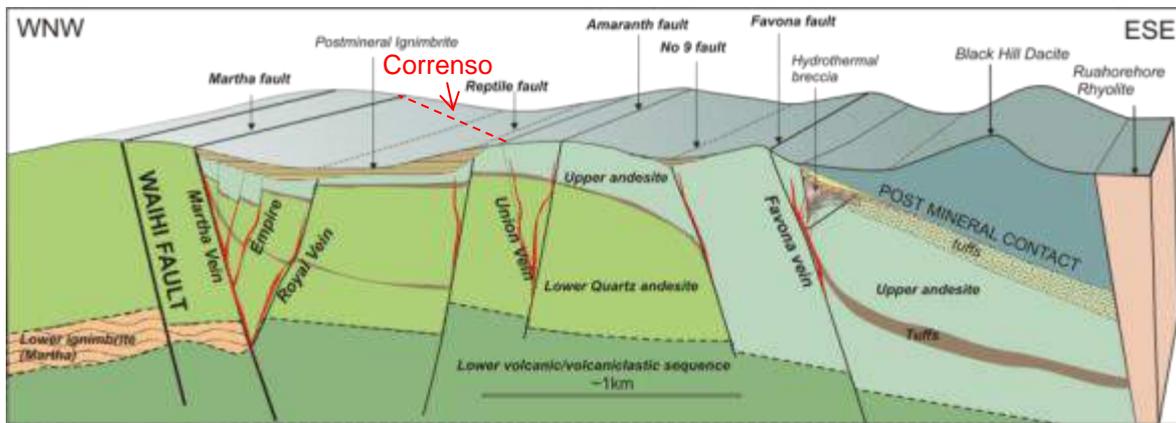
Figure 1(d) Schematic cross section illustrating key elements of fault structures in the Waihi area, including projected surface trace of Correnso.

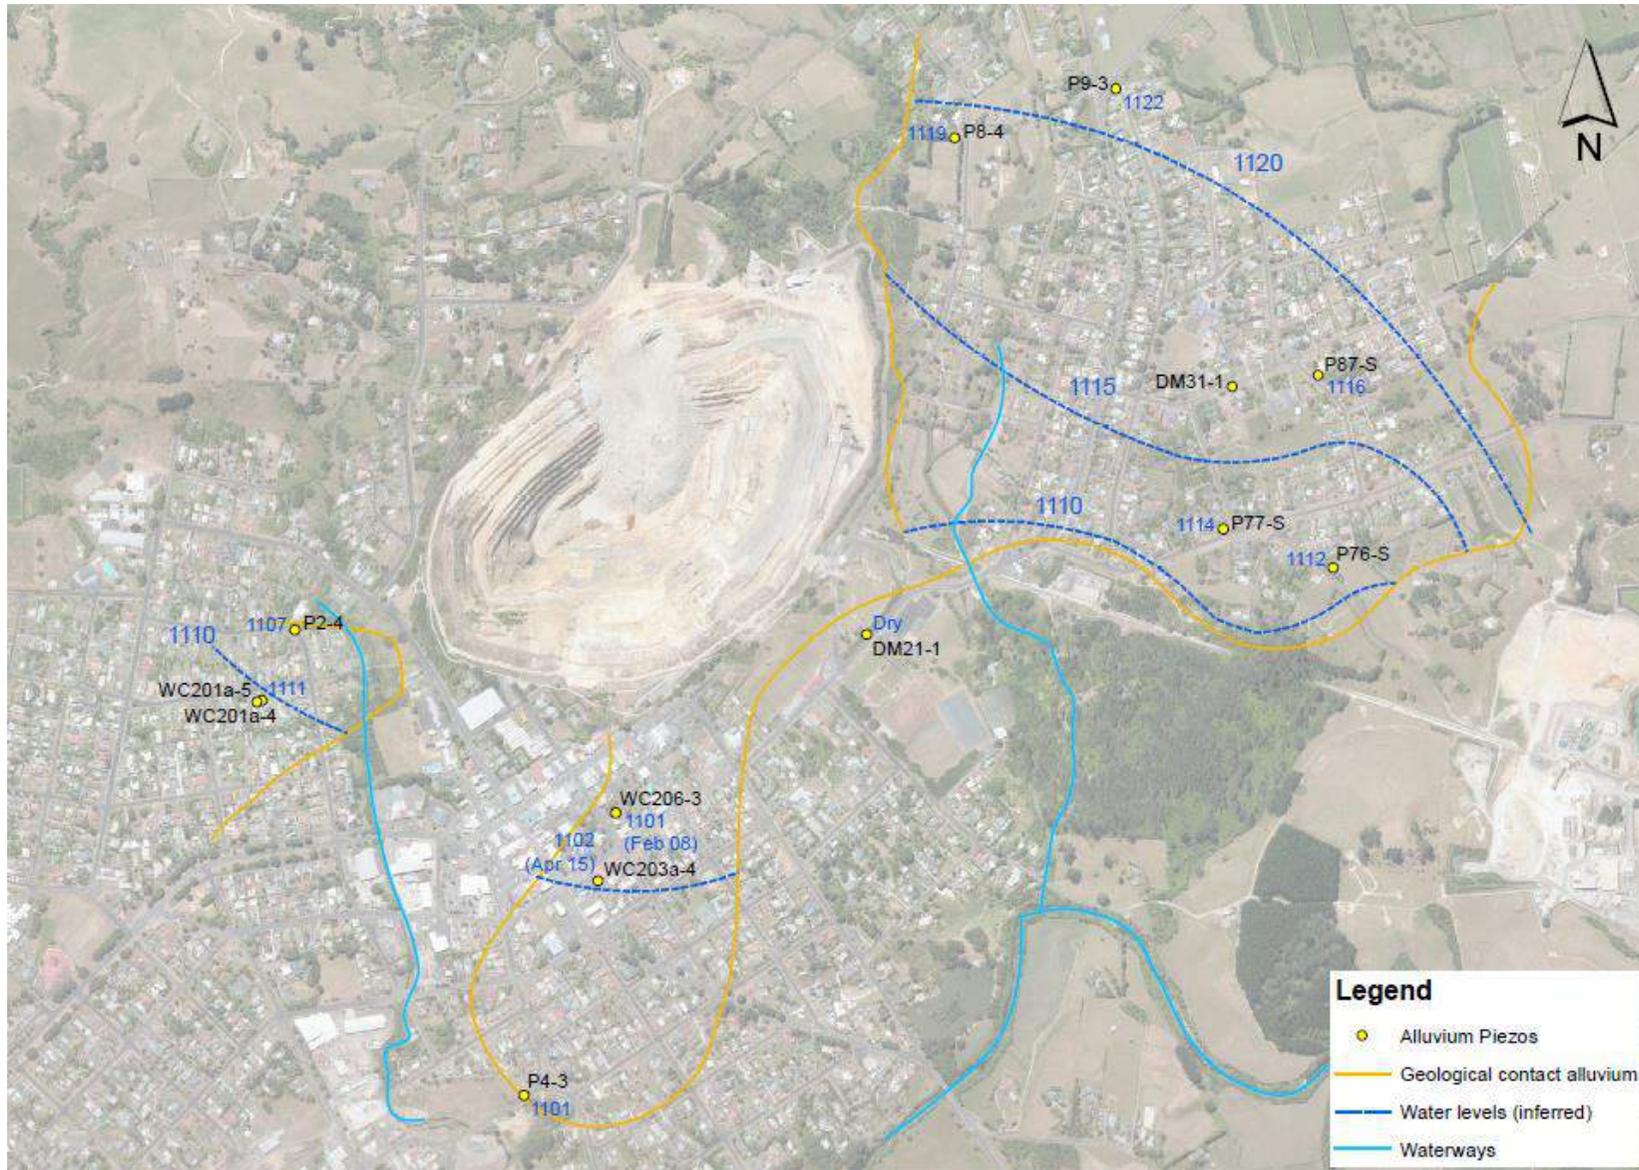
Figure 3: Alluvium Water Level Contours

Figure 3 shows the inferred contours for shallow groundwater in alluvium and in weathered younger volcanic materials and Figure 4 shows the water level trends over time. The overall contour pattern and the trend plots demonstrate that the shallow groundwater system remains essentially unaffected by dewatering of the surface and underground mining operations. Shallow groundwater levels are controlled principally, by rainfall infiltration, low surface soil permeability and natural and assisted drainage to surface water systems.

Contouring of the lobe southwest of Martha Mine (Figure 3) has been restricted by the loss of access to the wells at sites WC203 and WC206. For the purposes of completing the contour plan it was assumed that groundwater levels in the alluvium at these locations has remained the same as in previous years.

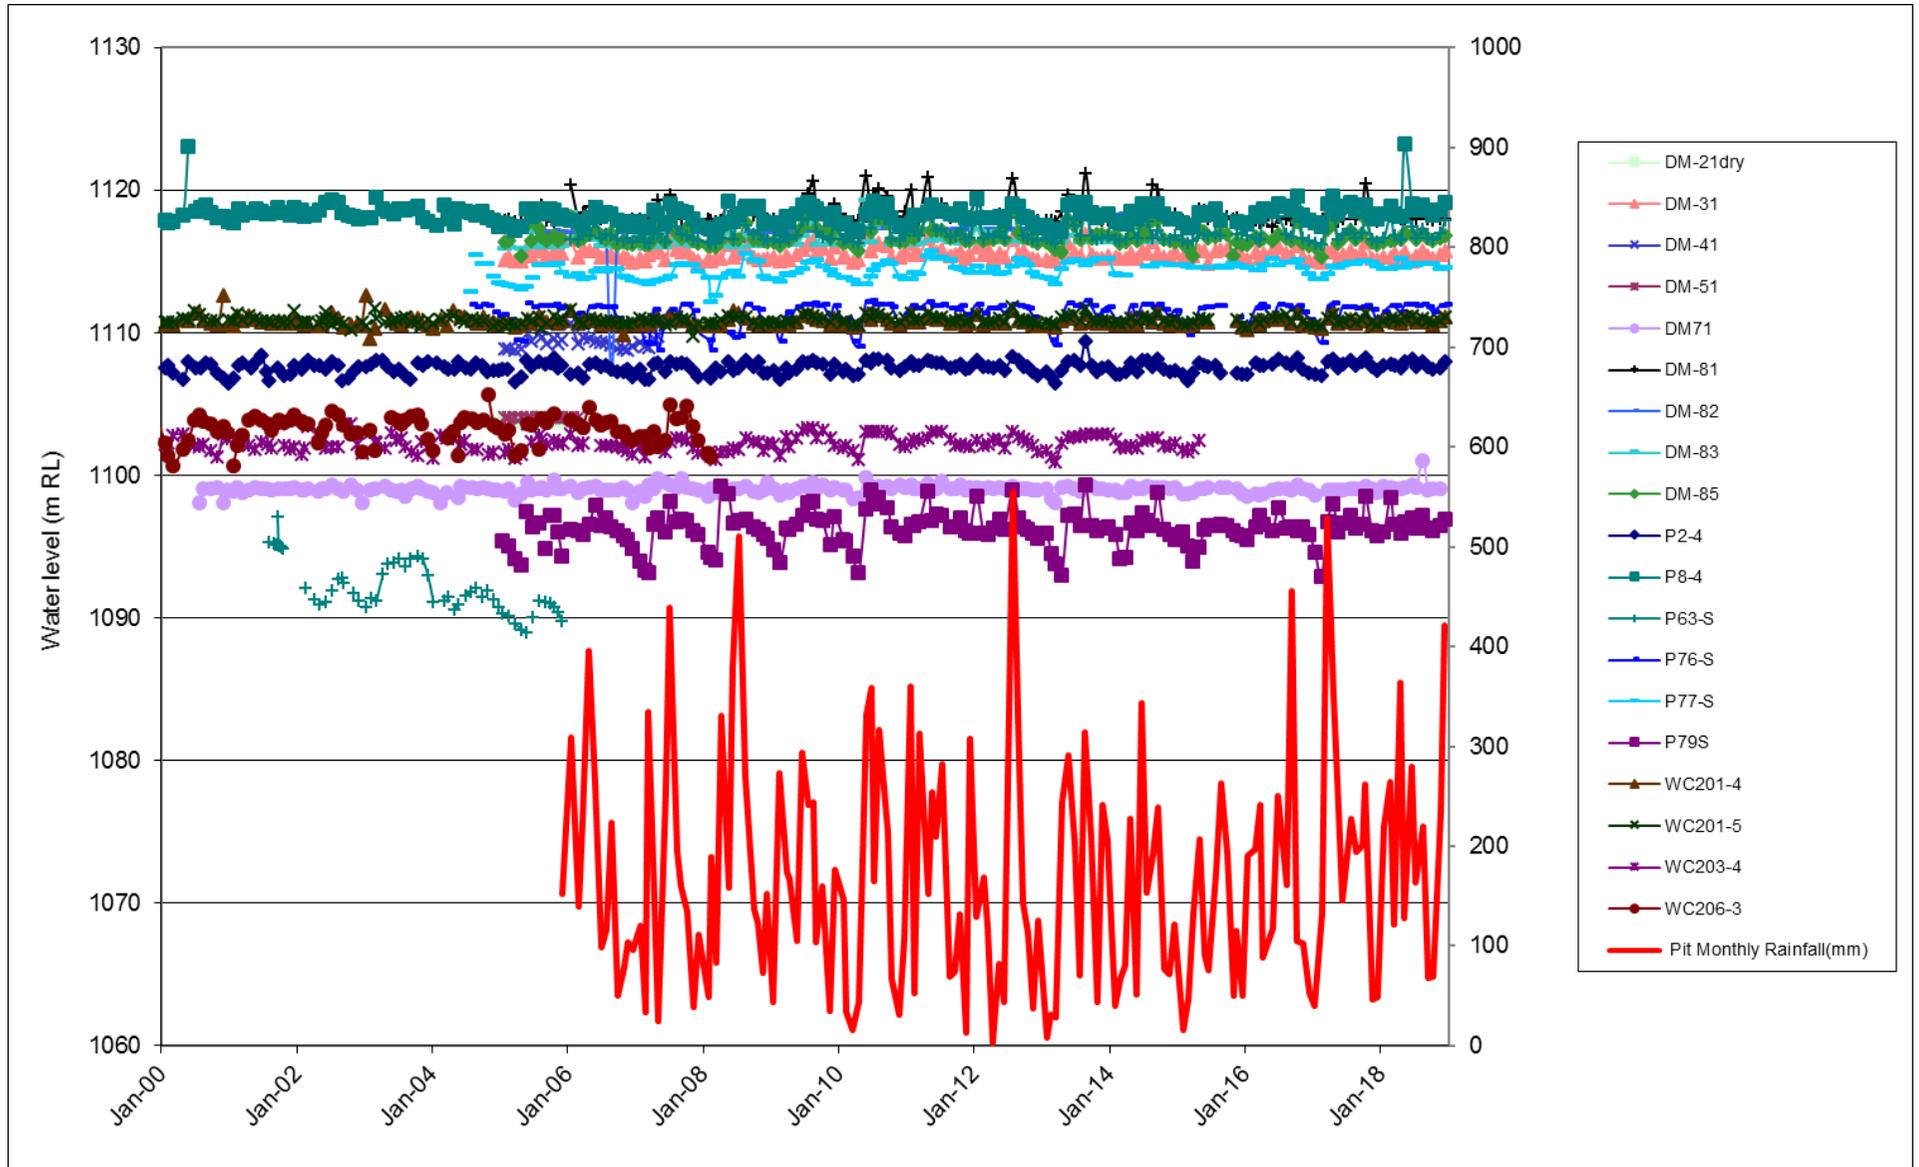
Figure 4: Groundwater Level Trends – Shallow Groundwater (Alluvium & Weathered Contact of Young Volcanics)

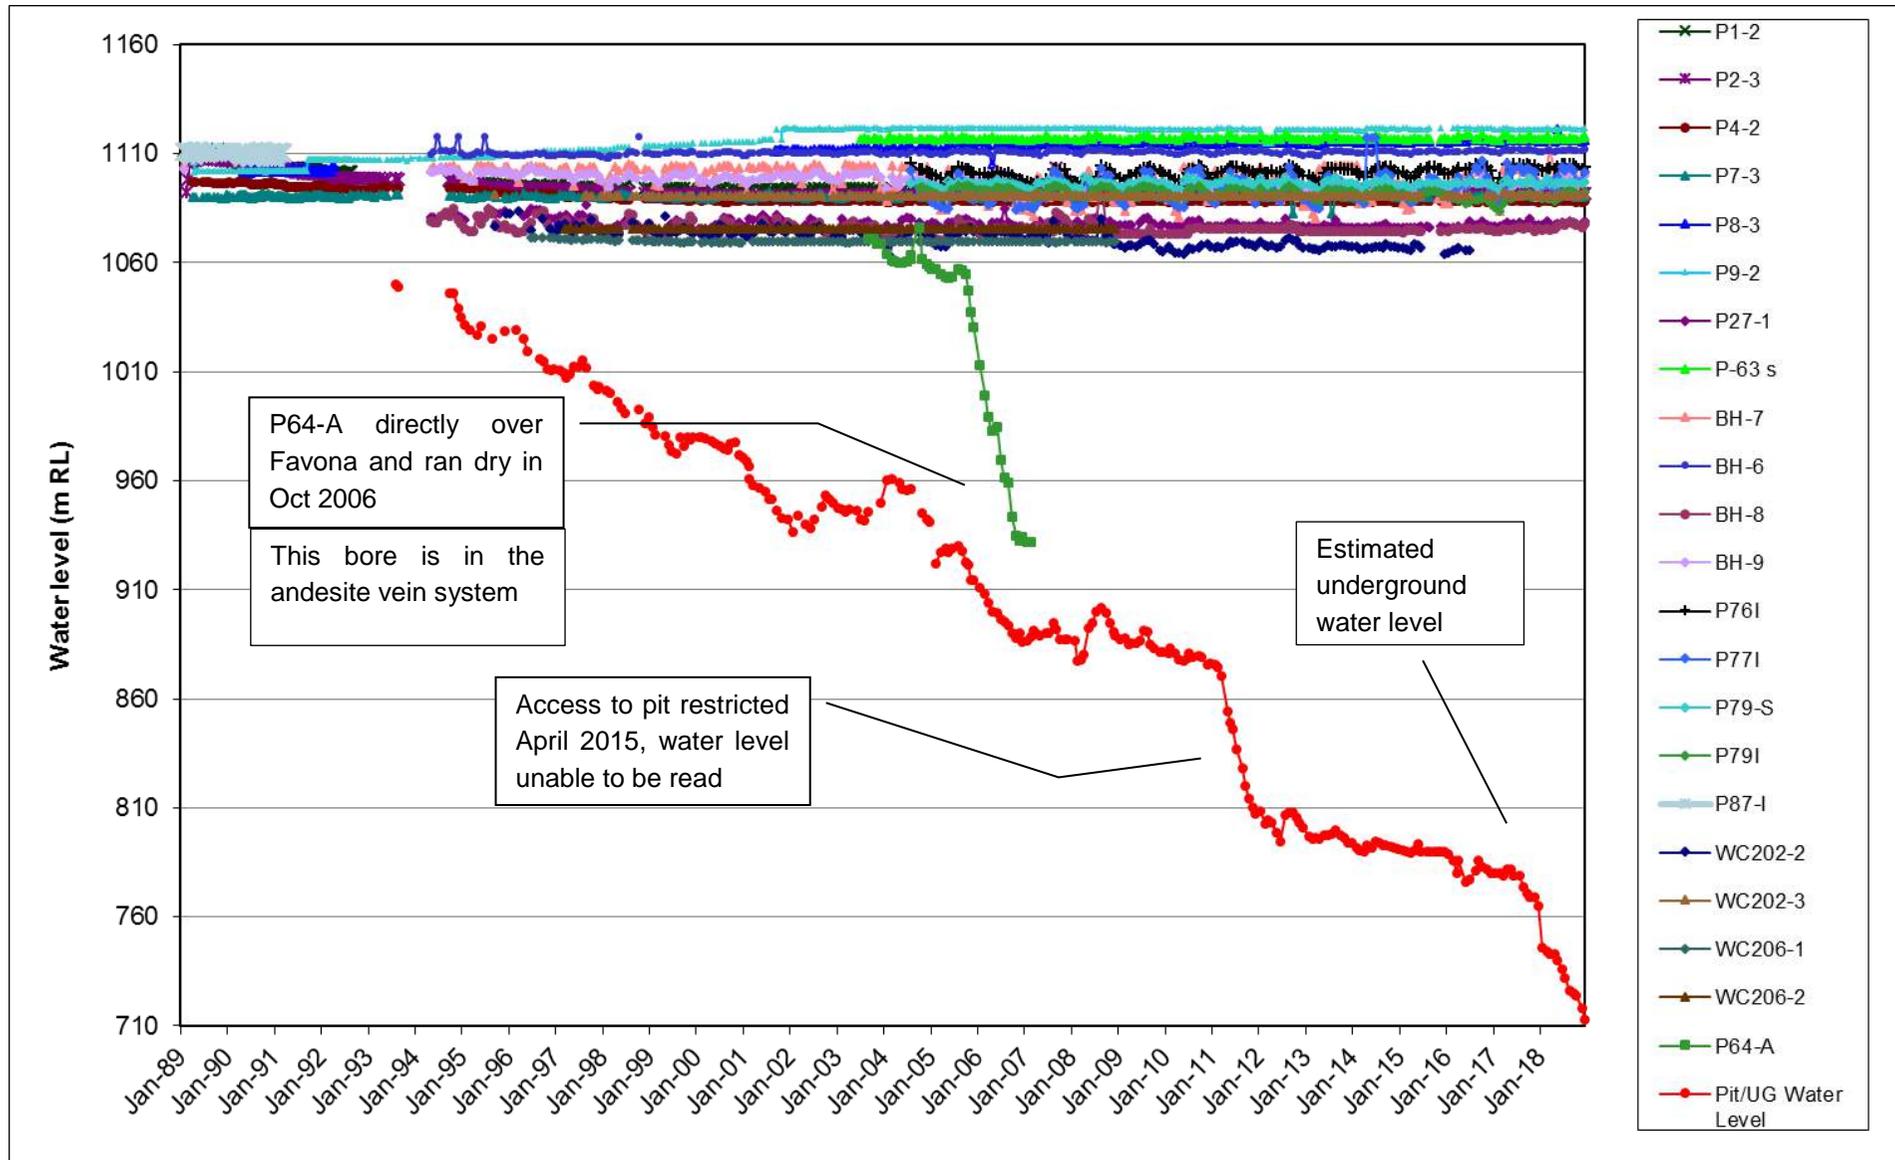
Figure 6: Groundwater Level Trends - Deeper Younger Volcanic Materials

Groundwater contours in the deeper portions of the younger volcanic materials below the shallow groundwater system are shown on Figure 5 and trends are graphed on Figure 6.

Prior to the start of dewatering at Martha Mine, groundwater levels in all rock units were similar. With the onset of mine dewatering, water levels in the veins and historic workings were drawn down. Groundwater levels in the various rock units below the shallow aquifer showed increasing vertical separation until about the mid to late 1990's. Thereafter, the water levels (in other than the veins and workings) stabilised and have remained stable since. This pattern is demonstrated in monitoring wells at site P2. With piezometer P2-1 following the vein water levels until water level dropped below the piezometer tip, P2-2 the upper andesite water levels P2-3, younger volcanic rock water levels and P4-2 alluvium (shallow aquifer) (Figure 6).

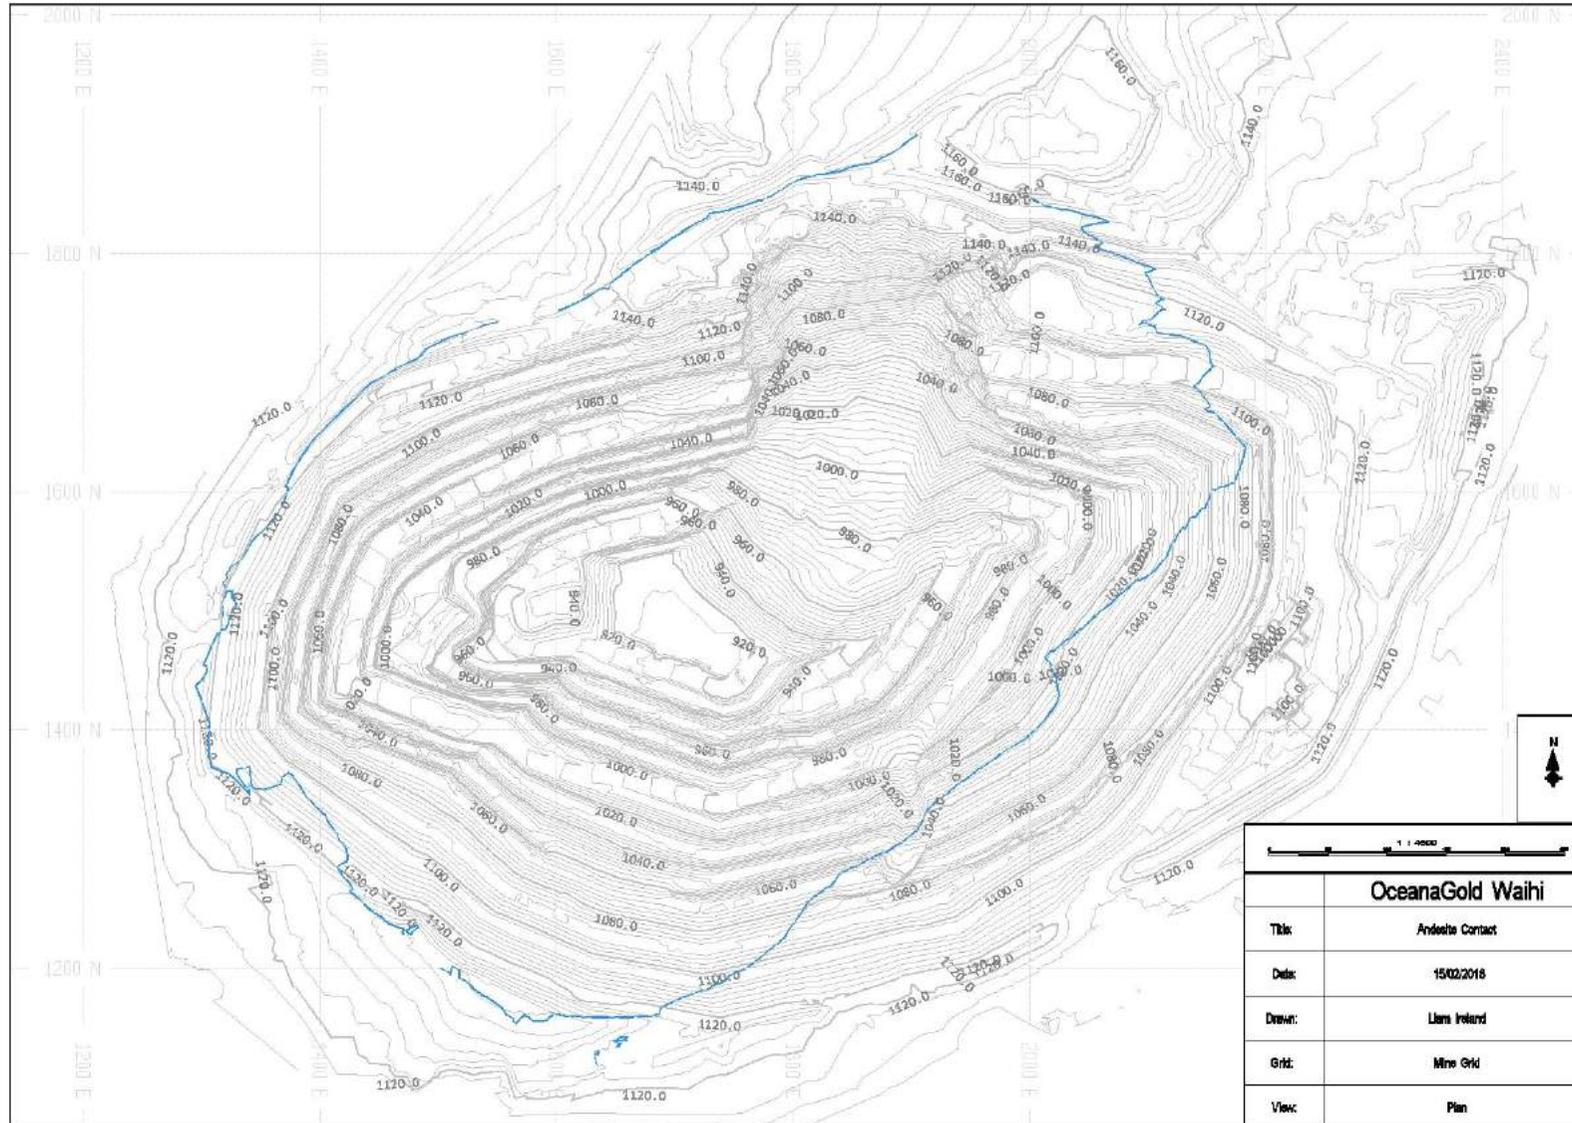
Figure 7: Andesite Younger Volcanic Materials Contact in Martha Pit

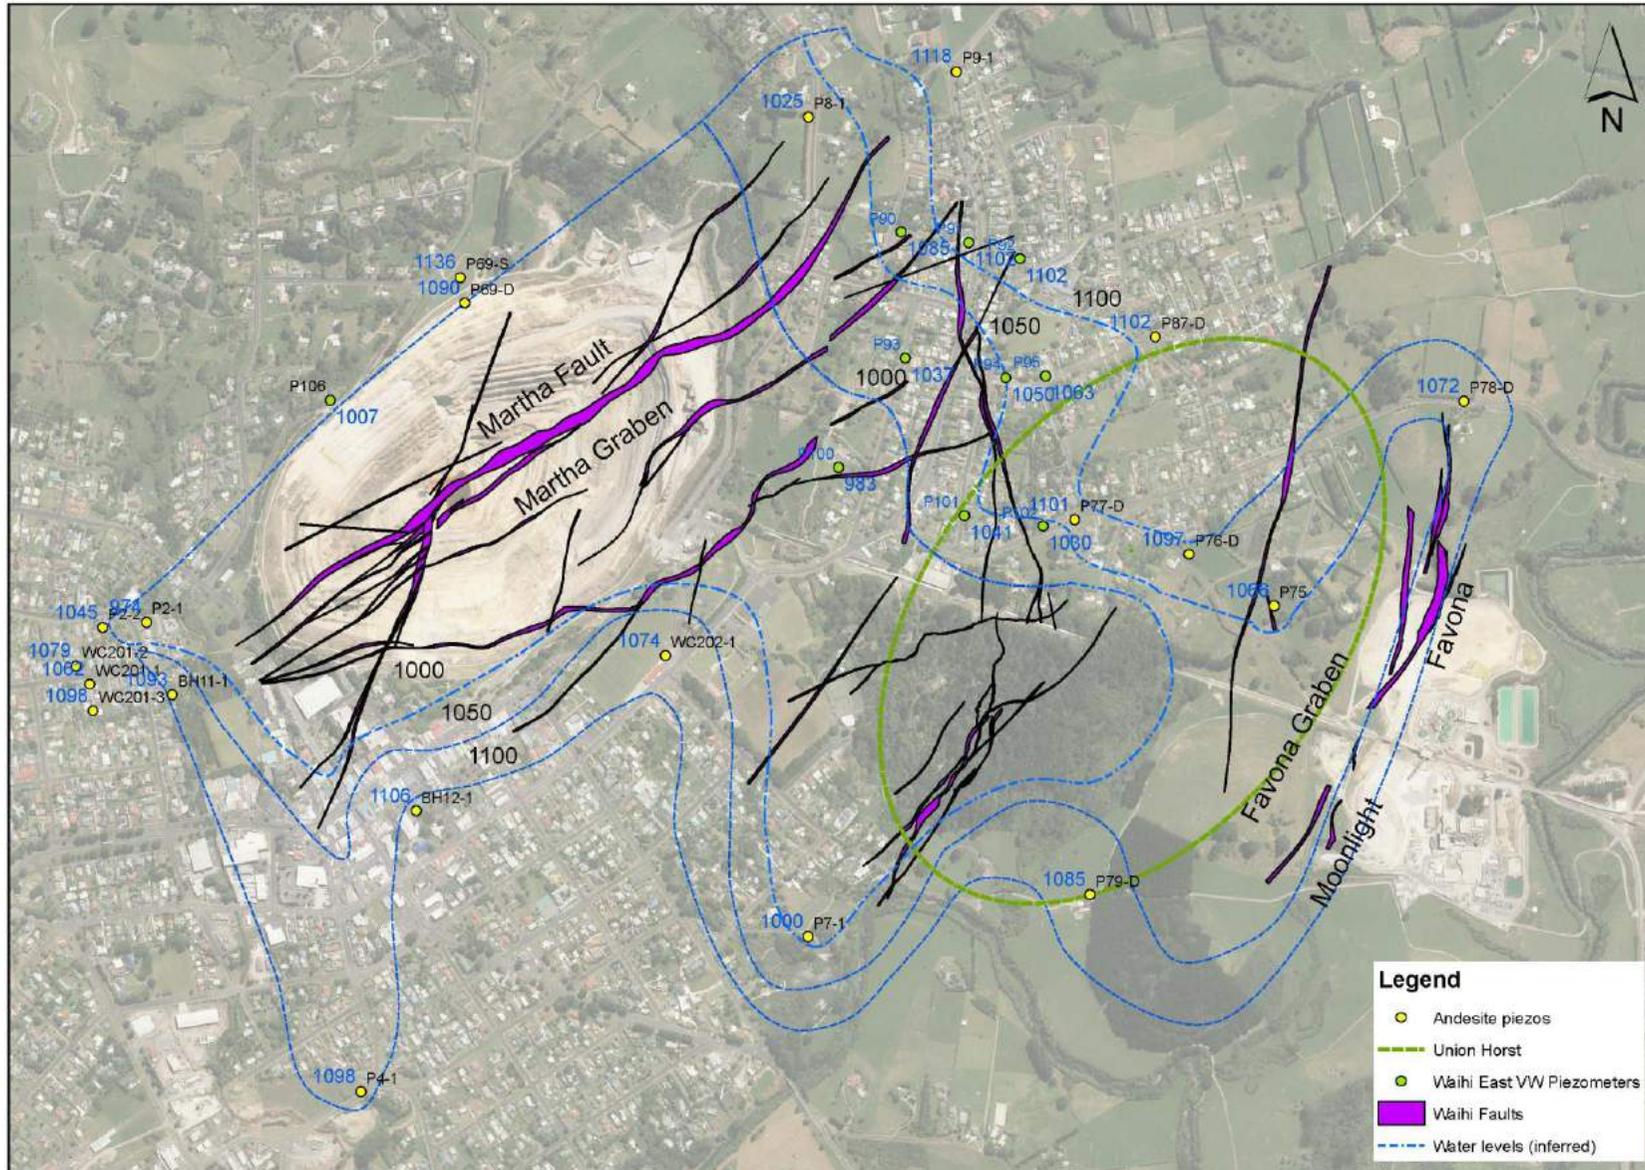
Figure 8: Andesite Water Level Contours

Figure 8 shows the scope of the dewatering effects in the andesite rock body as a result of dewatering to date. Data from the Waihi East vibrating wire piezometer units has been included. Figure 9 provides the water level trends in the andesite rock body. While groundwater level data is available for the vein systems and the shallower andesite rock, no monitoring data is available for intermediate depths within the andesite rockmass outside of development areas. Hence, groundwater levels between the vein and the shallow rockmass has been interpolated.

Figure 8 also indicates the dewatering centralised on the Favona system with the restriction of connection between Favona and the Union systems. The geological model in Section 1 indicates an up-thrown block (Union Horst Figure 1d and Figure 8) between the Union and Favona systems. This structural hiatus is likely to account for the restricted groundwater interconnection between the Martha-Union and Favona systems.

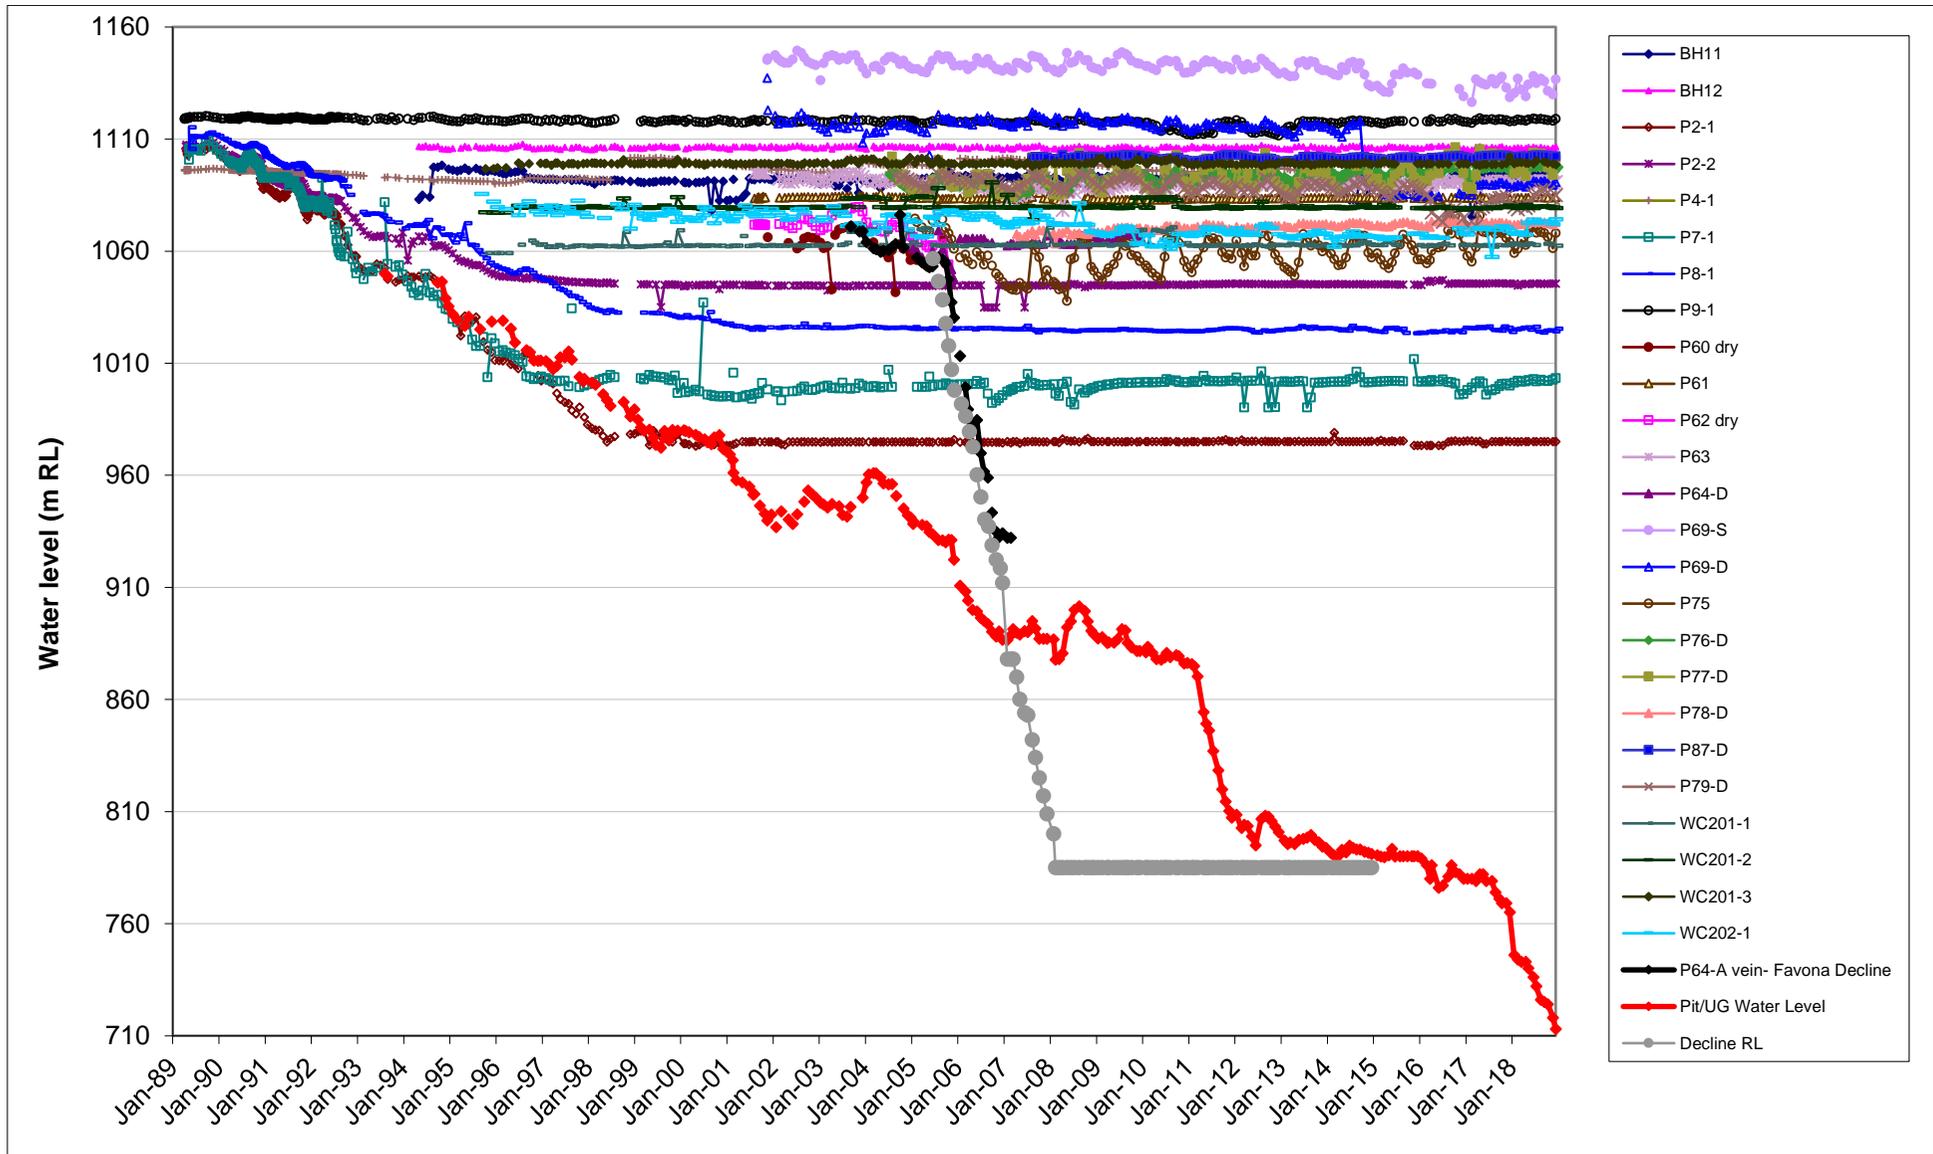
Figure 9: Groundwater Level Trends – Andesite

Groundwater levels in the andesite vein systems have responded rapidly and substantially to mine dewatering along the strike of the Martha Vein system, along the strike of the Trio vein system beneath Union Hill, and also along the strike of the Favona/Moonlight vein systems. An area of dewatering indicated between Martha Mine and Trio/Correnso vein systems suggests a relatively close linkage. Outside of these structures, the dewatering effect in the andesite rock is attenuated or absent. This is illustrated by the different responses shown on Figure 9.

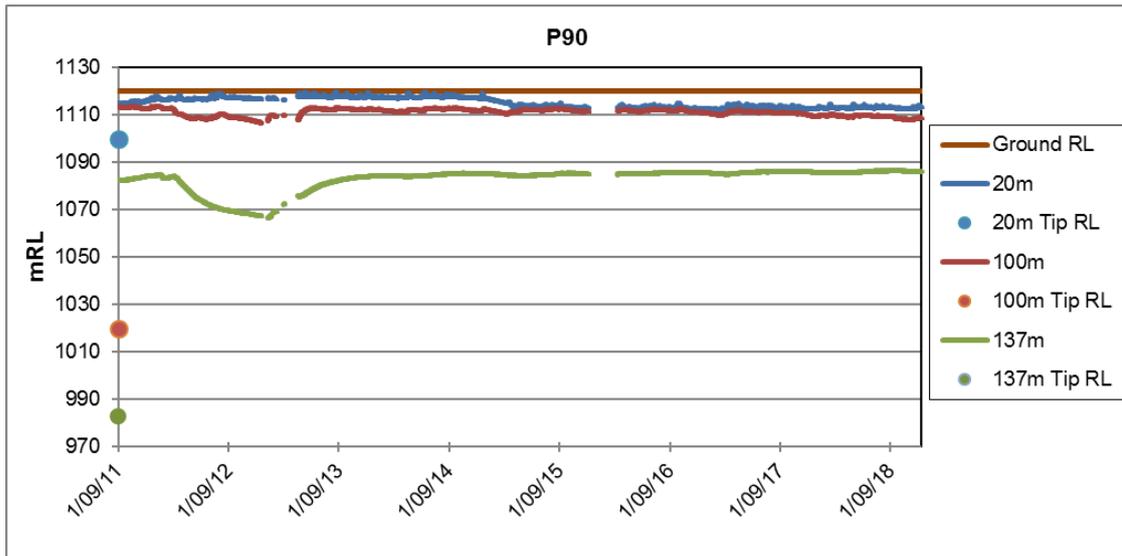
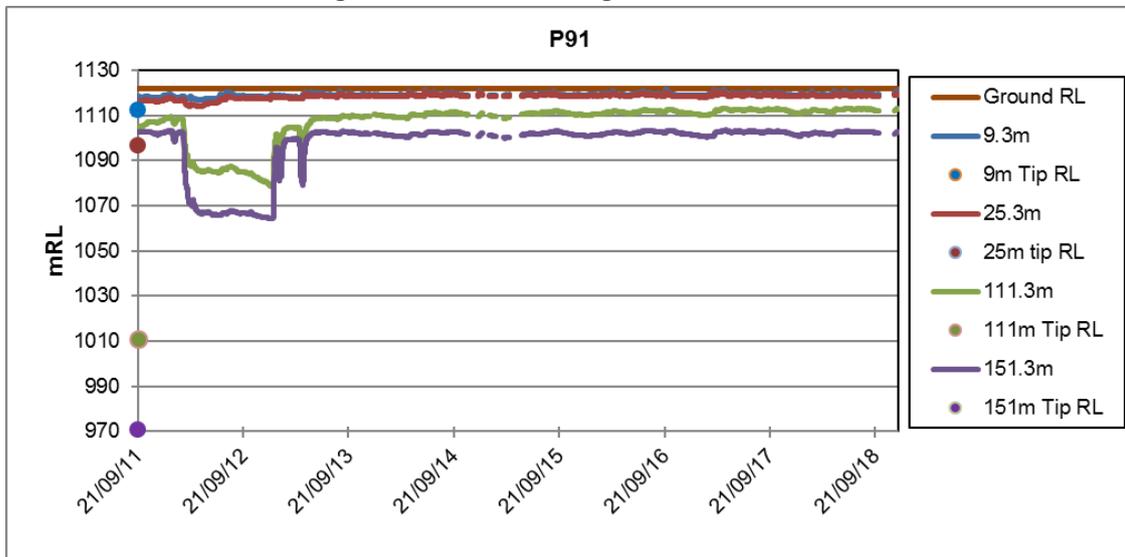
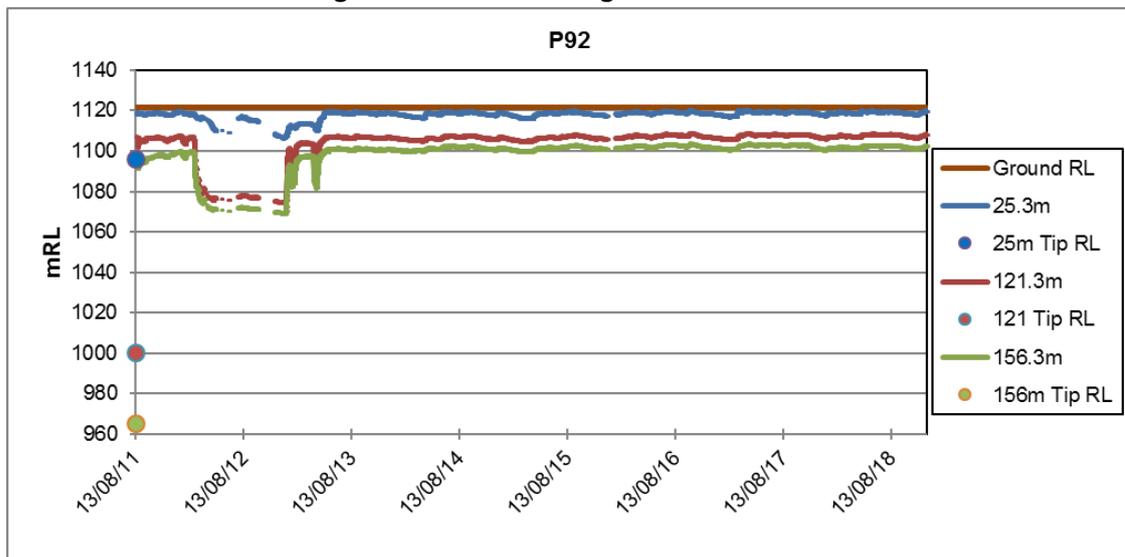
Figure 10: P90 Vibrating Wire Piezometer

Figure 11: P91 Vibrating Wire Piezometer

Figure 12: P92 Vibrating Wire Piezometer

Figures 10 to 18 provide the records from the piezometers expressed as mRL. The charts also display the depth of the piezometer tips. Separation between the shallow and deeper piezometers is evident in the records. The nine groundwater monitoring boreholes have indicated stable water levels in Waihi East.

Water levels were disrupted during 2012 to 2013 in P90, P91 and P92 by leakage down an incompletely sealed drill hole annulus. Pressures returned to normal after comprehensive effort to seal the leakage pathway.

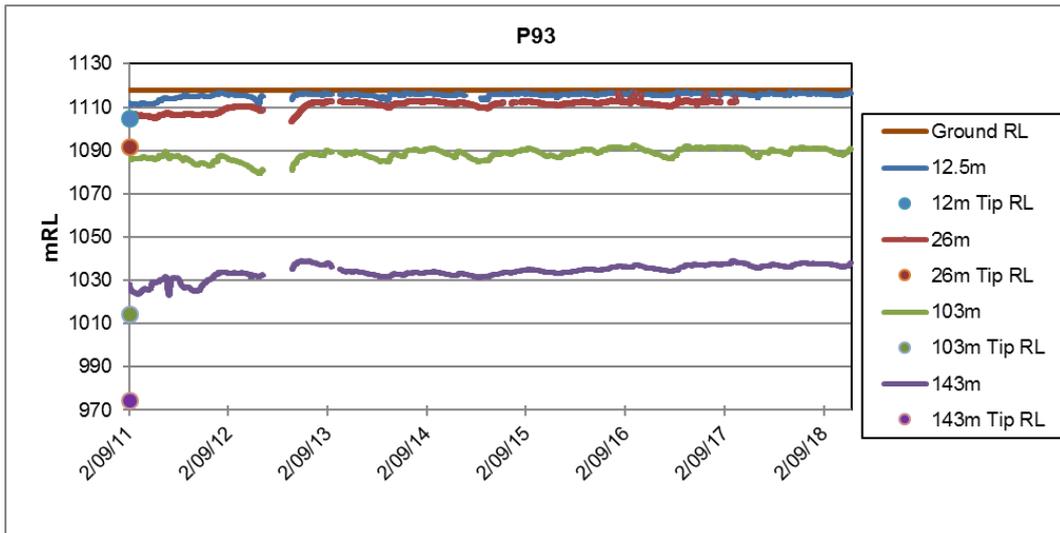
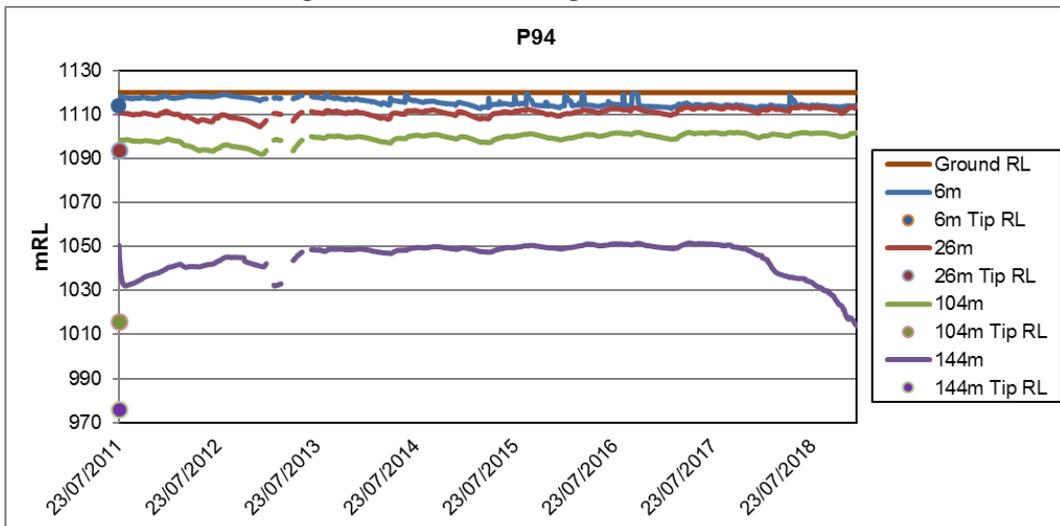
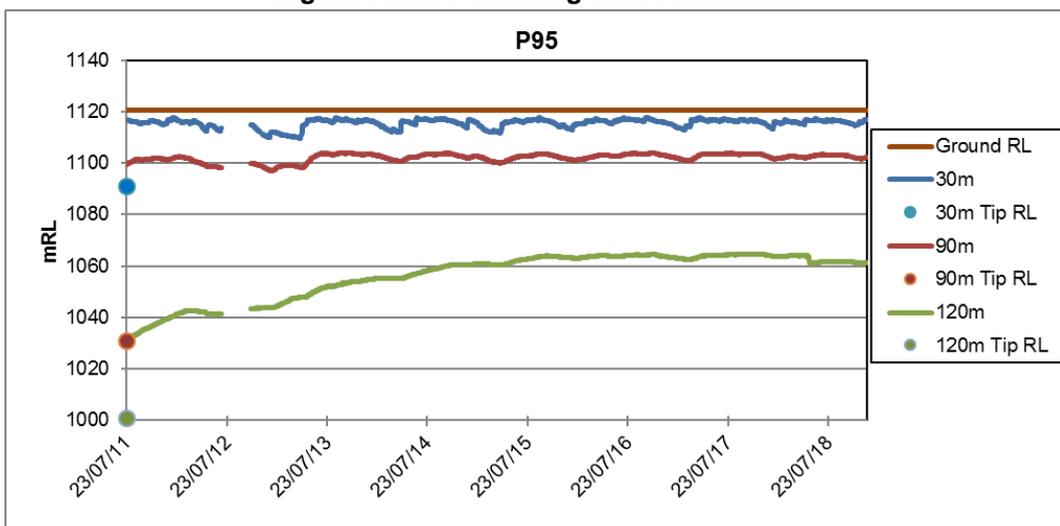
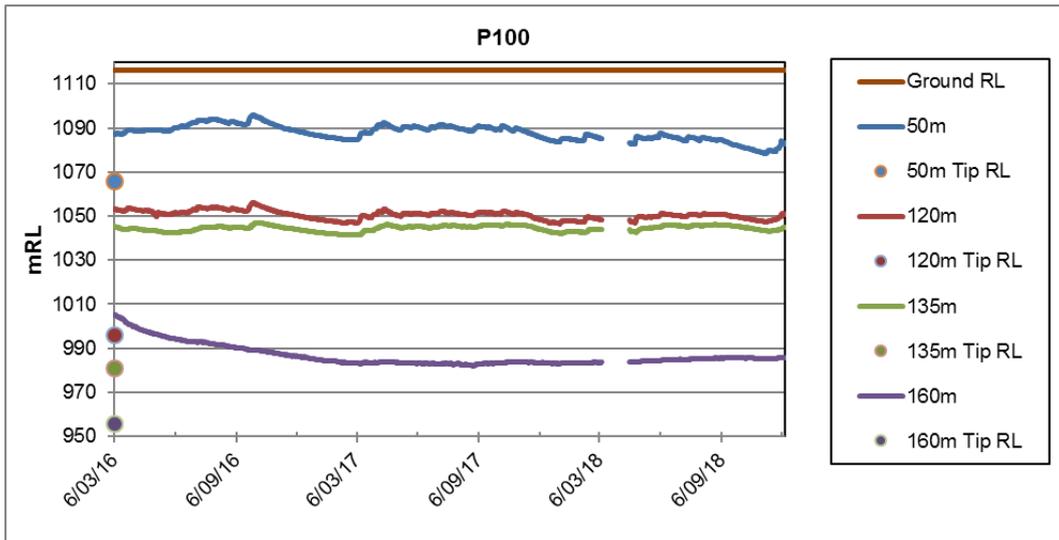
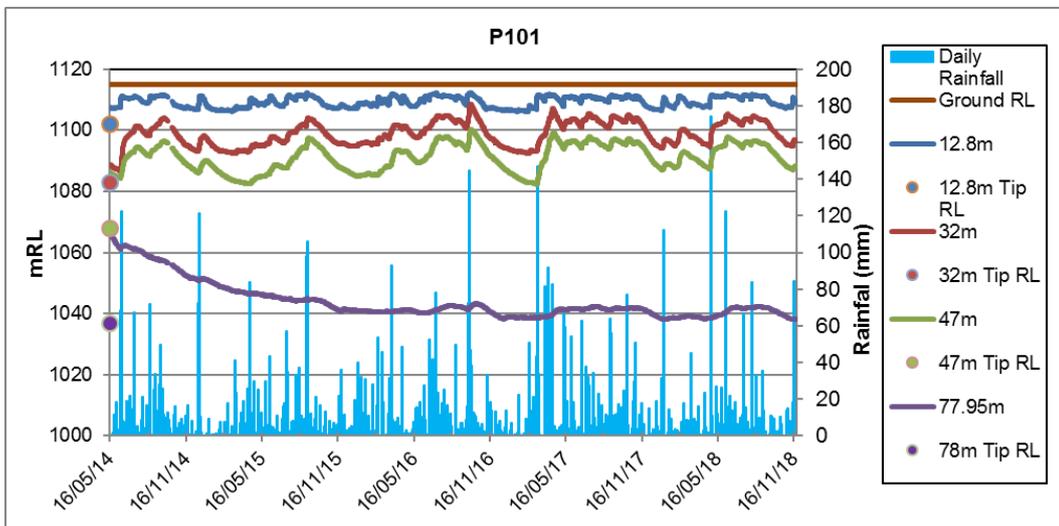
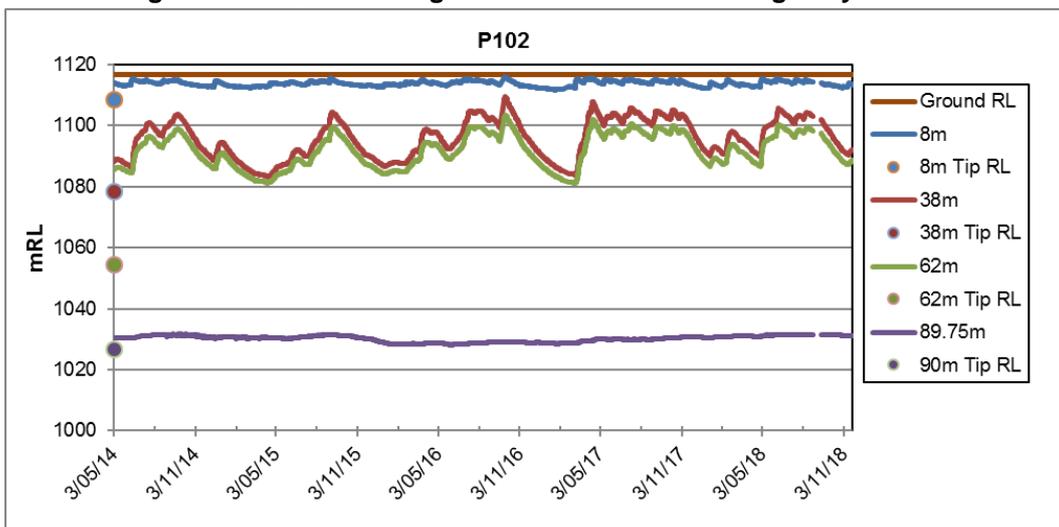
Figure 13: P93 Vibrating Wire Piezometer

Figure 14: P94 Vibrating Wire Piezometer

Figure 15: P95 Vibrating Wire Piezometer

Figure 16: P100 Vibrating Wire Piezometer

Figure 17: P101 Vibrating Wire Piezometer including daily rainfall

Figure 18: P102 Vibrating Wire Piezometer

During 2018, the 1050mRL piezometer in well P94 showed a drop in pressure believed to be a result of nearby mining causing relaxation in the country rock host rock surrounding the piezometer tip. The shallower piezometers at this location have not displayed any corresponding drop in pressure (Figure 14). The depressurisation is expected to stabilise once mining has passed the area.
