Martha Shallow and Deep Aquifer Report

Document Reference: WAI-200-REP-011-001

MARTHA SHALLOW AND DEEP AQUIFER REPORT 2019

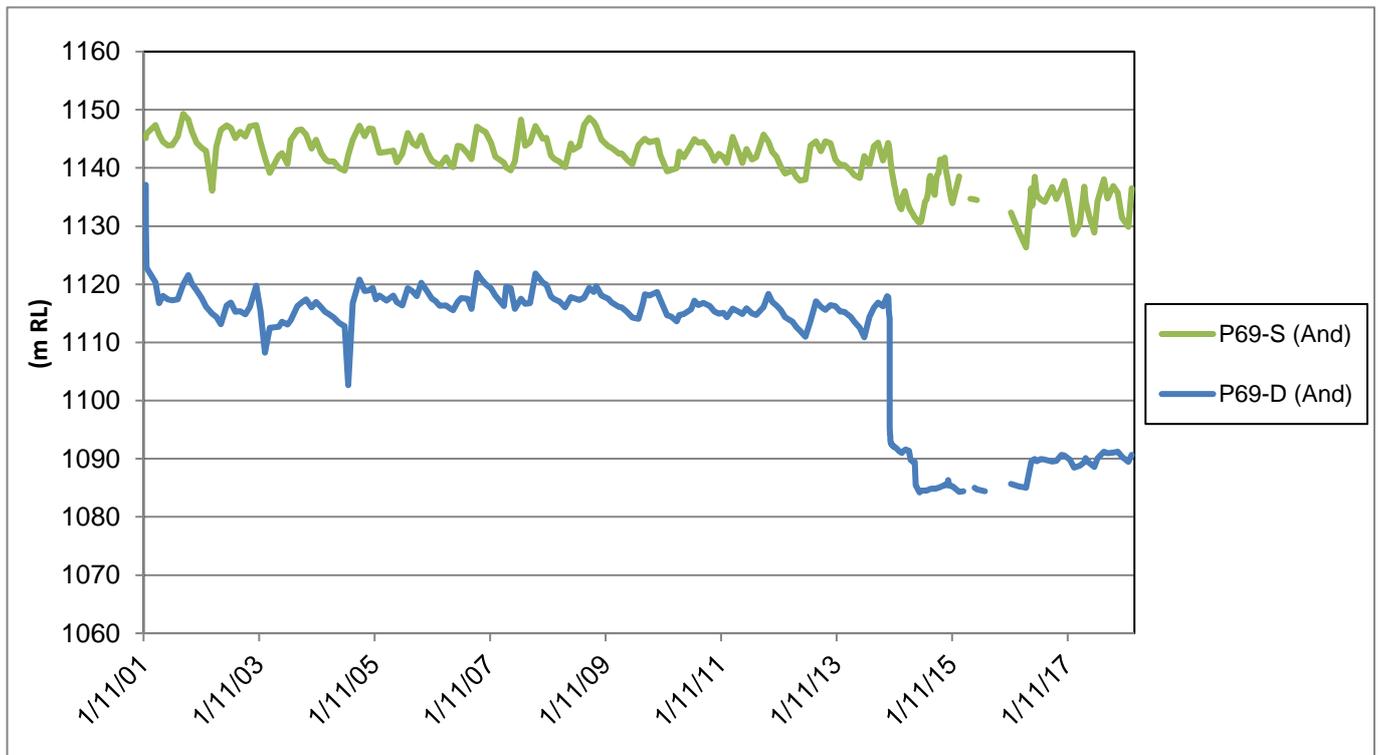
Figure 19: Water Levels P69 Pit North Wall

P69D & P69S were installed in 2001 and are located close to the rim of the North Wall of Martha Pit. They were considered control bores and previously uninfluenced by dewatering. Geotechnical stability work in the North Wall was undertaken in October 2014, partly due to excessive water. Drainage holes were drilled into the lower wall. Localised drainage of the wall resulted, and the water levels in P69D and P69S declined. By March 2015 the piezometers had stabilized with P69D and P69S declined by 32m and 12m respectively (Figure 19). With the large North Wall slip in April 2016, access to the piezometers was briefly restricted. Real time loggers were installed in mid-2017 and are currently programmed to record hourly.

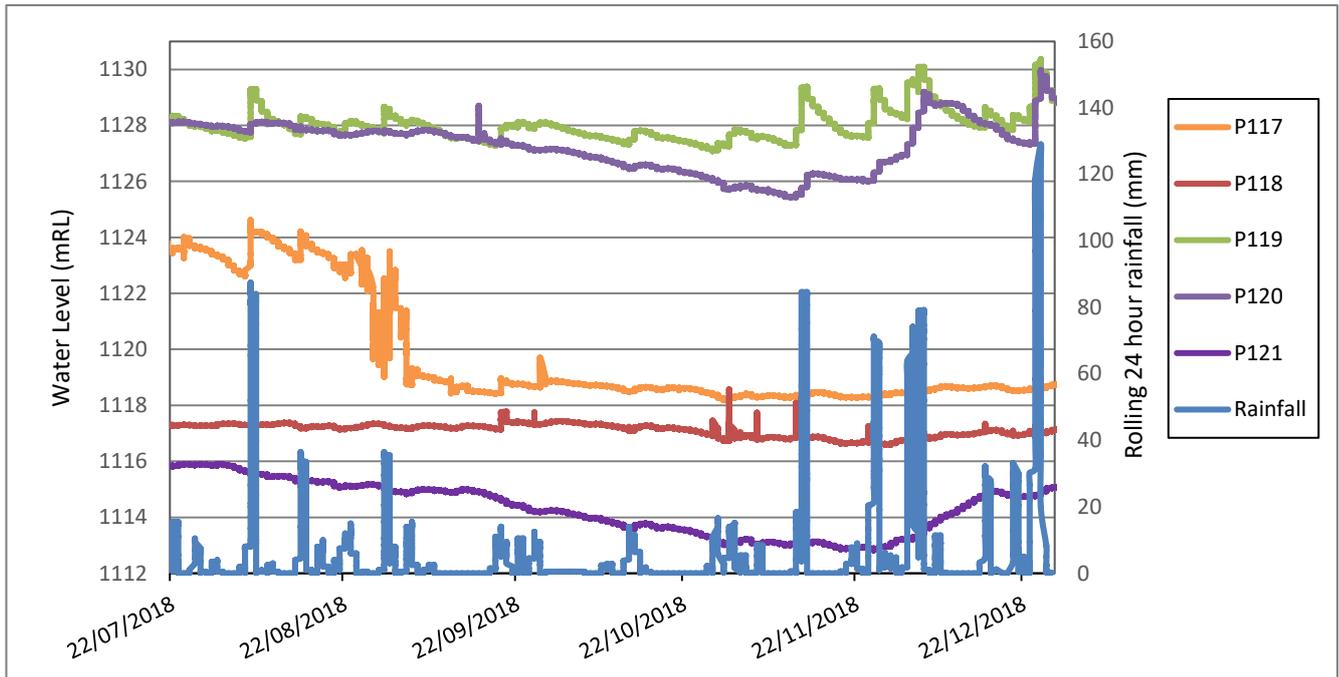
Figure 20: Water Levels in North Wall Piezometers

In mid-2018, five real time loggers recording hourly were installed in new wells (wells P117 – P121) to investigate the source of an area of seepage on the north wall of the pit (Figure 2). Water levels in well P119 appear to fluctuate with rainfall while in wells P 120 and P 121, levels follow long term seasonal trends within the andesite (Figure 20). These will continue to be monitored in 2019.

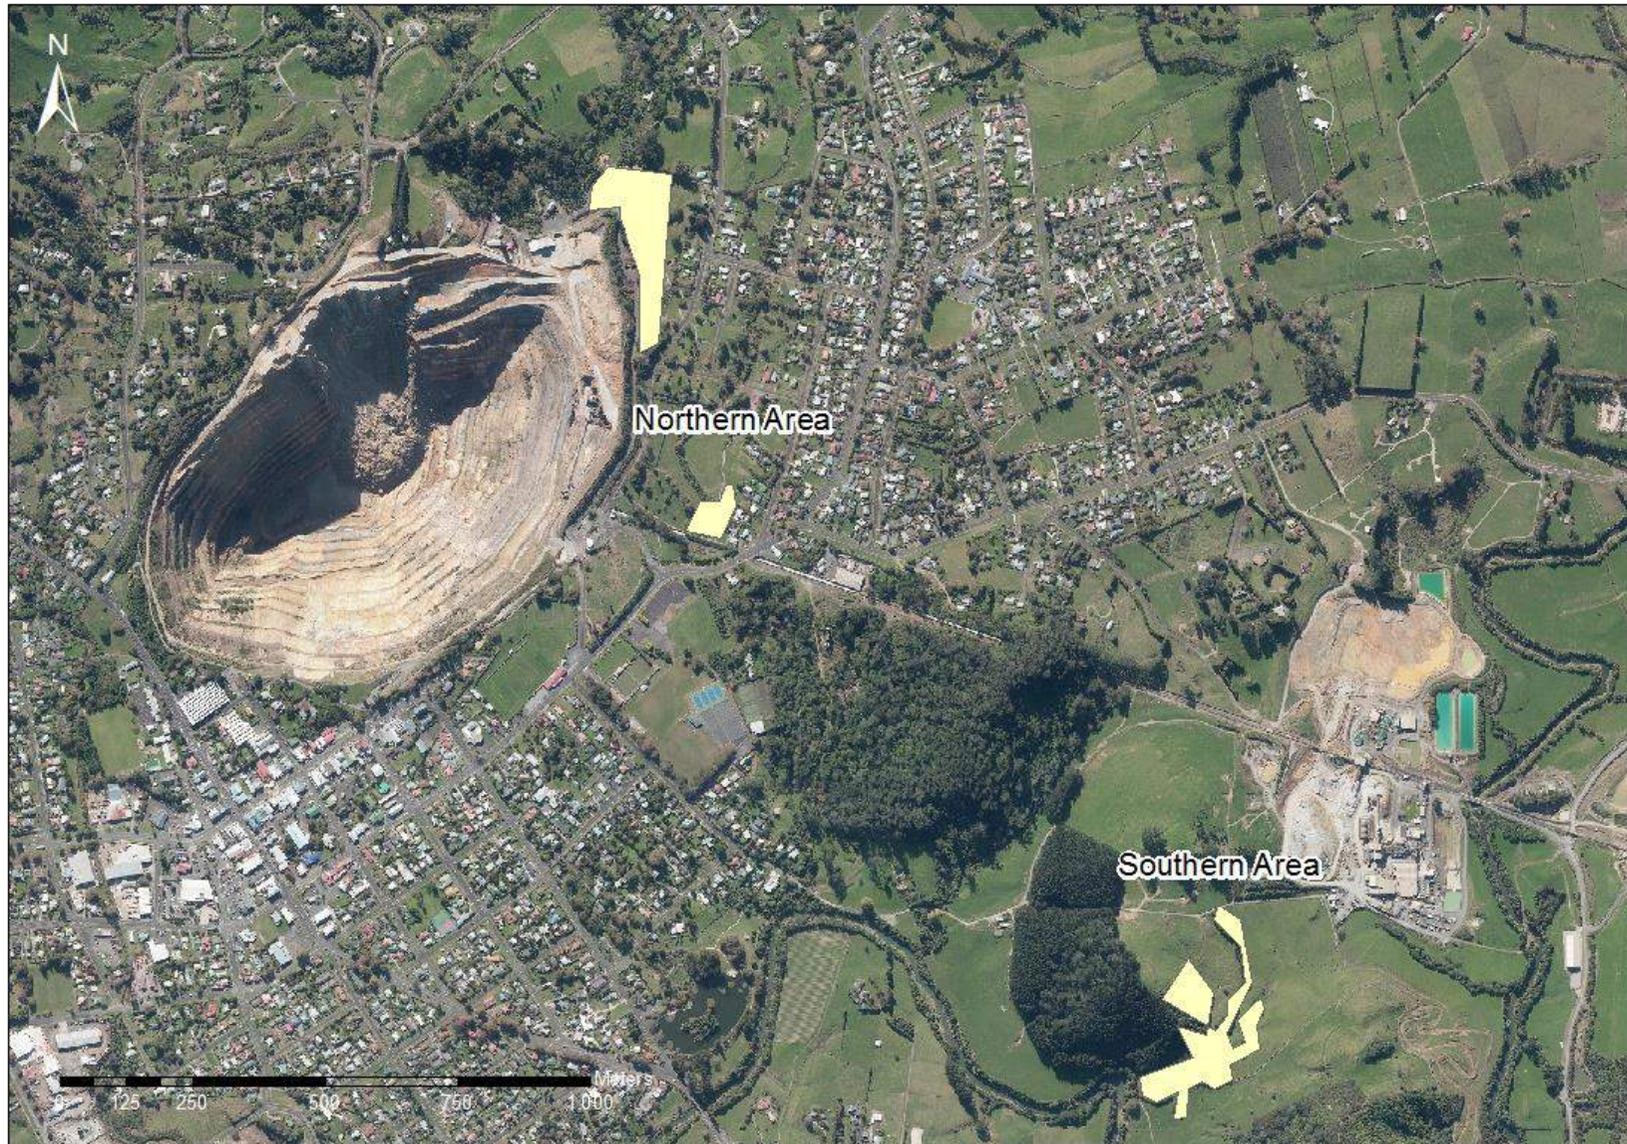
Figure 21: Northern and Southern Wetland Area

The first is located north of Martha Pit and is referred to hereafter as the Northern Area. The second area is located in the Union Hill, Winner Hill and Black Hill surrounds and is referred to as the Southern Area (Figure 21).

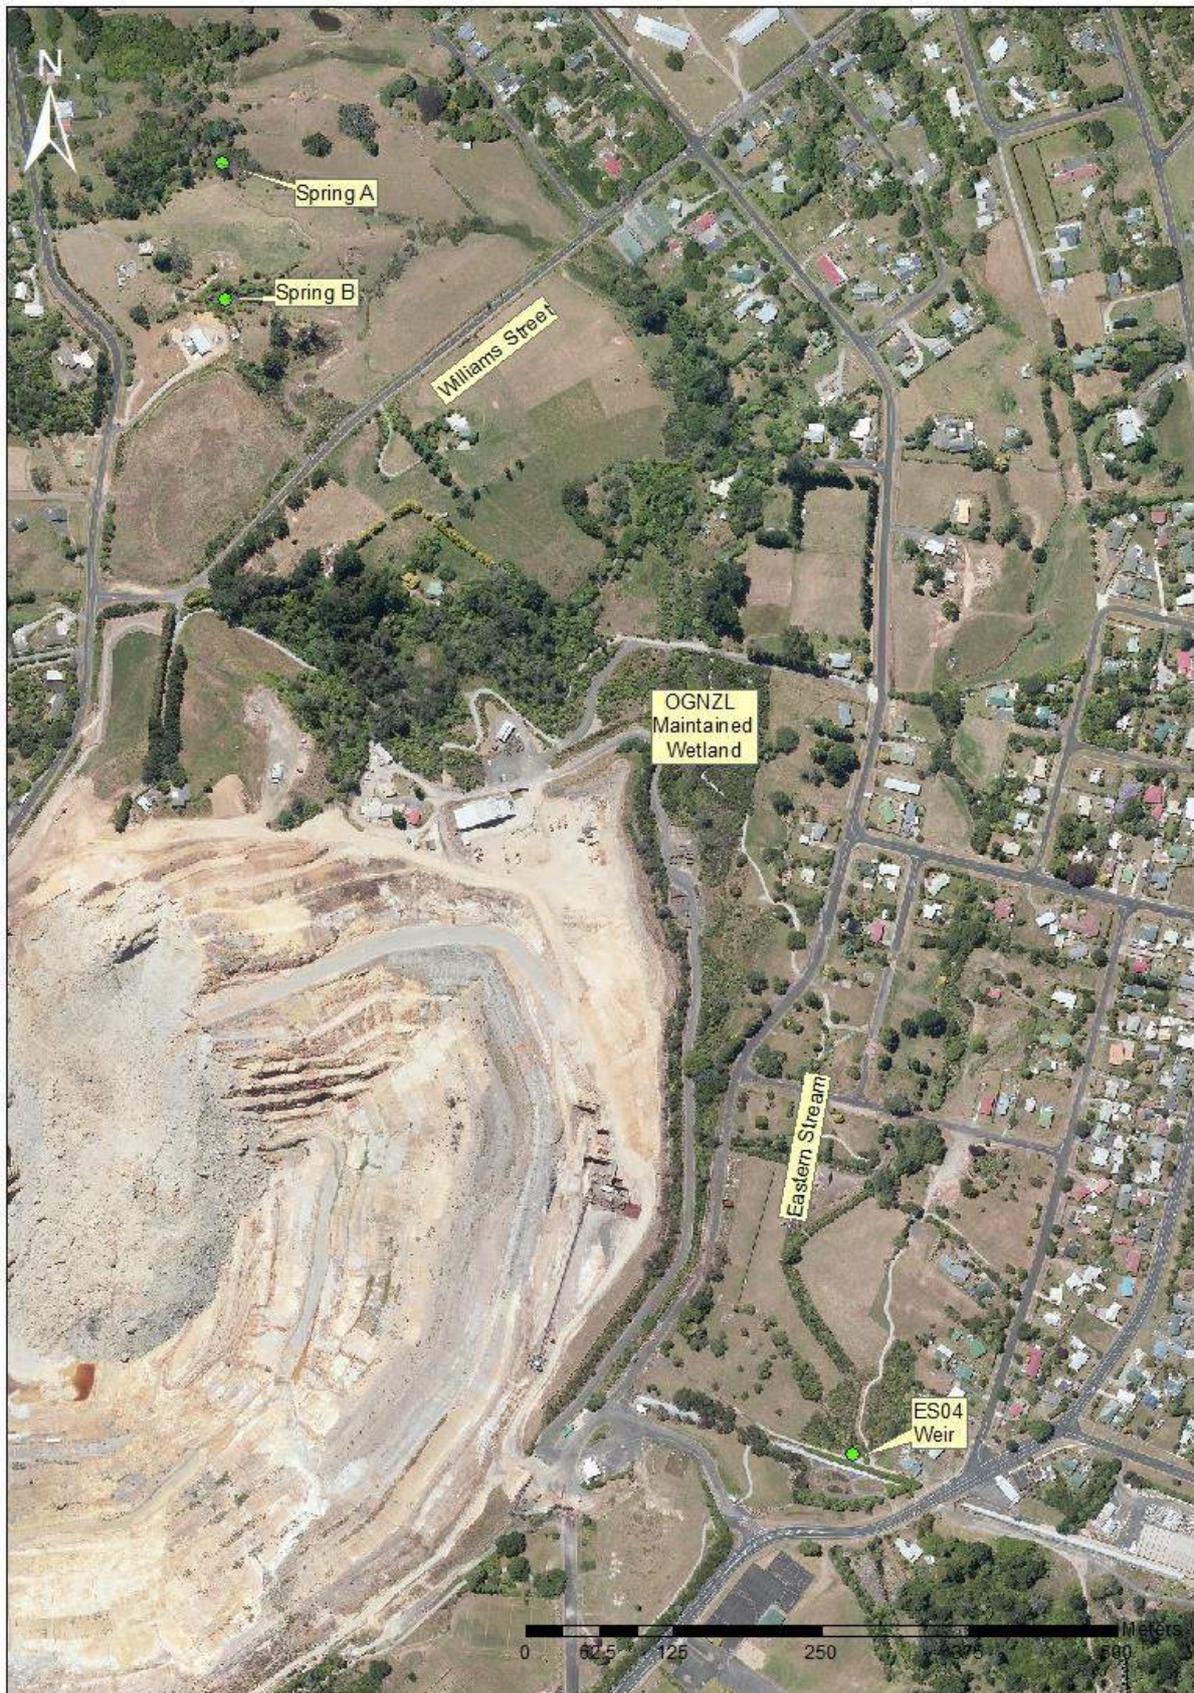
Figure 22: Northern Area Wetland

The Northern Area is located to the north of Martha Pit where younger volcanics/alluvium are located near the surface. Two separate areas of springs located between Williams Street and Bulltown Road drain south east into a wetland alongside the Pit Rim Walkway before joining the Eastern Stream. The area of wetland immediately northeast of the pit and the riparian margins of the Eastern Stream near the pit are maintained by OGNZL. No flow monitoring of this location has been undertaken in the past, however baseline flow monitoring further downstream on the Eastern Stream has begun at sampling point ES04 Weir (Figure 22).

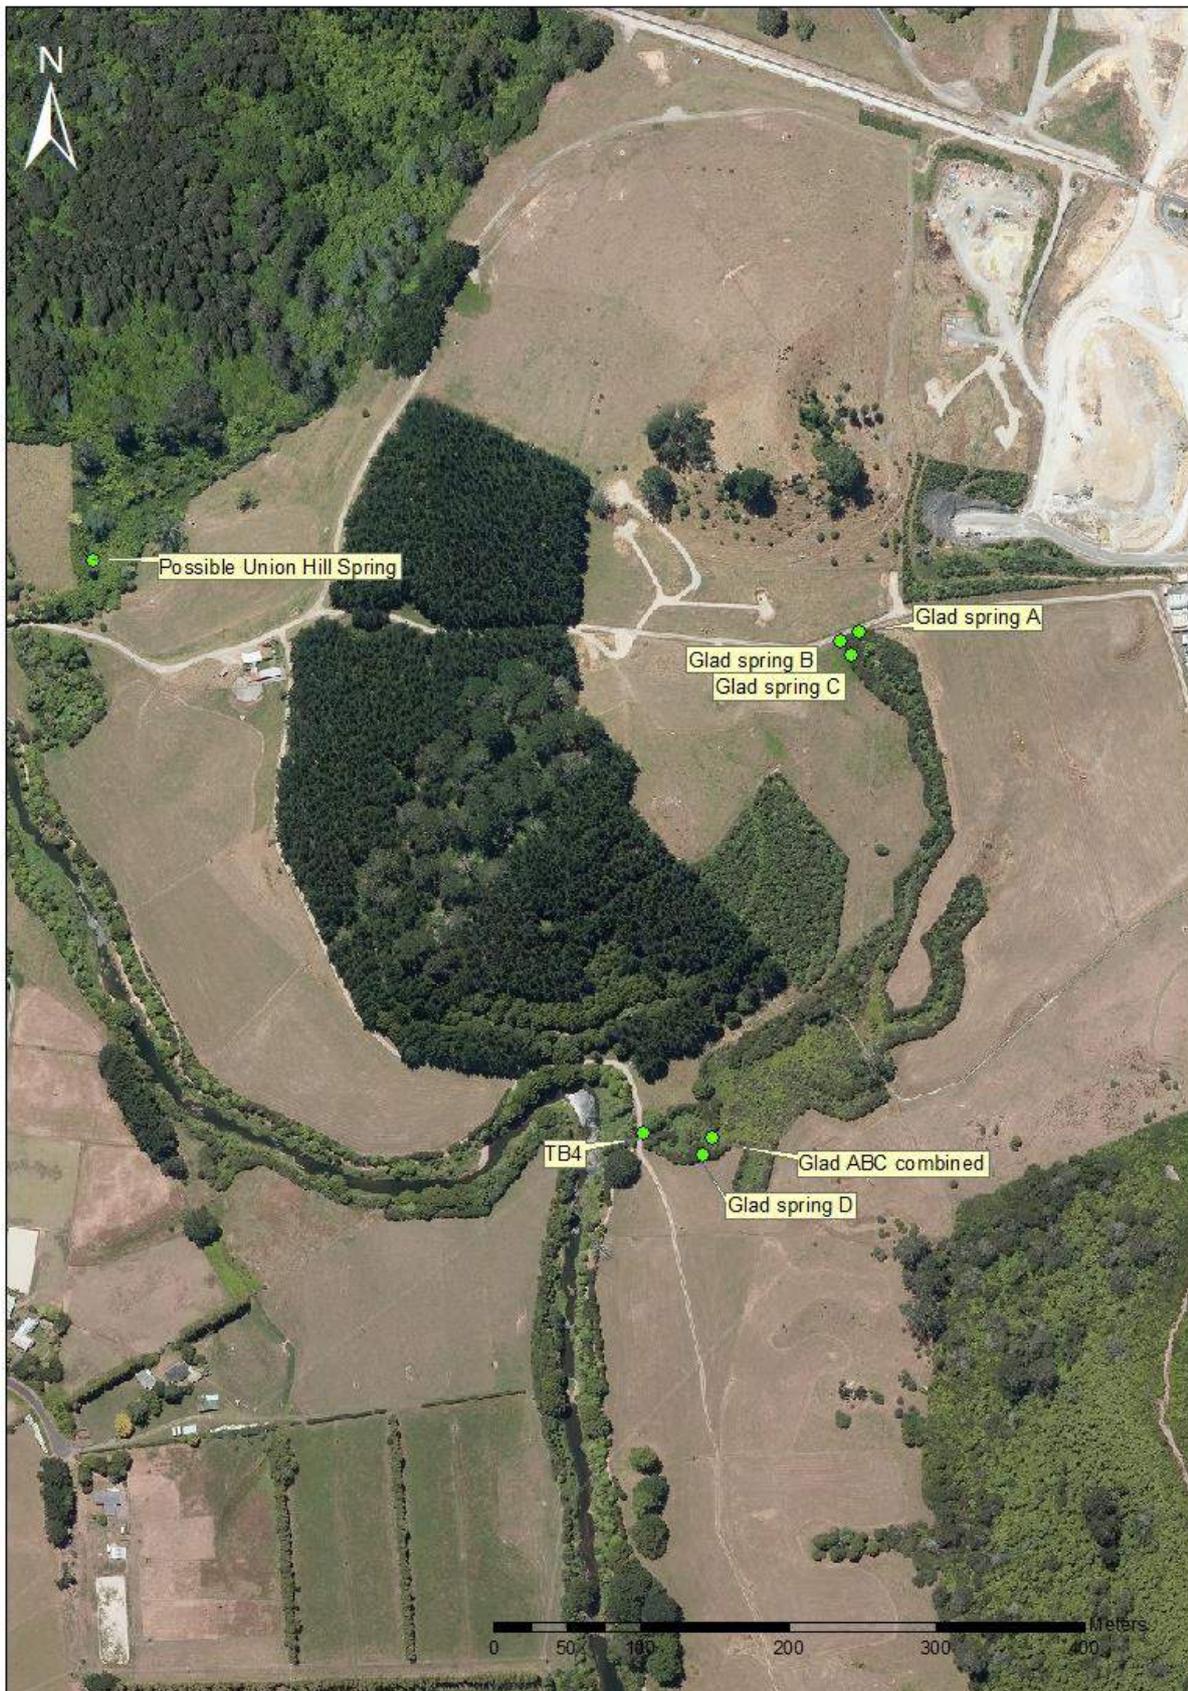
Figure 23: Southern Area Wetlands

The Southern Area consists of a collection of ephemeral springs that flow during winter or after heavy rainfall. Up to four separate springs flow from the south eastern side of Winner Hill (Figure 23). The springs run through a gully planted in natives and maintained by OGNZL, before eventually joining the Ohinemuri River. Flows from the springs are typically low and consequently, collecting flow rates at the springs themselves has not been possible. Collection of baseline flow data has instead commenced at TB4, where the springs join the Ohinemuri River (Figure 23). Initial monitoring has shown TB4 does not flow in summer.

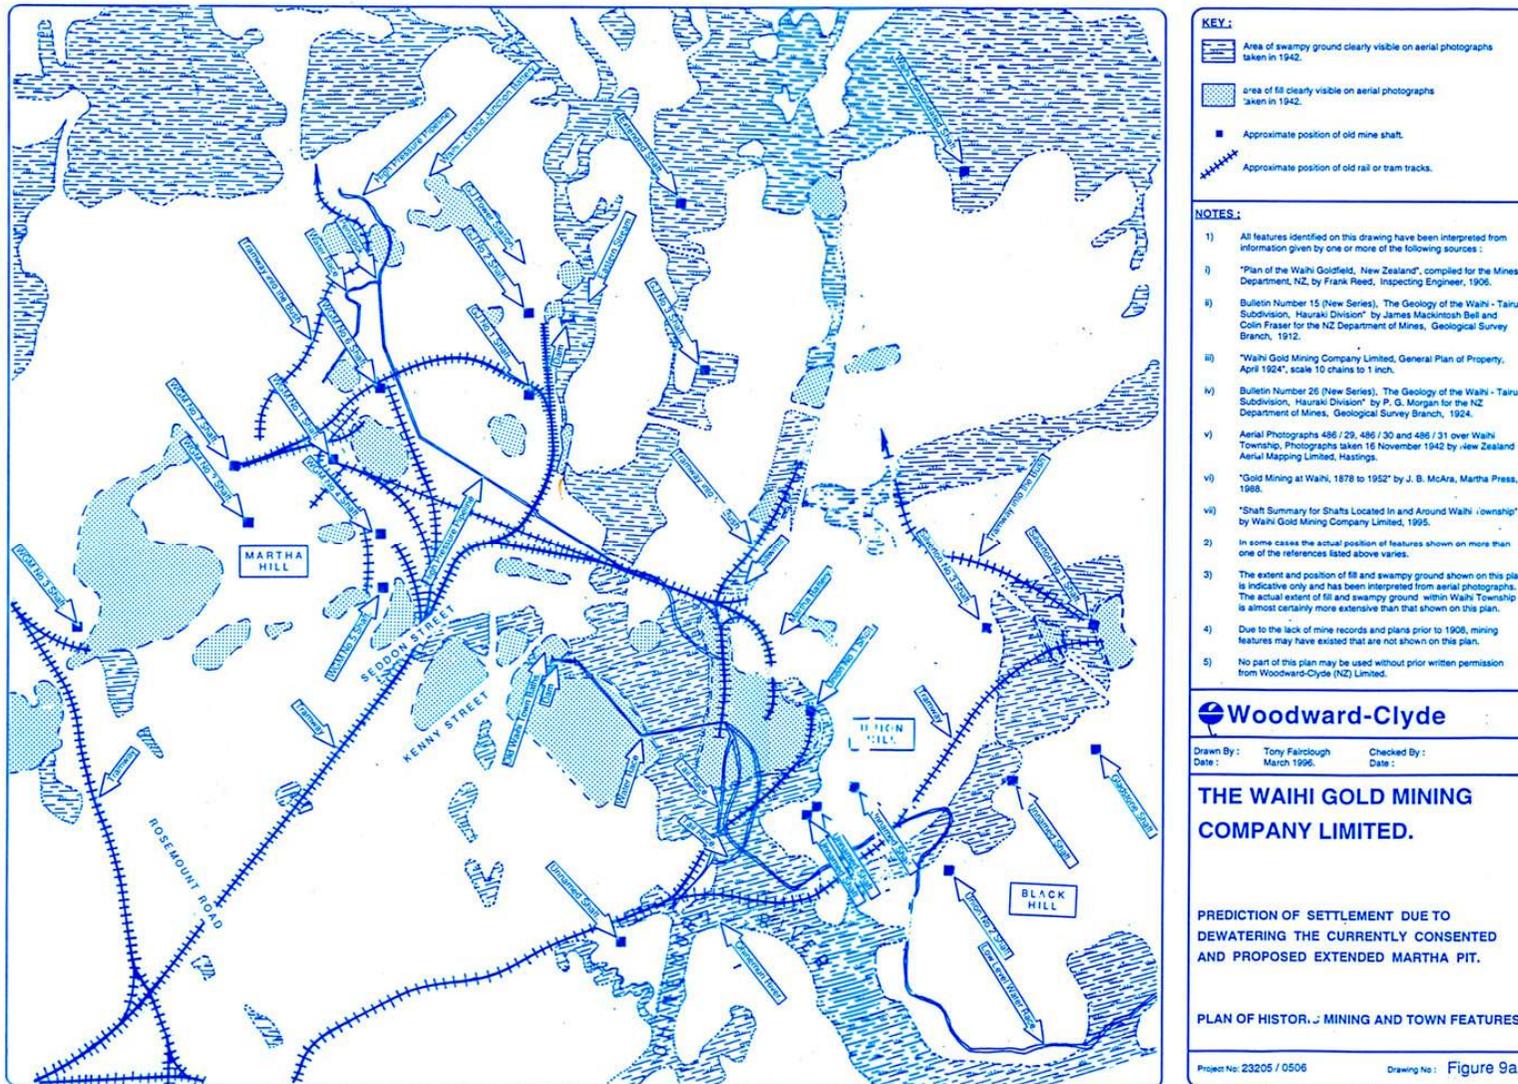
Figure 1 WWC (1996) Plan of Mining Features, Areas of Fill and Swamy Ground

This review has started with a figure (Figure 1 attached) generated by Woodward-Clyde in 1996 that identified relic mining features, areas of fill and locations of “swampy ground” based on a 1942 aerial photograph (refer Figures 2). We have interpreted these swampy areas as potentially being wetlands. This pre-modern mining plan has been lain over a recent aerial photograph to show where the areas of potential wetlands may still exist (Figure 3). In summary, it appears most of the potential wetland areas within the township, particularly in the east, have been infilled and developed into residential properties. Wetland areas to the north presently still remain, as do the areas to the south surrounding Union Hill, Black Hill and adjacent to the Ohinemuri River.

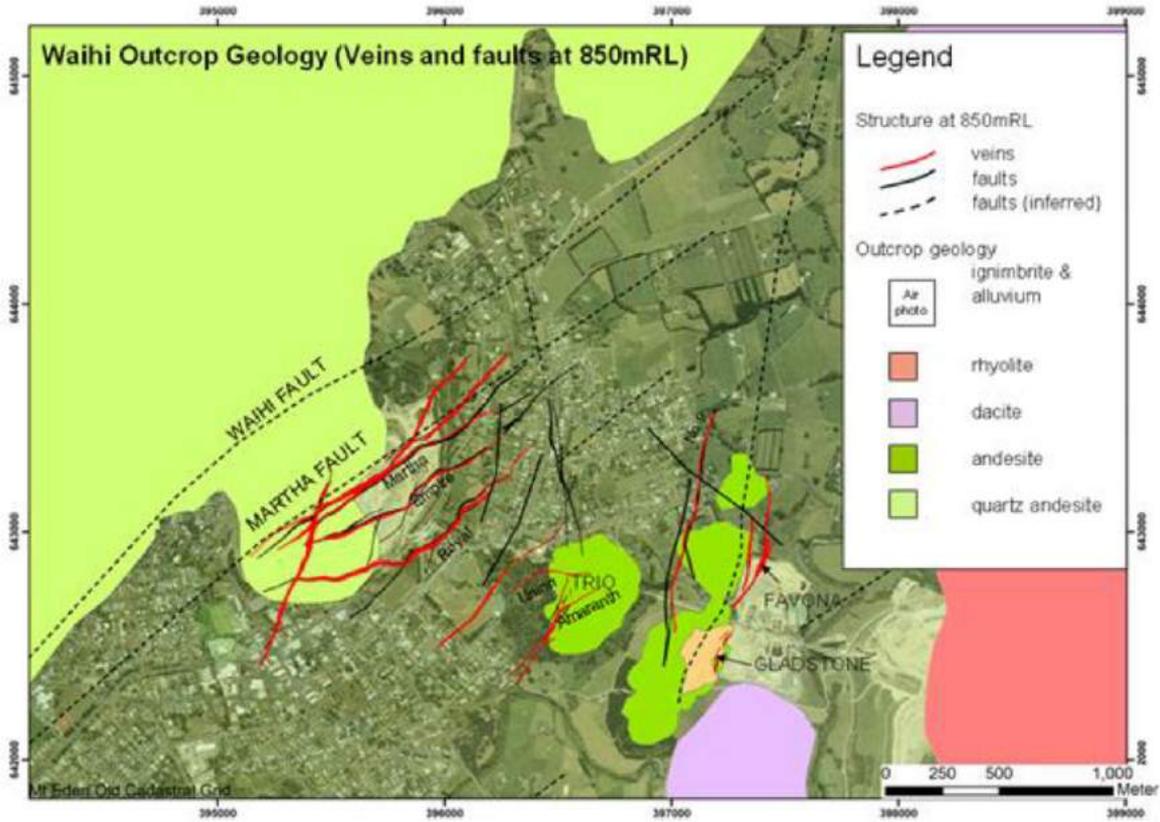
Figure 4 Geology of the Waihi Area

To assess the likelihood of these potential areas being spring fed, a map of the geology of Waihi (Figure 4), a topographic map (Figure 5) and high resolution historic aerial photographs have been used to make an interpretation as to whether springs are expected to occur in these locations or not based on the hydrogeologic setting.

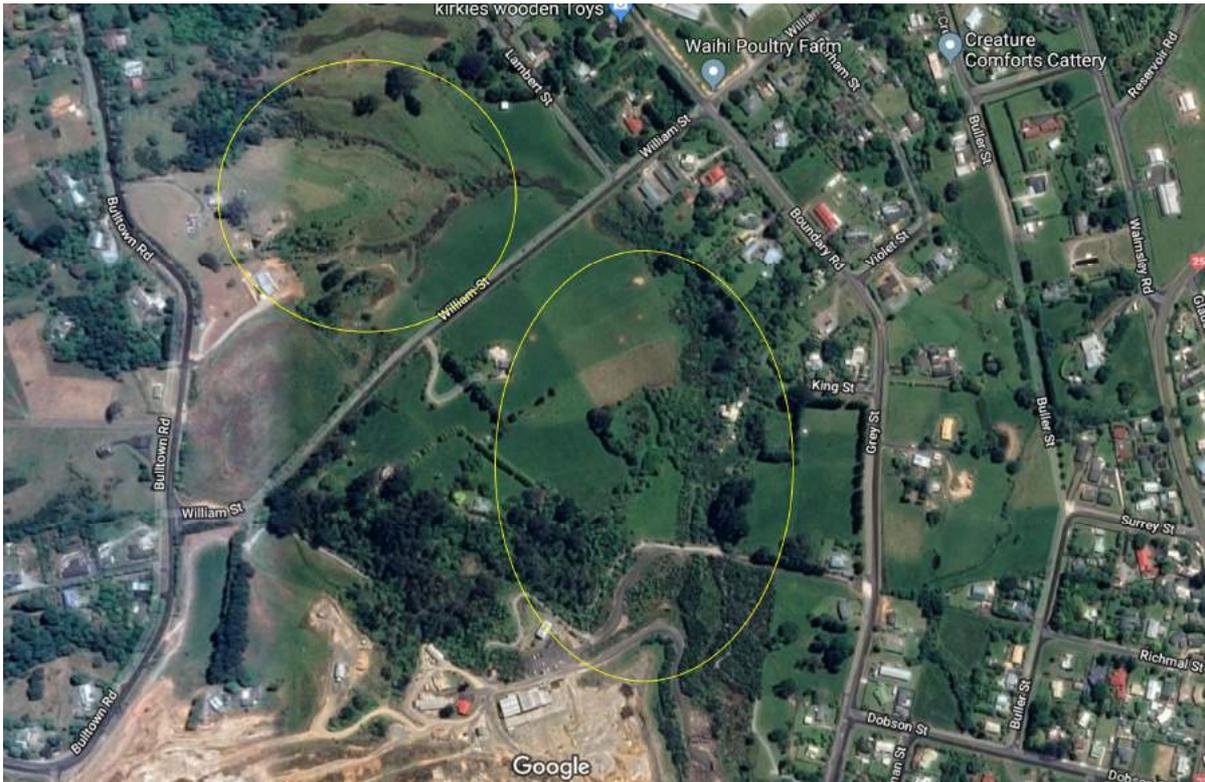
Figure 6 Northern Area Spring Fed Wetlands

The geology to the north of the Martha Pit in Waihi is dominated by a large massive body of quartz andesite at the surface which is largely devoid of springs. There is one area, however, where young volcanics/alluvium are present at the near surface where contact springs can occur. This area is some 400 to 500 m due north of the Martha Pit wall in between Williams St and Bulltown Rd (Figure 6). Review of the aerial photographs clearly shows what are likely to be springs forming two reaches that flow eastward to wetland areas that drain to the south.

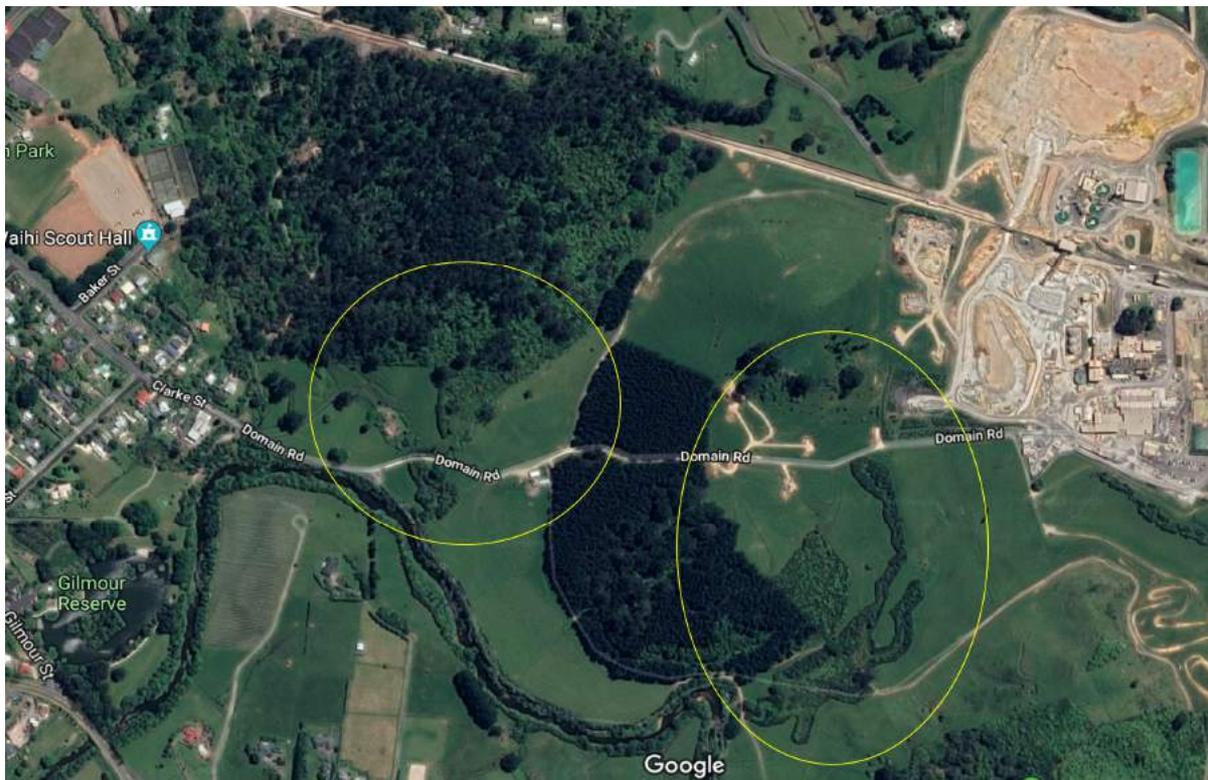
Figure 7 Southern Area Spring Fed Wetlands

The geology to the south of Waihi consist of volcanics/alluvium at the surface and there are two exposures of andesite that protrude though the sediments that form the Union and Black Hills (Figure 7). This older andesite is weathered in the near surface which has allowed the development of a soil regolith cover. This regolith allows the surface infiltration of water into the soil profile, which then allows the soil moisture to move under gravity to form spring, usually at a change in slope or where it meets the contact with the volcanics/alluvium. As shown on Figure 7 there are two locations adjacent to Domain Rd where springs are indicated to be discharging into wetland areas before entering the Ohinemuri River.
