**By now you will be well aware of the rock fall on the north wall which happened just before 5.00am on Tuesday 26 April. Approximately two million tonnes of rock has fallen from the wall. In this Update we explain why it occurred and what happens now.**

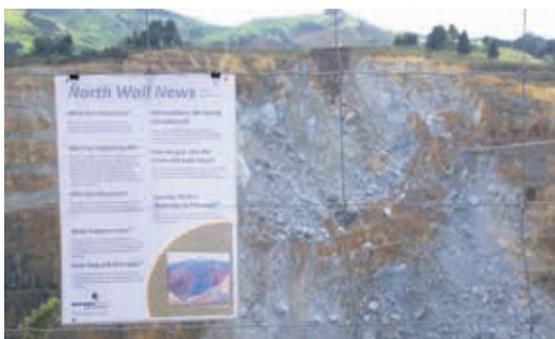
The effects of historic underground mining beneath the north wall combined with the rock structure of the wall as seen in the 2 April 2015 slip weakened the area.

Monitoring of the other walls shows that the movement was restricted to the section of the north wall which has fallen. There may be some subsequent smaller rock falls as the area settles. There are certainly some very large boulders within the slip area that will fall.

We wait. There is still unstable material which will fall. While we are waiting for this to happen we will determine the safest way of dealing with the fallen material and stabilising the north wall. Then we can determine the safest way of re-entering the pit. In the meantime any work near the slip has stopped. We are continuing to upgrade the perimeter road to the south of the pit and have moved a short section fence near the viewing area at the Cornish Pumphouse. This activity is unrelated to the 26 April rock fall.

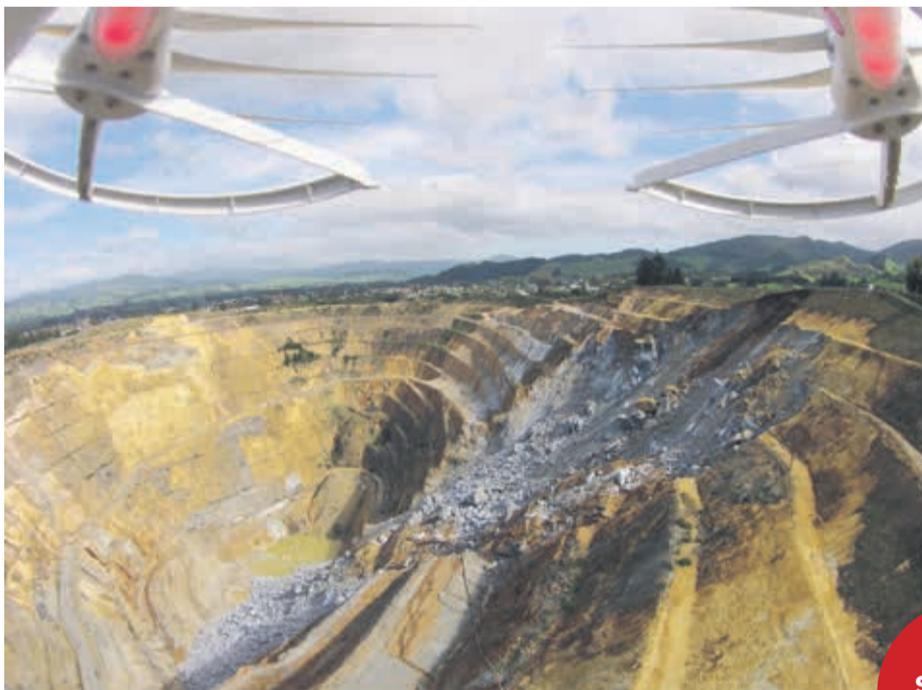
This photo was taken with our quadcopter a few hours after the rock fall. It clearly shows the amount of material that has fallen out of the wall and how much is in the bottom of the open pit.

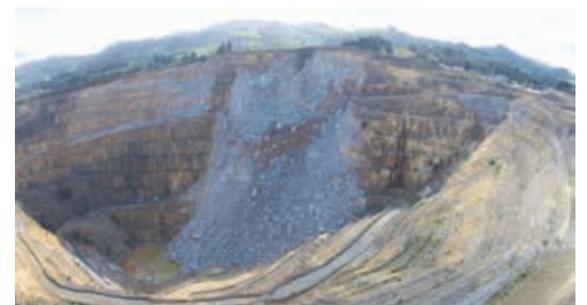
Quadcopter photo taken late last week.
