Mining 101

North wall rock fall

In this *East Ender* we explain why it occurred and what happens now.

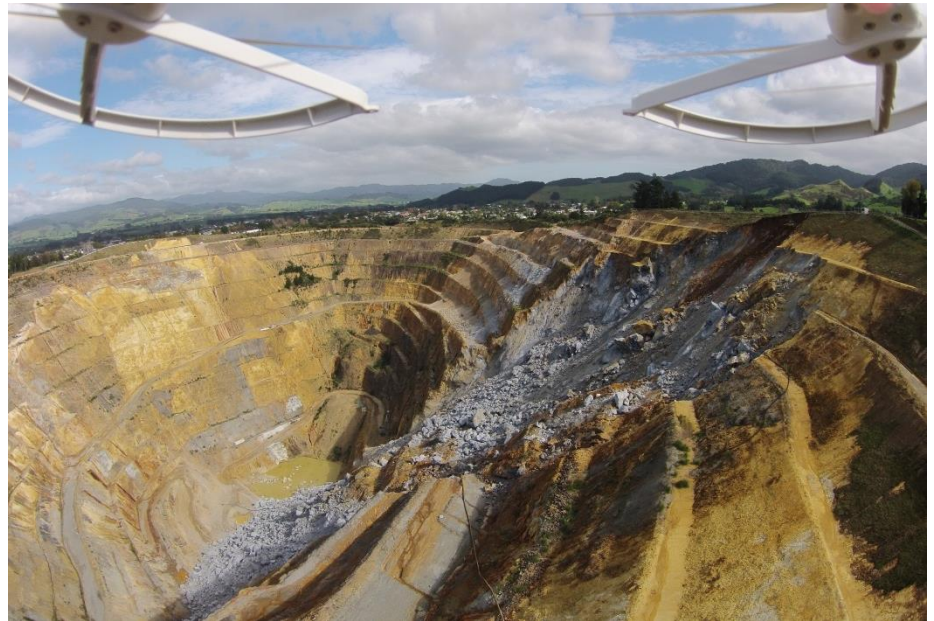
Approximately two million tonnes of rock has fallen from the wall.

Above: This photo was taken by with our quadcopter a few hours after the rock fall. It clearly shows the amount of material that has fallen out of the wall and how much is in the bottom of the open pit.

There was a smaller rock fall on 2 April last year. After this all mining in the open pit was halted. We have been monitoring the north wall using a sophisticated radar system and a range of other devices. This monitoring told us that the wall was moving. We advised the community of the likelihood of another rock fall on 20 April. We closed a section of the Pit Rim Walkway at that time.

The effects of historic underground mining beneath the north wall combined with the rock structure of the wall as seen in the 2 April 2015 slip weakened the area.

We wait. There is still unstable material which will fall. While we are waiting for this to happen we will determine the safest way of dealing with the fallen material and stabilising the north wall. Then we can determine the safest way of re-entering the pit. In the meantime any work near the slip has stopped. We are continuing to upgrade the perimeter road to the south of the pit and have moved a short section fence near the viewing area at the Cornish Pumphouse. This activity is unrelated to the 26 April rock fall.

Monitoring of the other walls shows that the movement was restricted to the section of the north wall which has fallen. There may be some subsequent smaller rock falls as the area settles. There are certainly some very large boulders within the slip area that will fall.

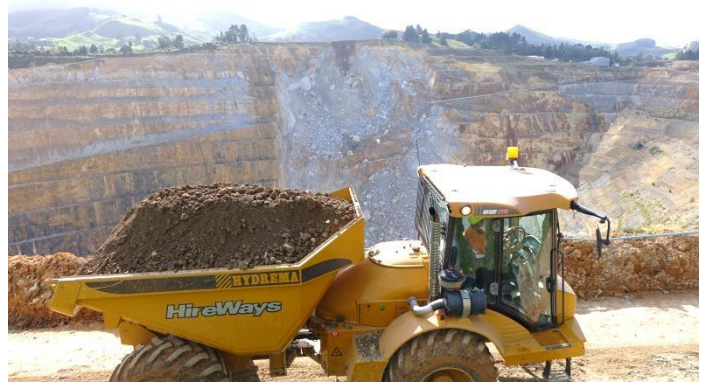
Above: Work on the southern perimeter road continues. This road will be used to transport material from the new north wall pit access to the crusher. This road is currently being widened, which has meant that the fence near the Cornish Pumphouse has been moved a few metres.
