OCEANAGOLD

Managing the Hazards Associated with Open Stopes

Charles Gawith
OceanaGold Waihi Operations

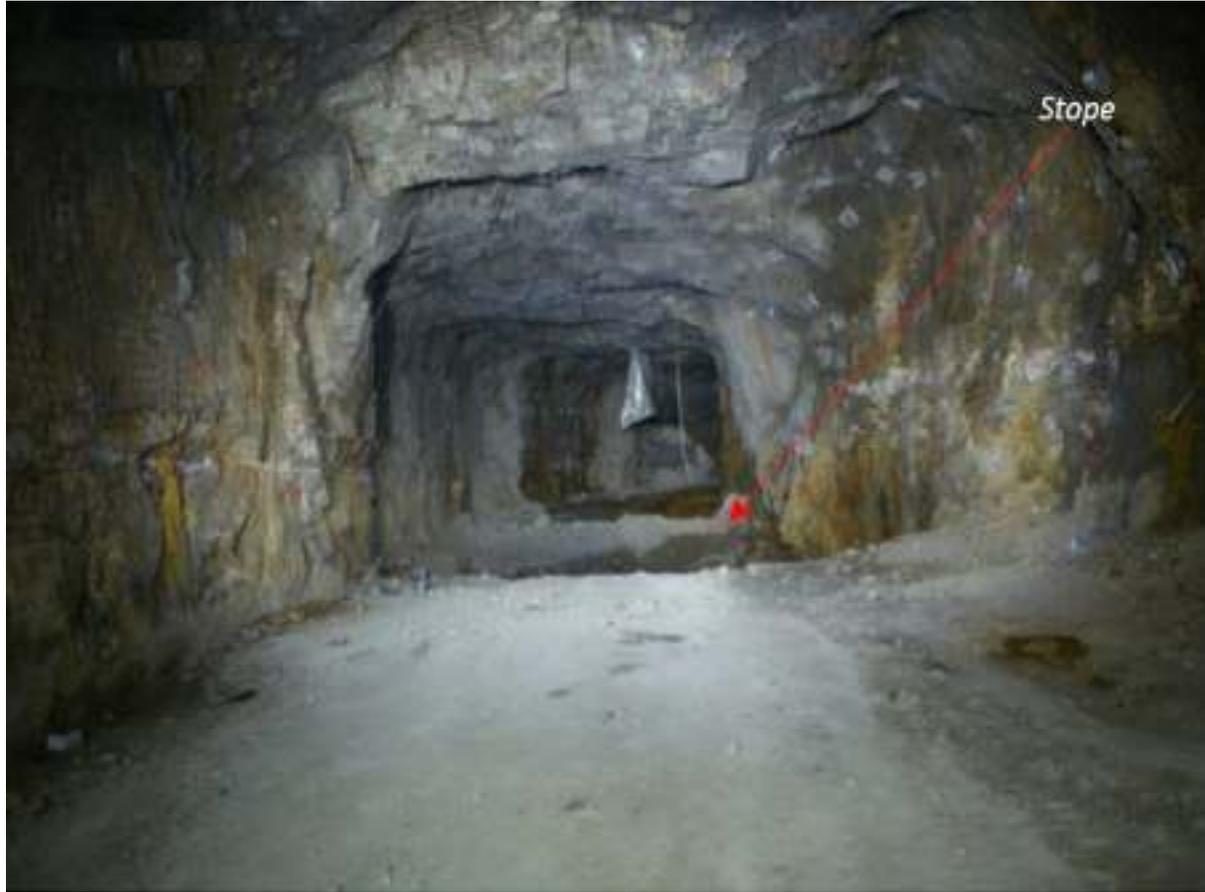
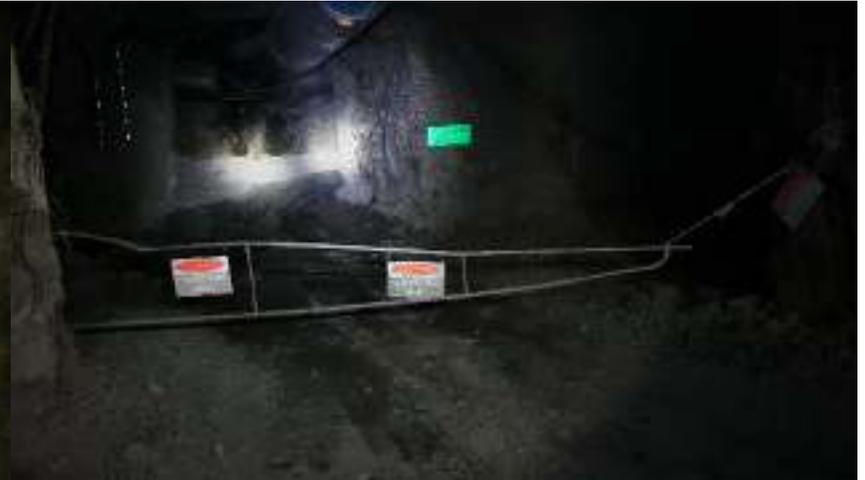
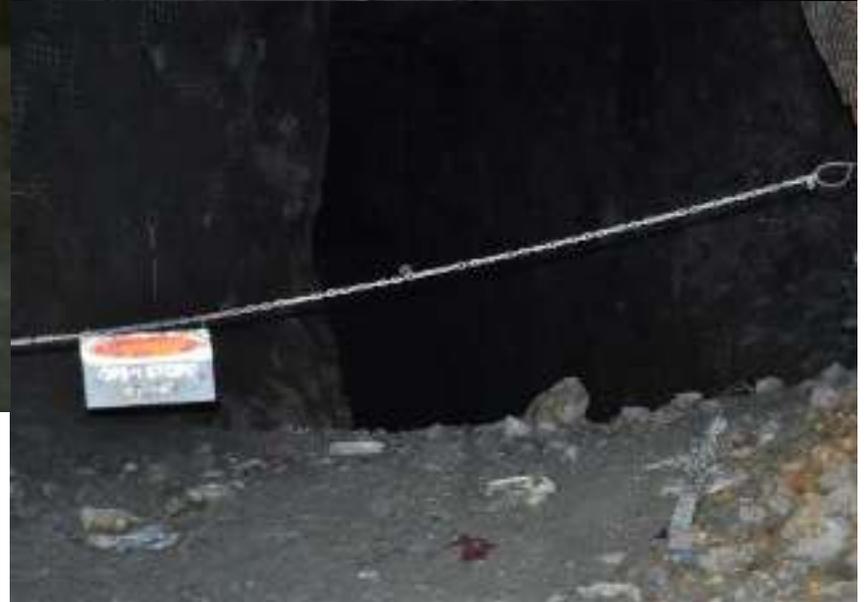
Location of the Incident

- **7:15am loader operator assigned task to commence backfilling operations at the 840-1-South**
- **Underground loader 122 was out of service so operator assisted charge-up crew until lunchtime.**
- **15:05pm loader operator proceeded underground in loader 123 to commence the backfilling task.**
- **15:40pm loader operator contacted remote operator on level below for confirmation that the appropriate barricades etc where in place as per procedure.**
- **Approximately 18:00pm remote operator discovered loader 123 upside down on the 825-1-South level and initiated emergency response.**

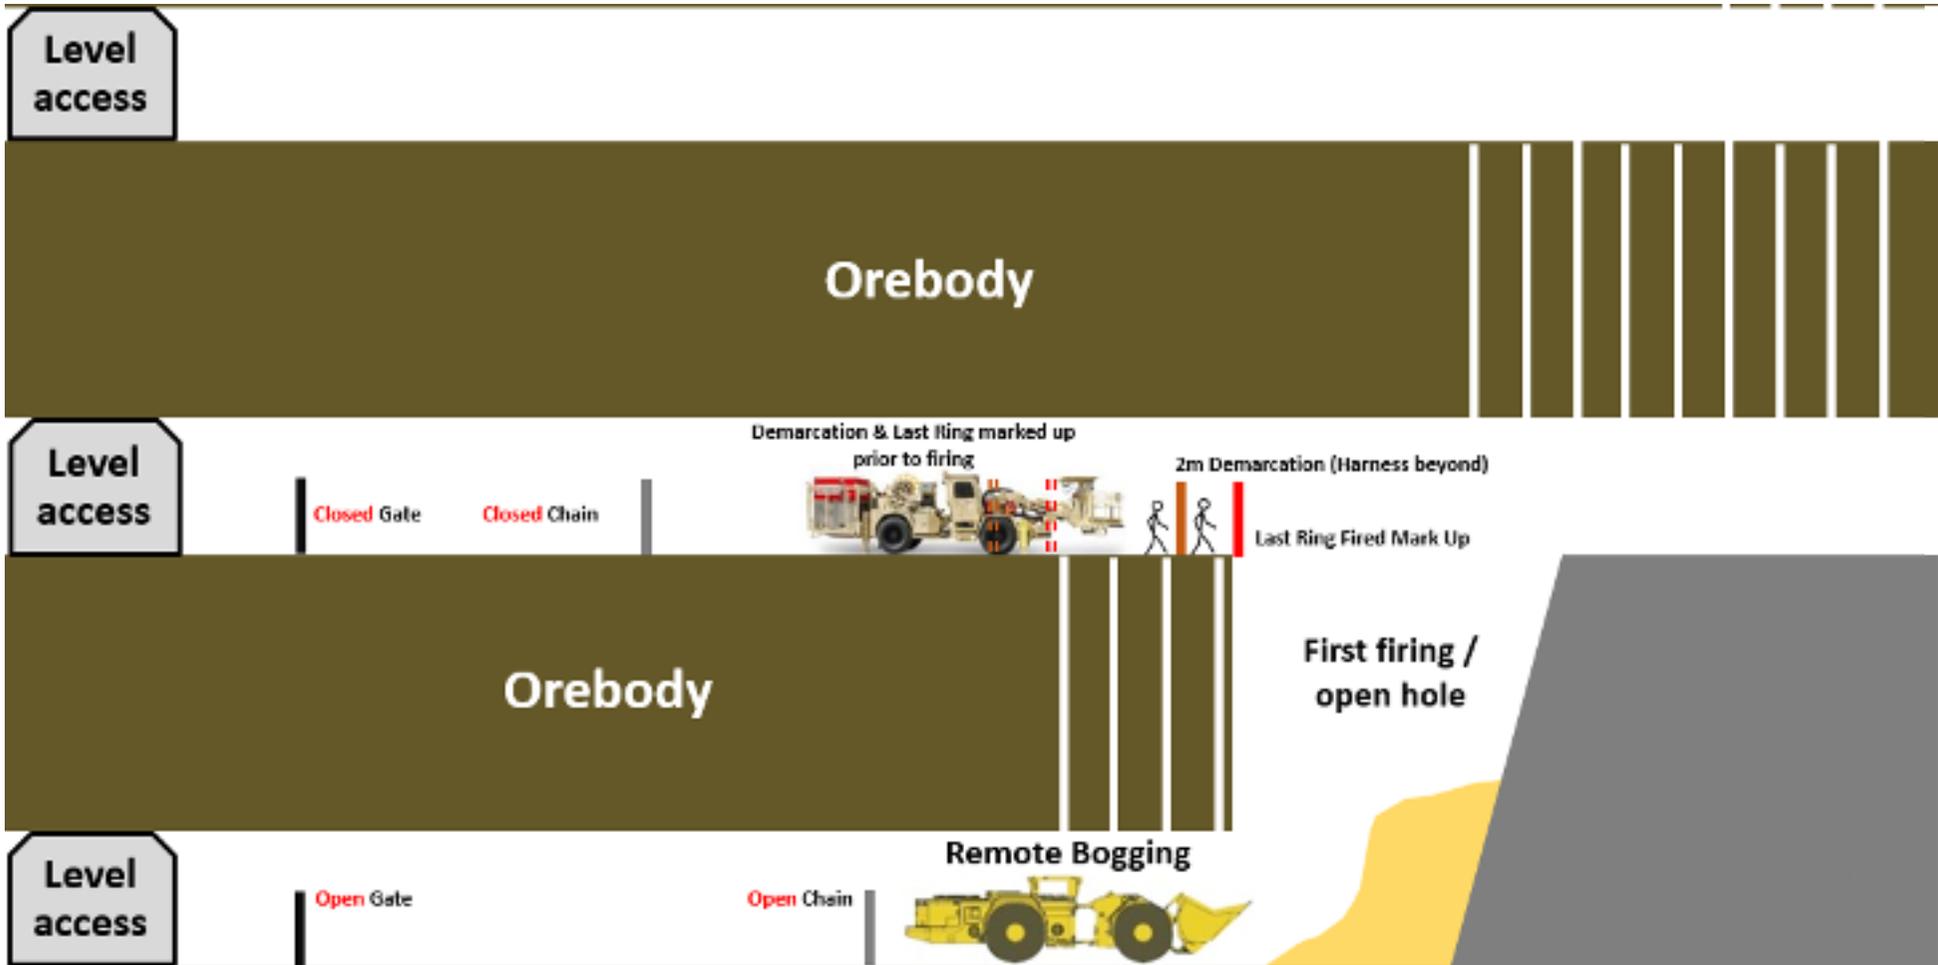
Why Steel Stop Logs Can't be used at Waihi

- Installing the Steel Stop Log has the same primary risk as the building of a waste bund. That is a loader drives towards an unprotected void with a bucket full of steel as opposed to a bucket full of rock!
- The increased complexity of installing the Steel Stop Log when compared to the rock bund construction was likely to lead to ad hoc modifications or on the fly hacks in the field.
- Steel Stop Logs and their associated chains require a significant amount of ongoing maintenance and checks. These multiple activities increase the risk associated with working around open stopes.
- Steel Stop Logs could give an operator a false sense of security as it will not stop their loader from entering a stope.
