Union Hill Heritage Features Monitoring Plan

(Trio, & Correnso Mines)

February 2023

Document ID: WAI-200-PLN-02

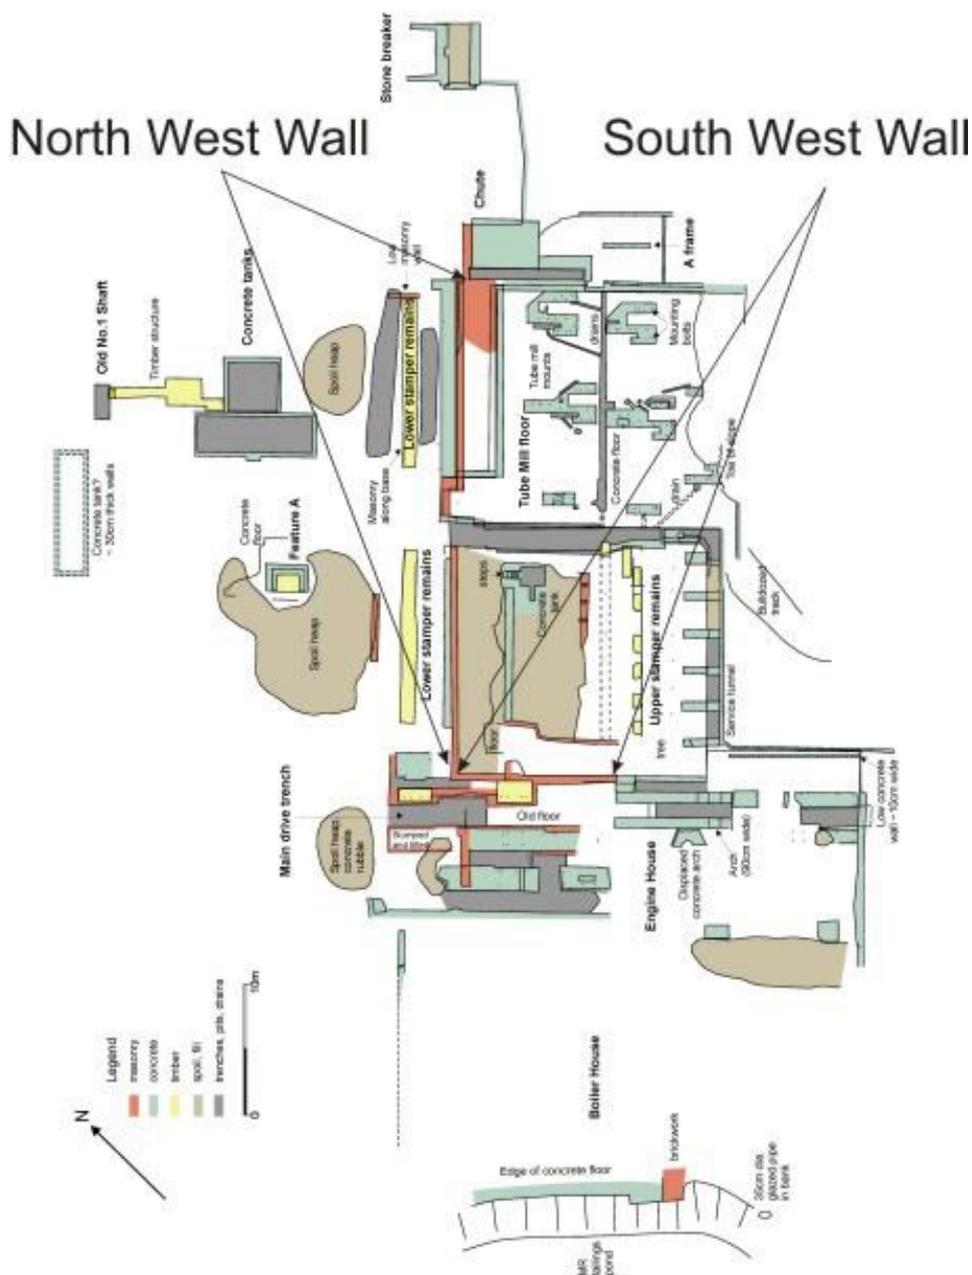
Figure 3. Location of Battery Walls

For the most part, the relics associated with the battery are mass concrete (machinery foundations etc.) and are immune to any blast-related vibration effects. However, there is a masonry wall that separated the upper and lower stampers that is more susceptible to damage than the mass concrete and is deteriorating due to natural degradation, visitor climbing, and vegetation (refer Figure 3 for location).

As with the other relics, the risk to the wall from blast vibrations is minimal and ongoing natural degradation and vegetation are the main threats to the wall's stability. However, monitoring of the wall for block movement was desirable, and monthly visual inspections of the wall were therefore included.

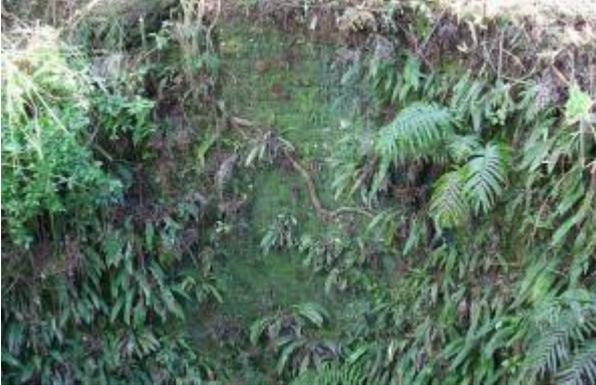
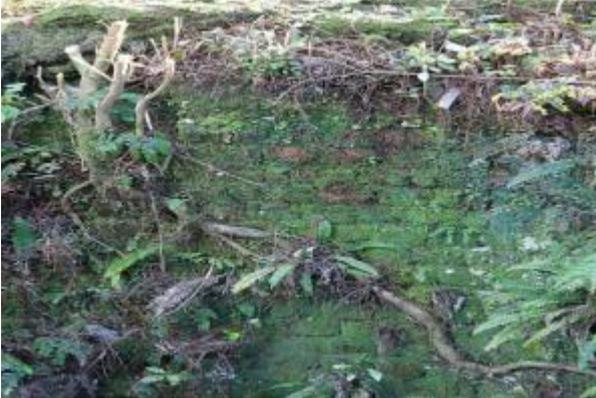
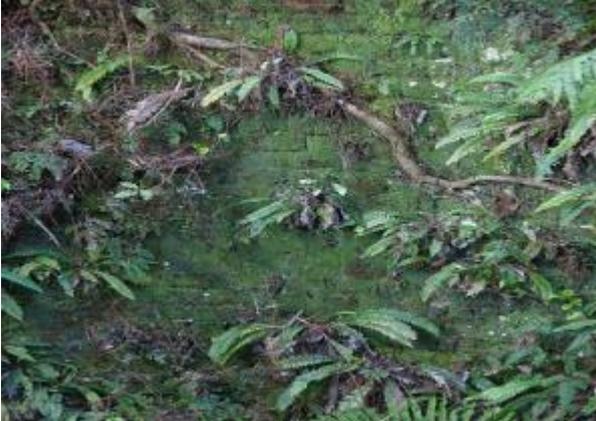
Item: Kilns	Location / Status
<p>Kiln 10: Extensometer fitted across one crack in vertical mortar end joint in the brick rings – real time monitoring</p>

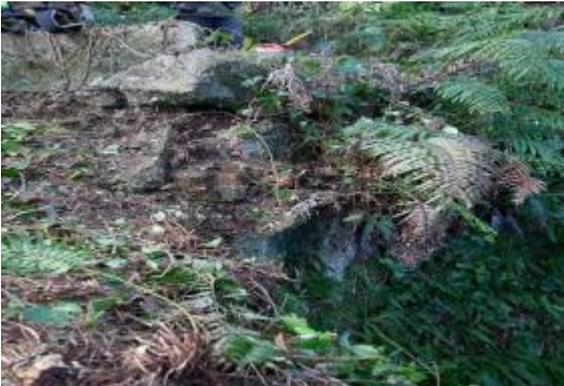
<p>Kiln 10: Extensometer fitted across one open horizontal crack in the brick rings at the perimeter – real time monitoring</p>

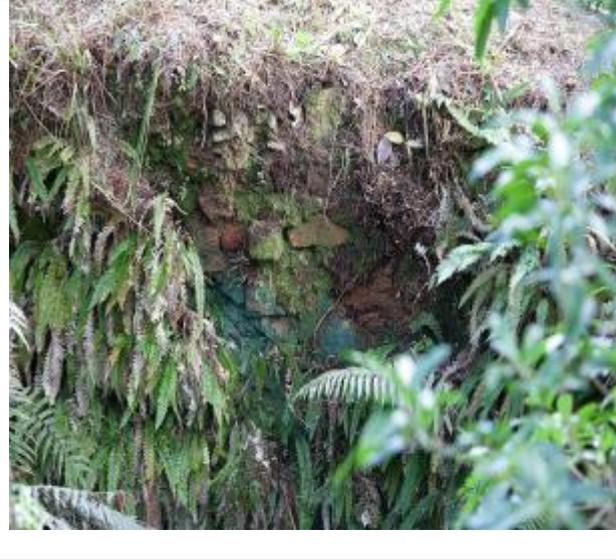
<p>Kiln 9: Identification of two “indicator areas” (one driven by organic pressure (roots) and one without signs of vegetation locally) at risk of stone earth or brick movement – visual monitoring</p>

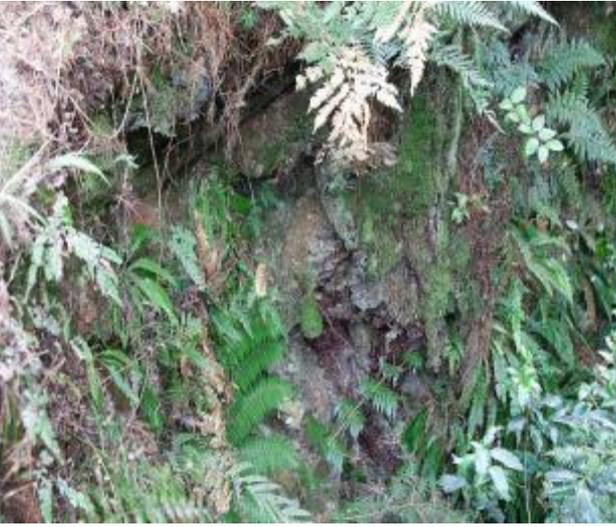
<p>Kiln 7: Identification of two “indicator areas” (one driven by organic pressure (roots) and one without signs of vegetation locally) at risk of stone earth or brick movement – visual monitoring</p>

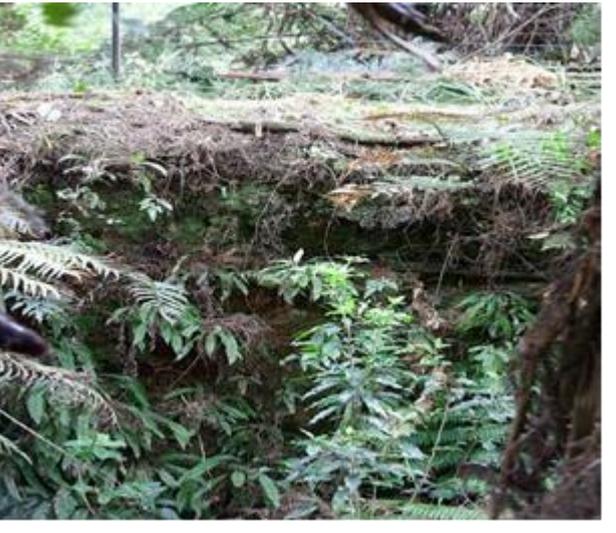
<p>Kiln 7: Identification of two “indicator areas” (one driven by organic pressure (roots) and one without signs of vegetation locally) at risk of stone earth or brick movement – visual monitoring</p>

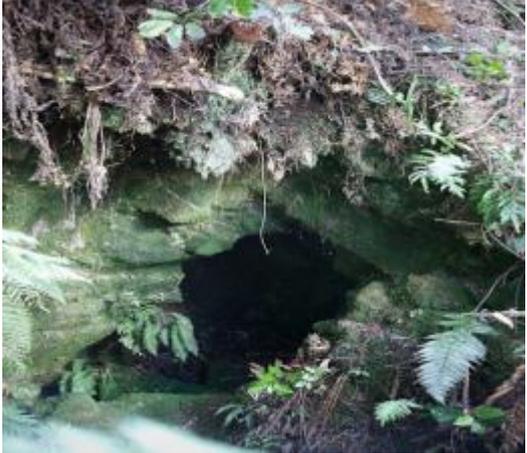
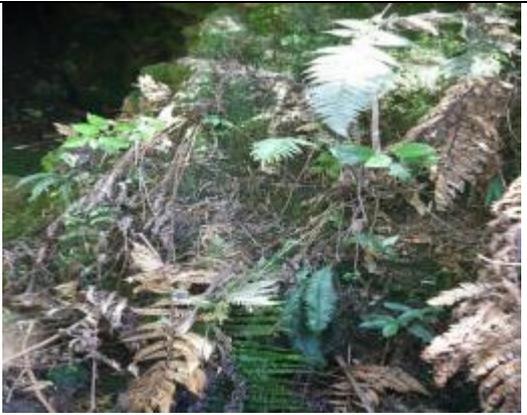
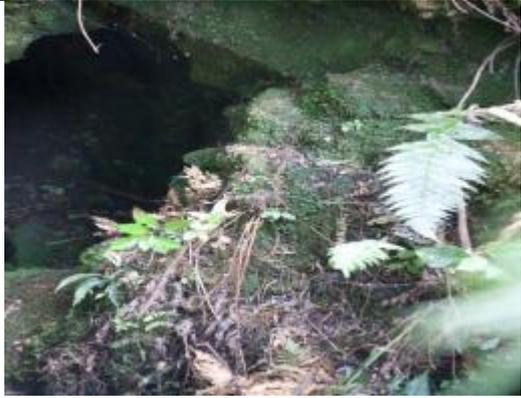
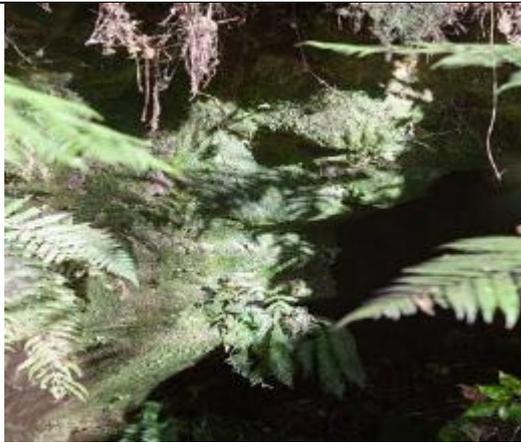
<p>Kiln 5: Identification of one "indicator area" (one without signs of vegetation locally)</p> <p>where the vent / loading area comes into a kiln – visual monitoring</p>

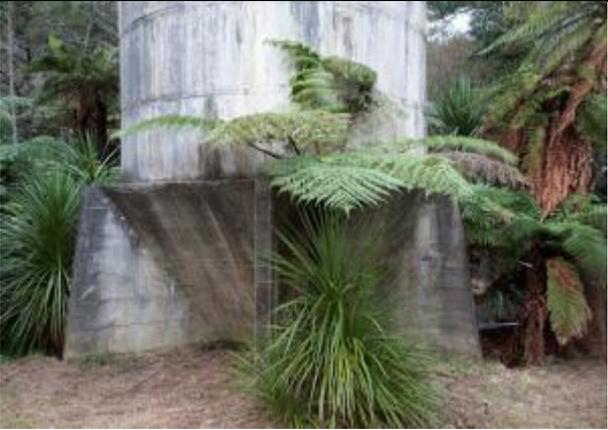
Item	Location / Status
Tanks	
Accelerometer on ground at Tank Four – real time monitoring

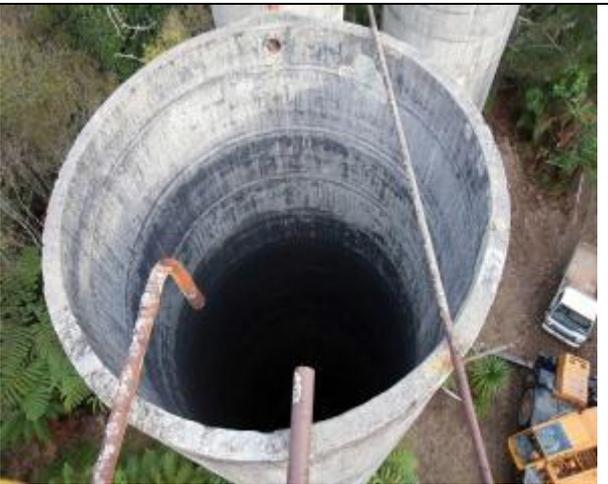
Accelerometer on top Tank Four – real time monitoring

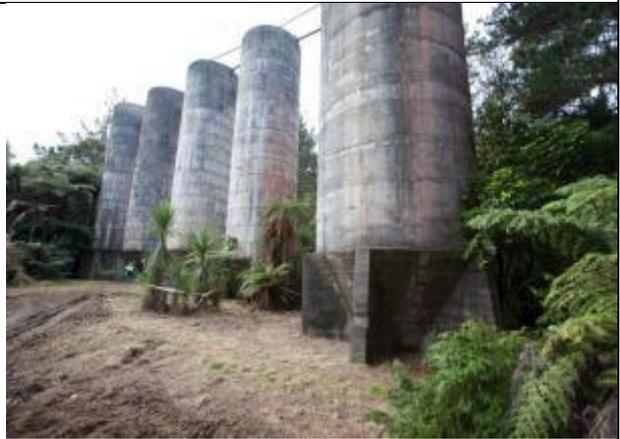
General - Pipes on Top of Tanks

<p>Visual monitoring of damage to Tank 1 Rim – Annual Inspection</p>
