Rehabilitation and Closure Plan

Document Reference: WAI-200-PLN-011

2021-22 Rehabilitation and Closure Plan

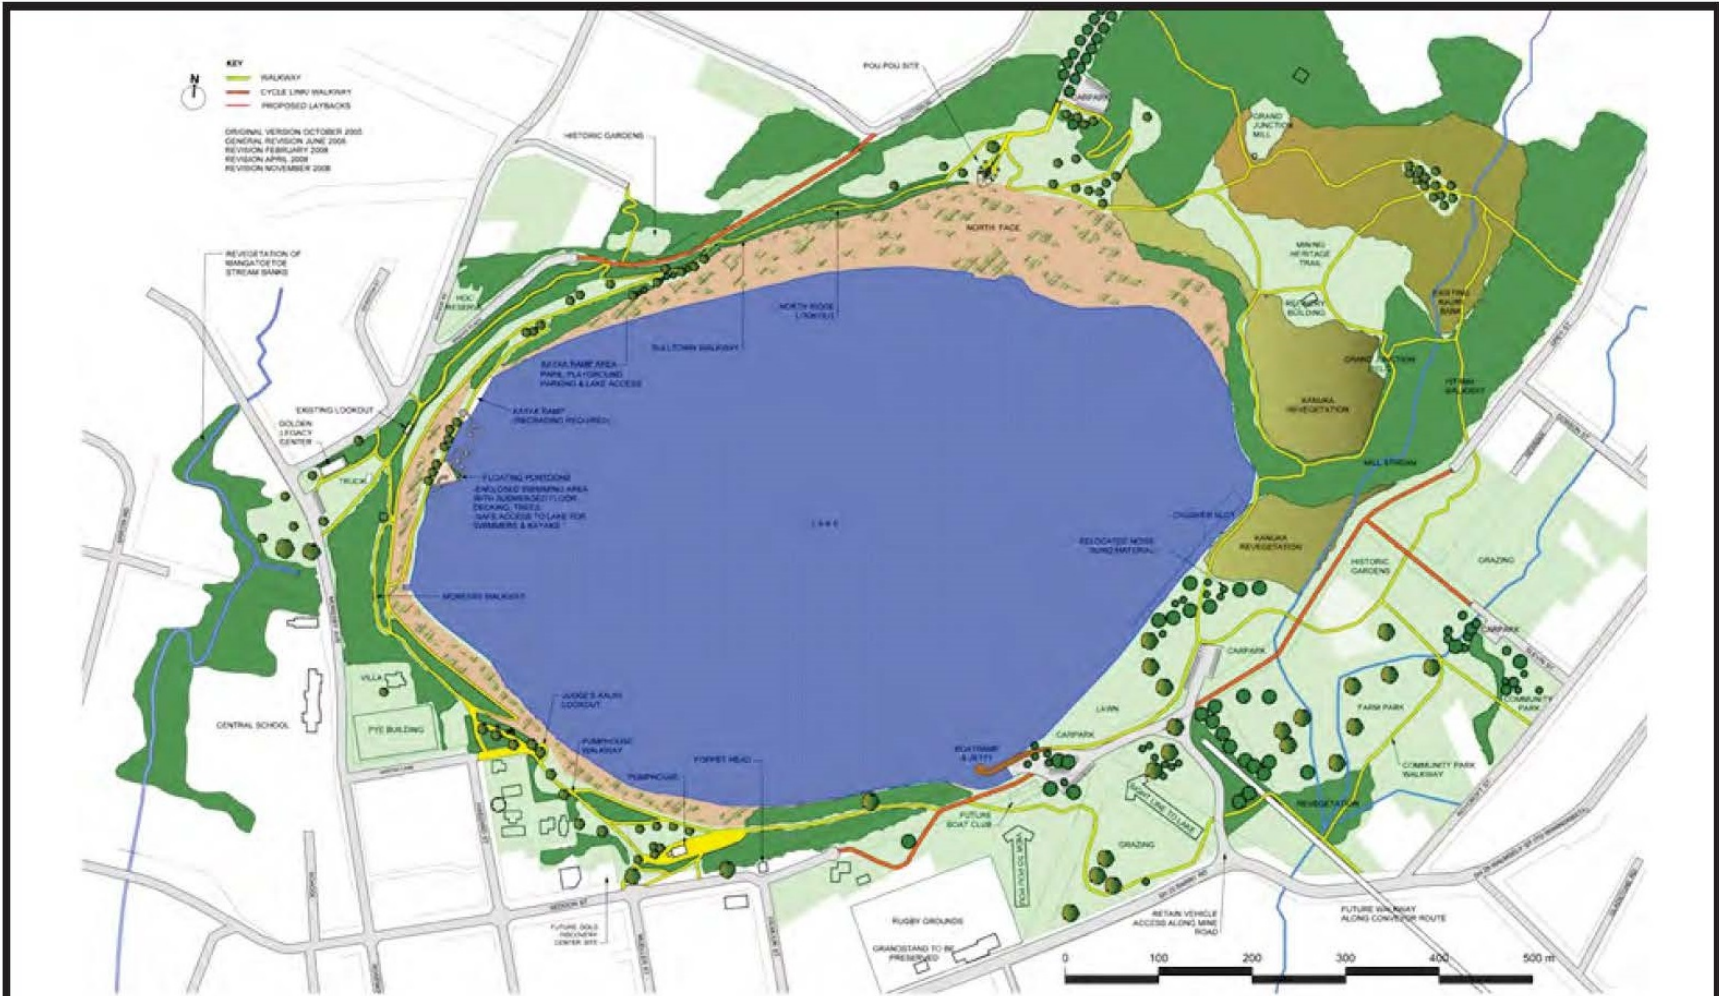
Figure 2: Closure Plan for Mine Lake and Surrounds

<p>Closure Plan for Mine Lake and Surrounds (source: Landscape Design Company)</p>	<p>Figure 2</p> <p>Date: 17 October 2016</p> <p>File: D:\Data\Waihi Gold\Closure\...Figure 2.odr</p>
---	--	--

The conceptual closure plan for the open pit prepared in 2008 and shown in Figure 2 remains mostly unchanged. However, as part of Stage 4, the north wall will require realignment (Figure 3).

In the event of sudden closure, a swimming pontoon is provided for, located at the western end of the pit. The shape of the pontoon approximates that shown in the pit closure concept plan (Figure 2) and includes a submerged swimming area.

Some further planting may be necessary in the surface facilities area only. The assumption is to plant around 1.2ha of kanuka vegetation as shown in Figure 2, plus some other individual trees.
