Rehabilitation and Closure Plan

2022-23

Document Reference: WAI-200-PLN-011

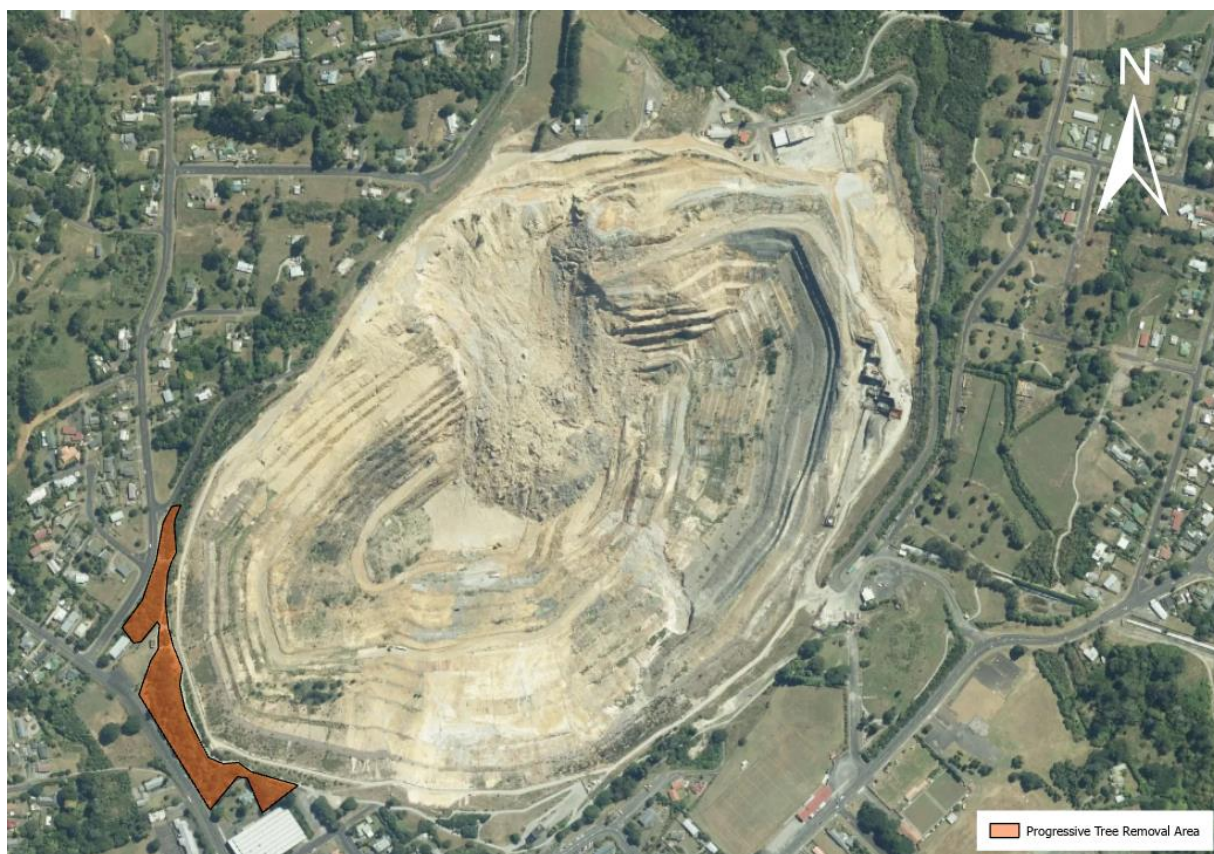
Figure 1: Martha Pit Progressive Tree Removal Area.

For large weed trees (namely wattles and pines) with a screening function at the western side of the pit (**Error! Reference source not found.**), a process exists at present whereby the OGNZL Senior Environmental Advisor – Operations contacts HDC’s Strategic Planning Project Manager prior to their removal. The two then visit the site, discuss the proposed plans for tree removal and agree on any need for mitigation, i.e. infill planting. This process is working well, and the intention is that this process will continue.

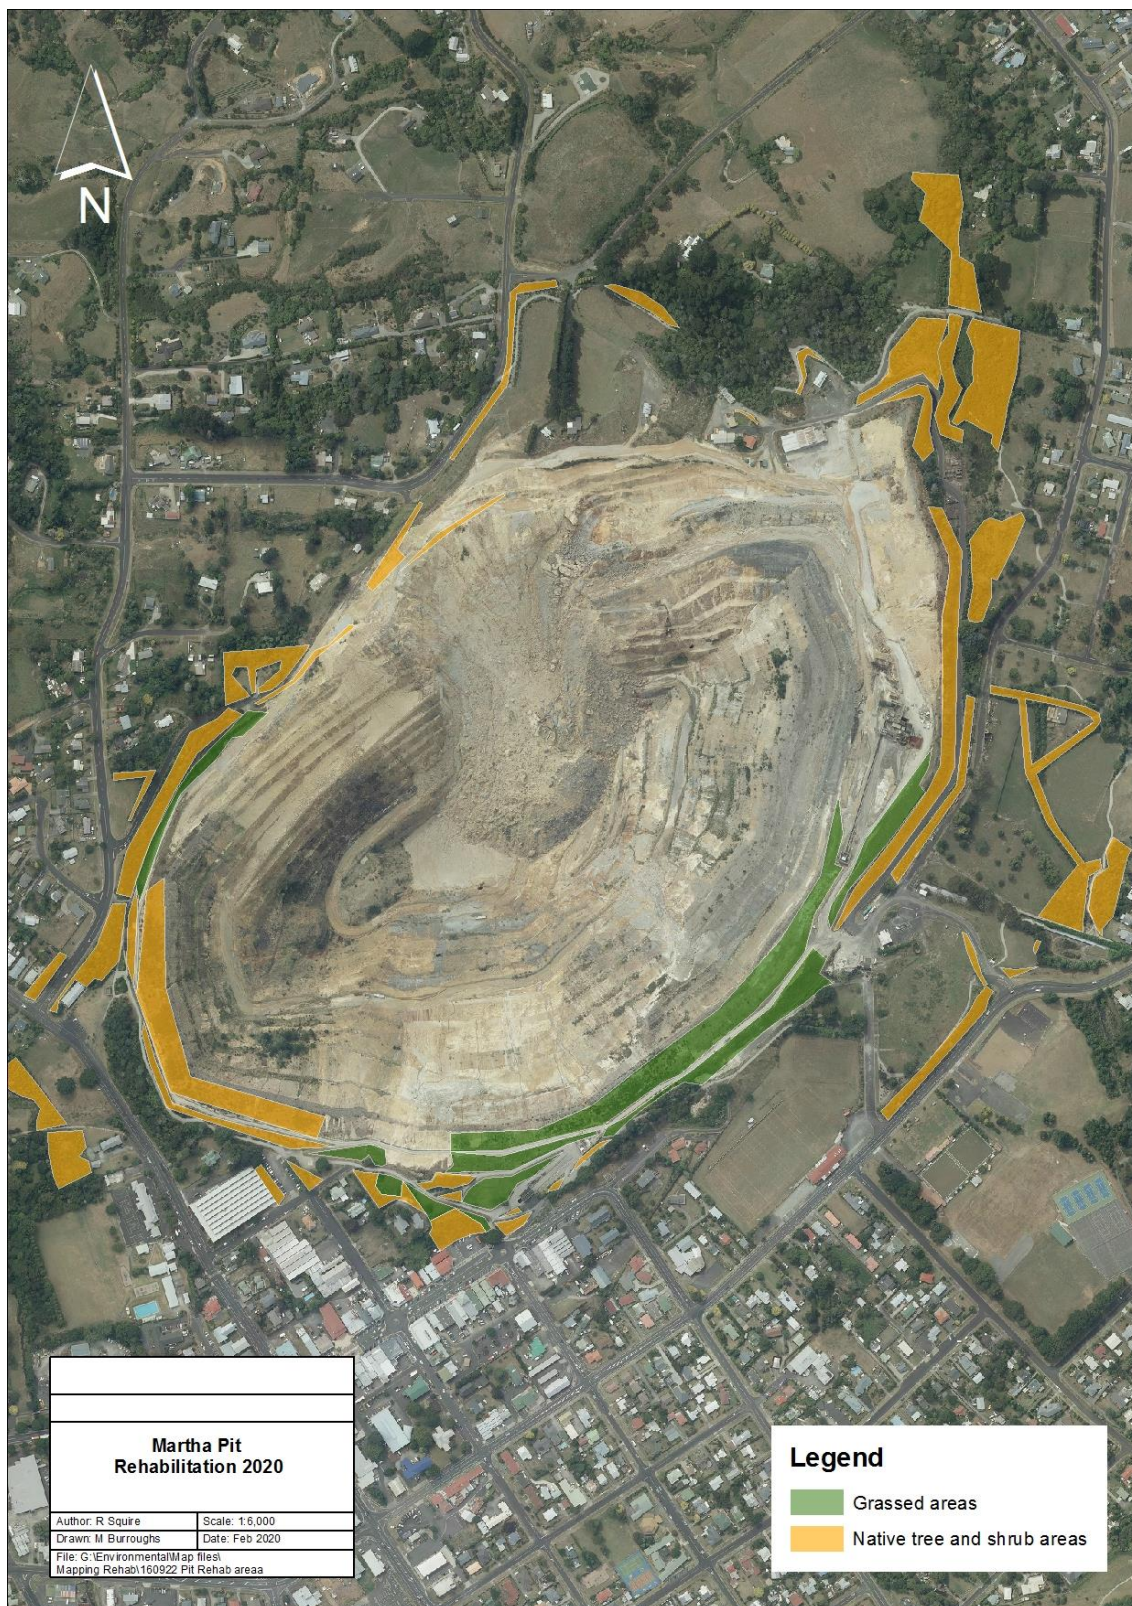
Figure 4: Rehabilitation of Open Pit and Surrounding Areas.

Note: No new areas of rehabilitation have occurred since the 2020 version of Figure 4.

Figure 4 shows the areas that have been rehabilitated around the open pit and pit-rim walkway, as well as some adjacent areas that could be described as “discretionary”. In 2012 this included plantings along the Mangatoetoe Stream west of the pit. Other recent planting areas include the north wall of the pit, undertaken in 2018.

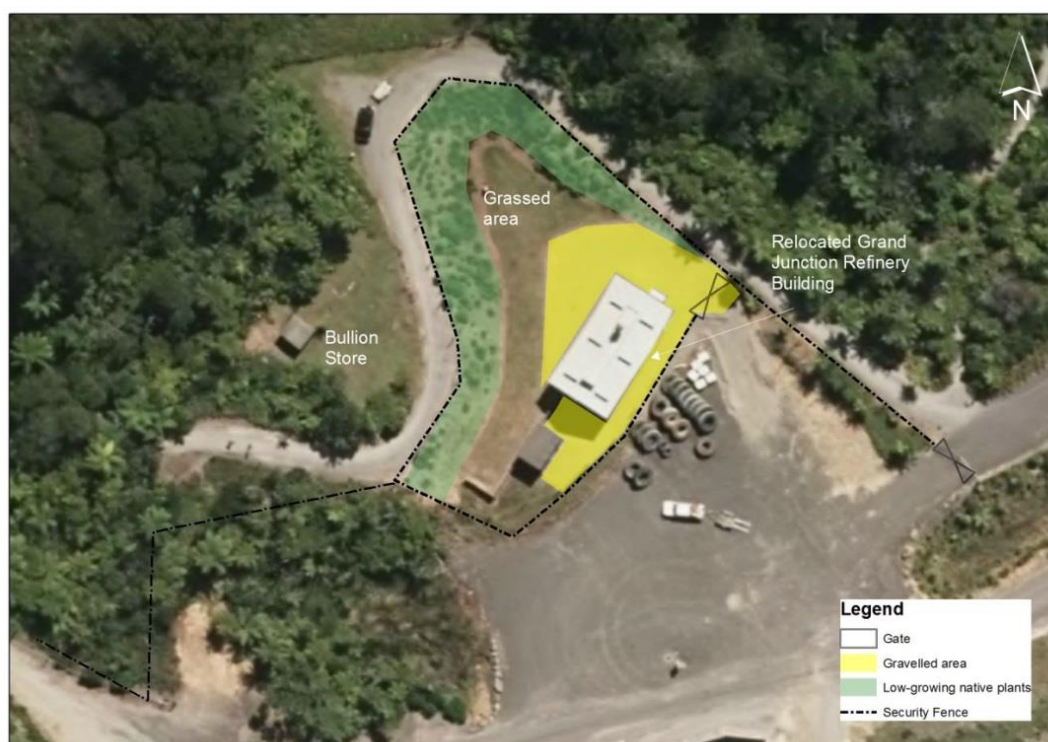
Figure 7: Grand Junction Refinery Landscaping.

The Grand Junction Refinery Building was relocated in March/April 2010 and subsequently refurbished in accordance with the Conservation Management Plan (and Figure 6). Landscaping work has largely been completed (Figure 7), although ongoing minor and agreed improvements to the building and curtilage continue (i.e. in 2017 a historic ore wagon, refurbished by a local resident was placed on display beside the building).

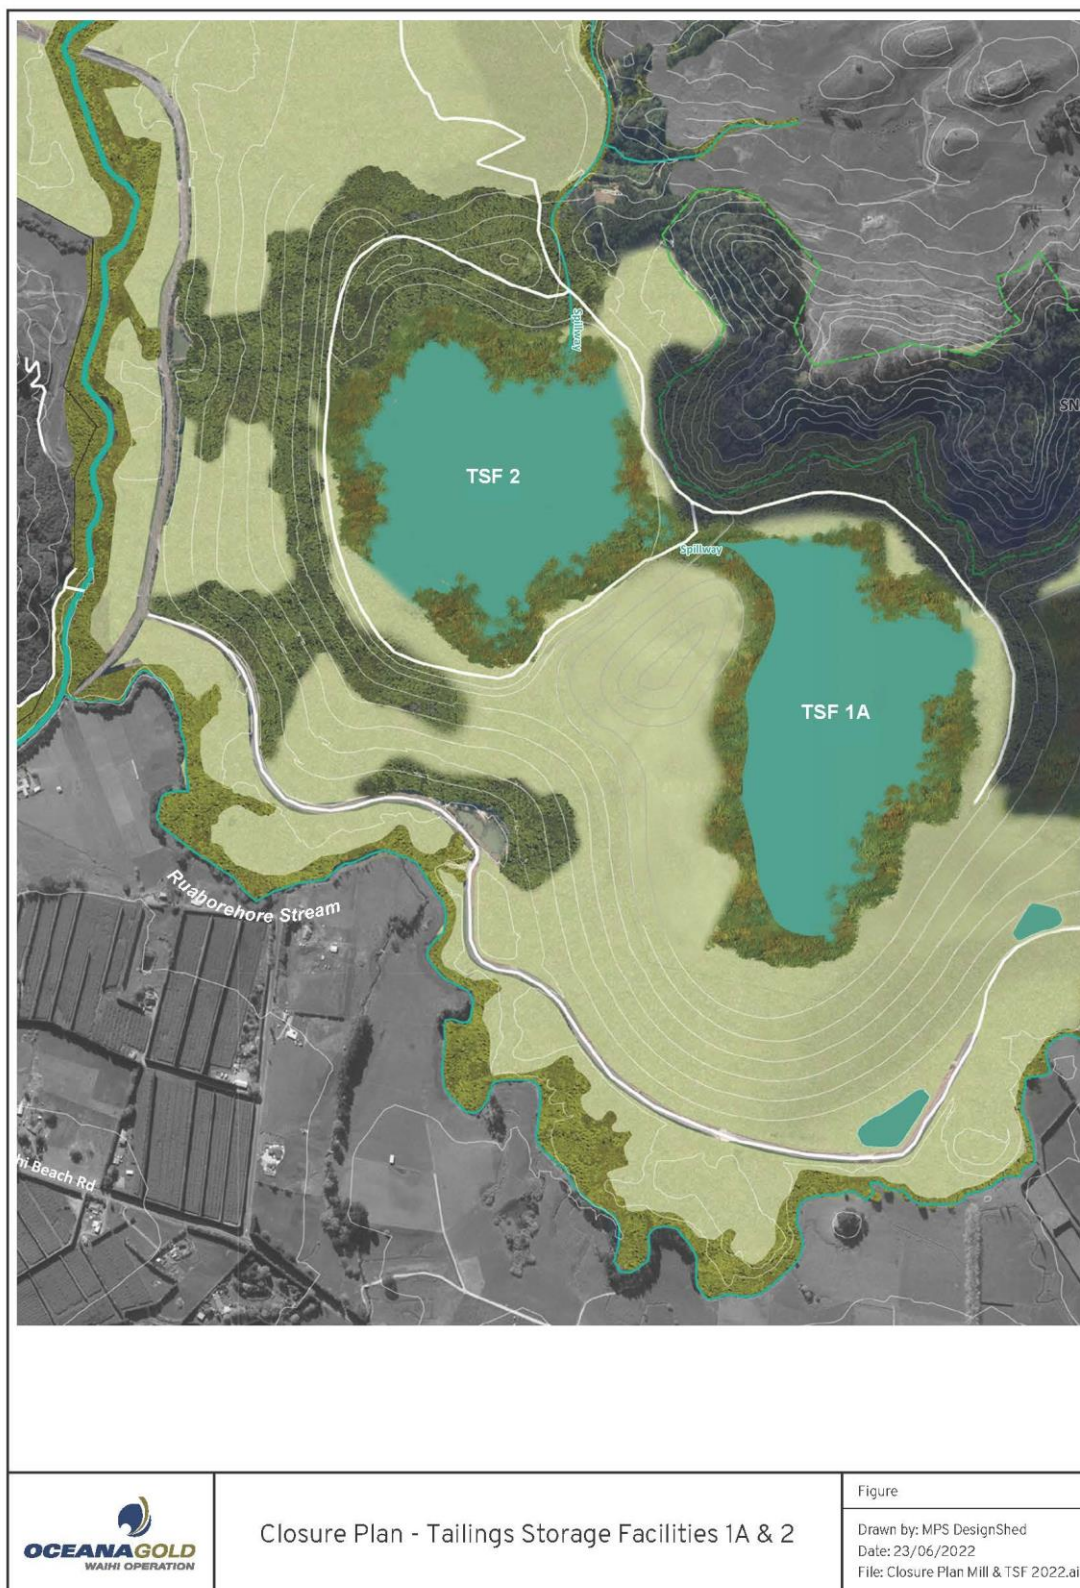
Figure 9: Concept Closure Plan 2021.

The overall original concept plan for the rehabilitation of the Waste Disposal Area (Figure 8) remains generally unchanged. Figure 9 provides an updated version of Figure 8. Slight differences include the possibility of more embankment native vegetation and the presence of walking or cycling tracks. These have yet to be defined. Figure 10 shows a summary of rehabilitation completed at the Waste Disposal Area to date.

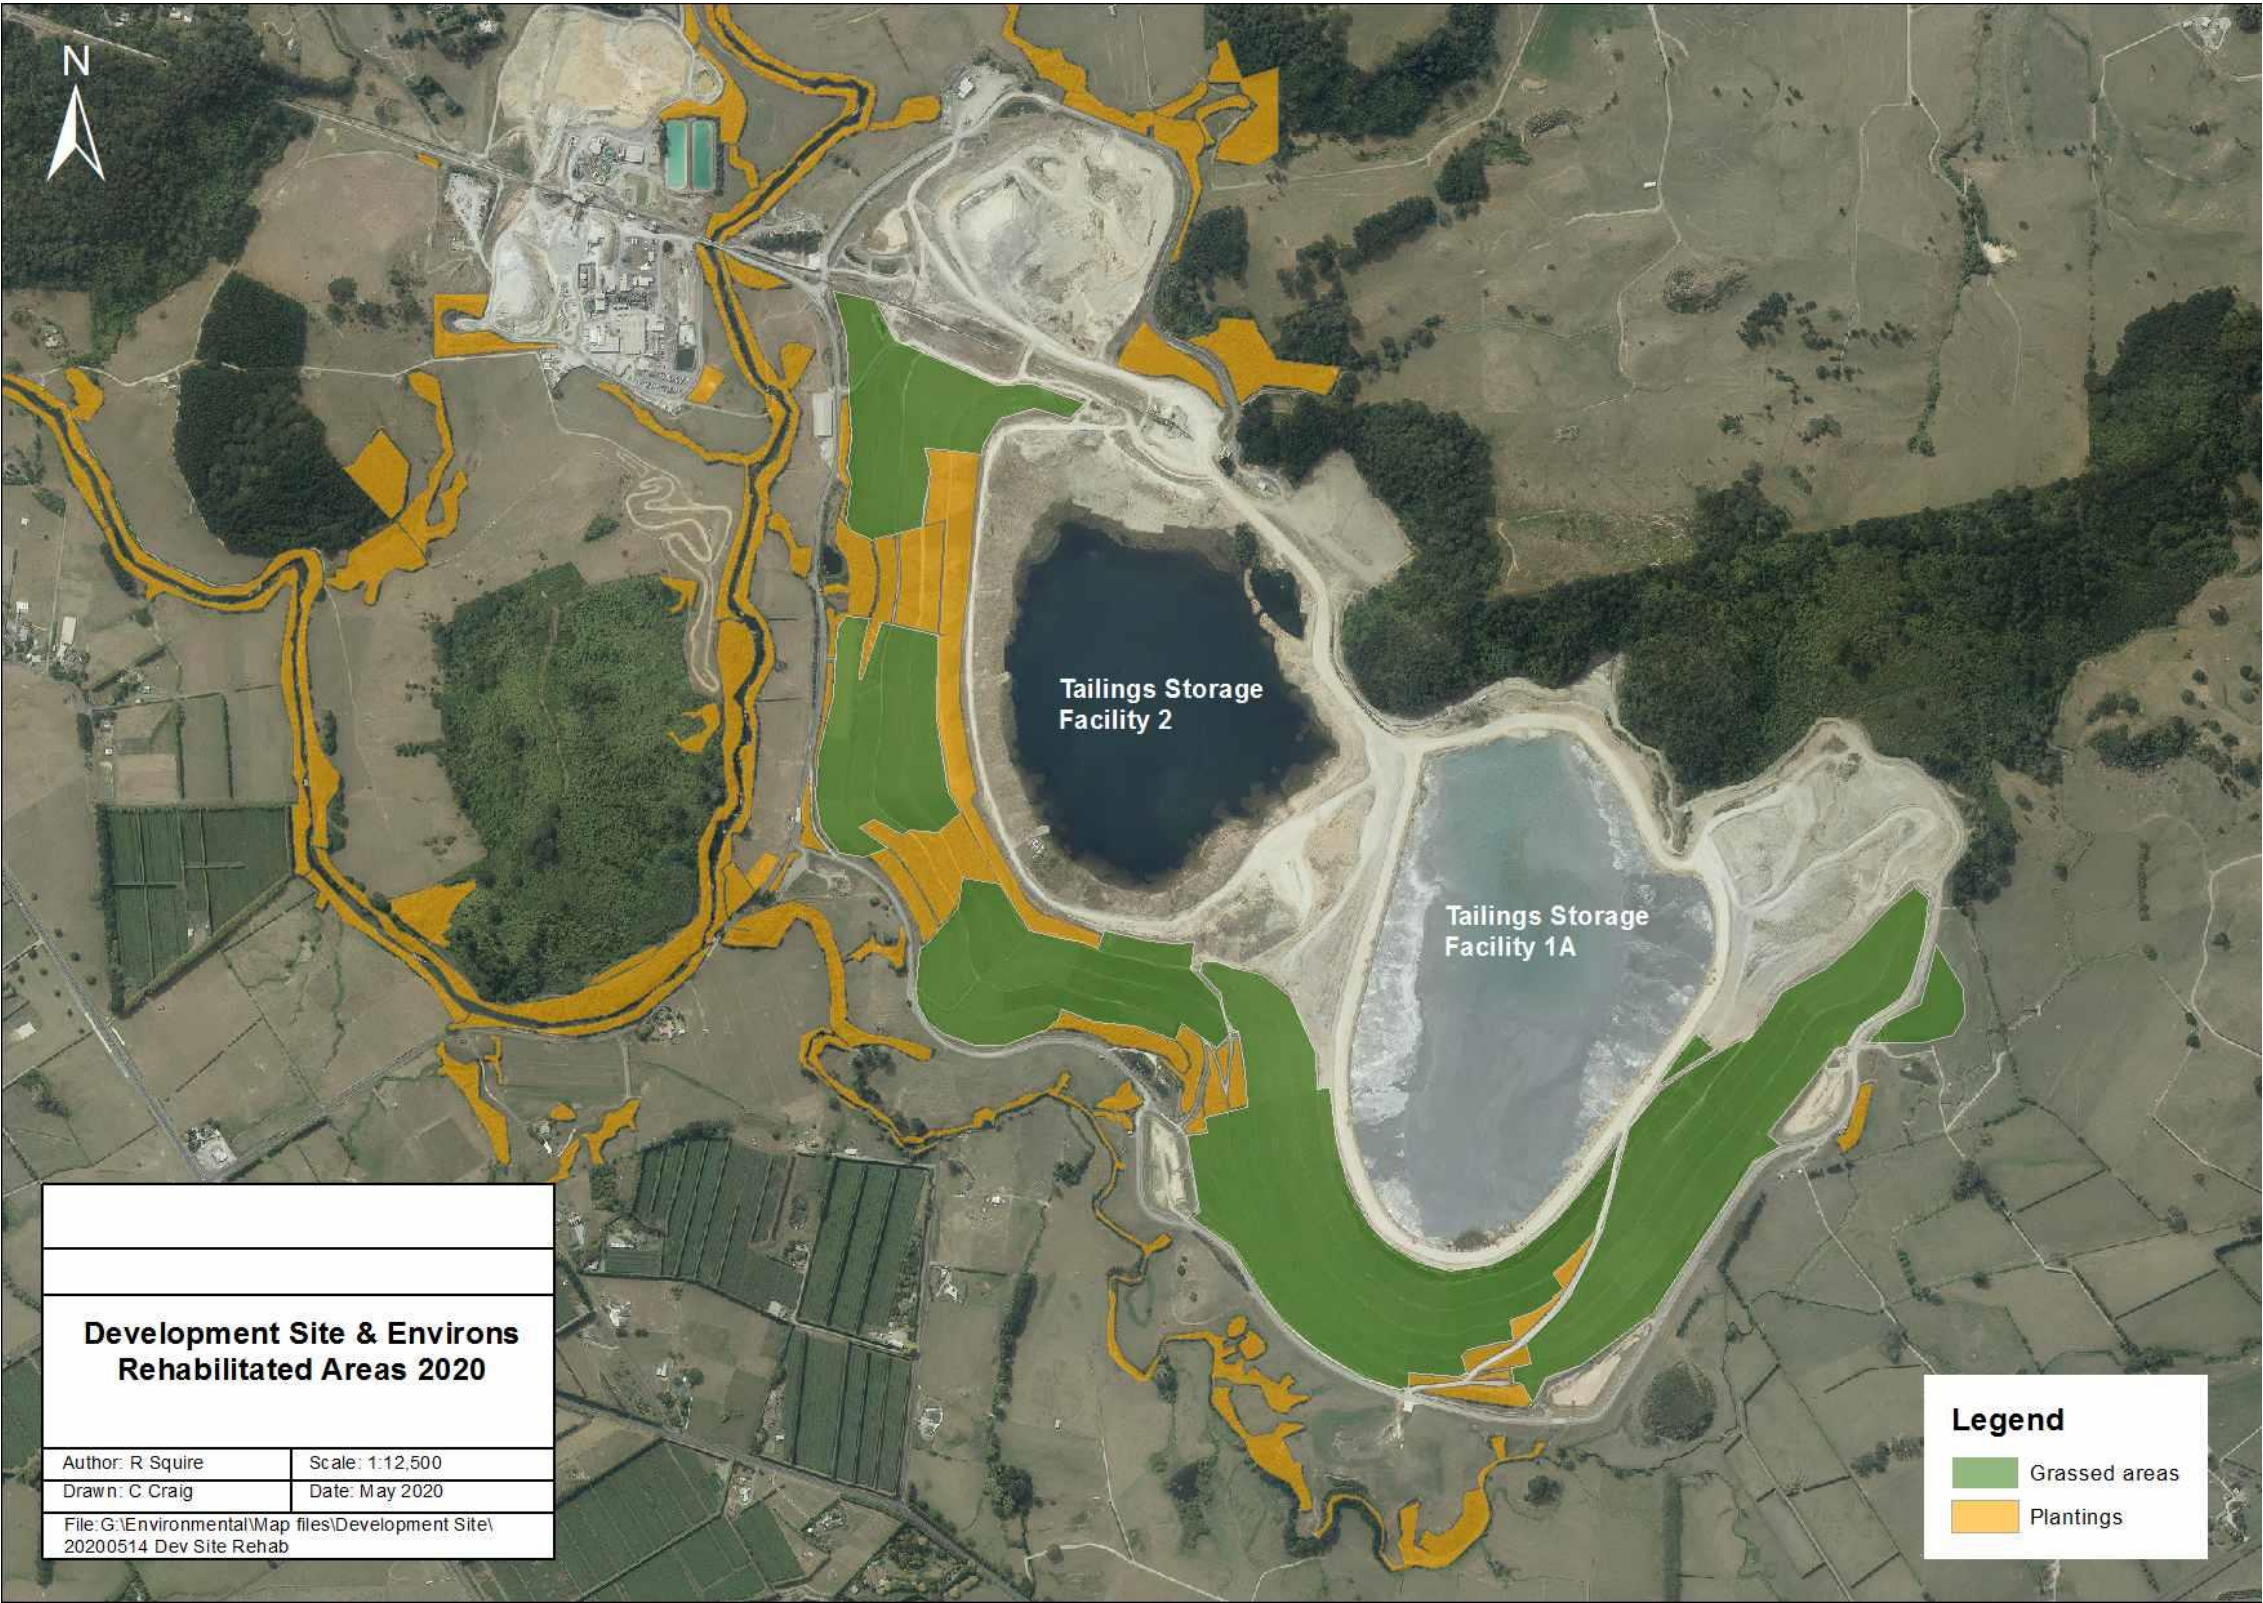
Figure 10: Development Site & Environs Rehabilitated Areas.

Note: There have been no new areas of rehabilitation during 2021-22.

The rehabilitated waste rock embankment is fenced into 1ha paddocks as areas become available. Figure 10 shows areas of the embankment that have been rehabilitated up to the present. There was a 1.2m crest raise on TSF1A during the 2021-22 reporting period. Topsoiling and seeding will be conducted once the full lift is completed.

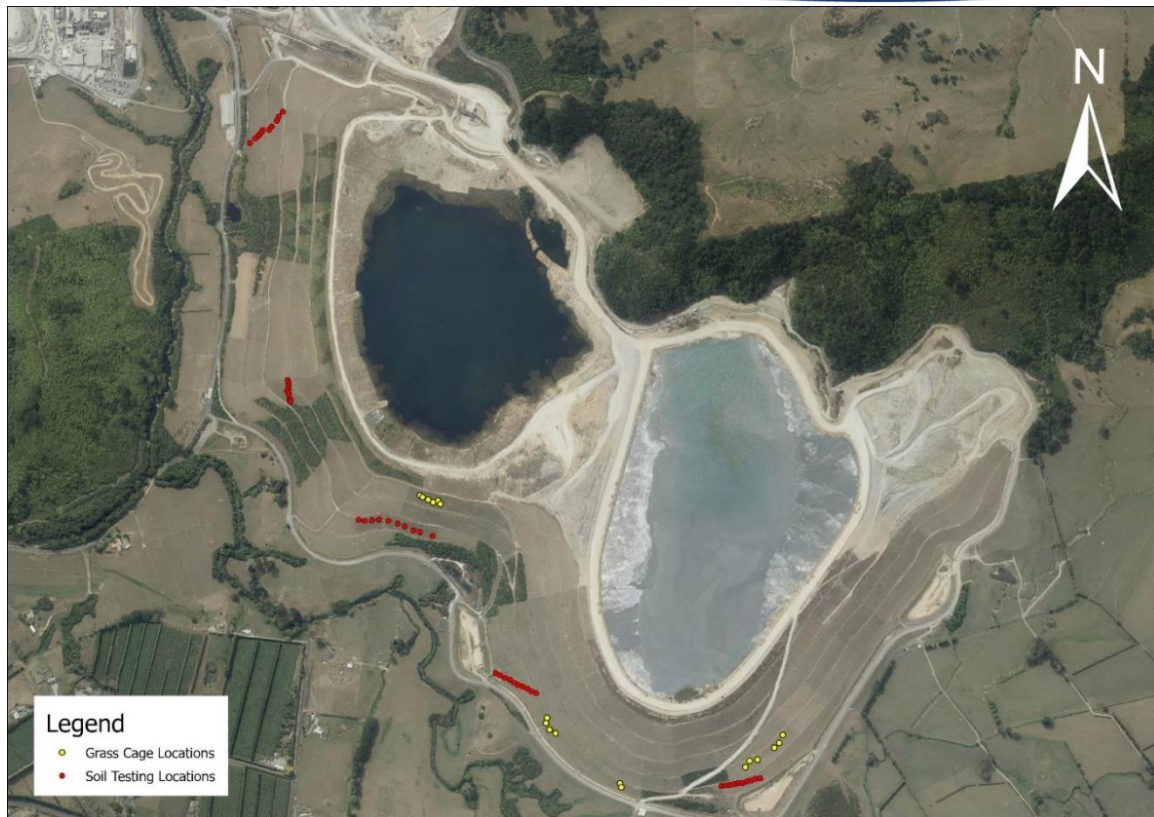
Figure 11: Pasture Monitoring Locations.

A site visit did not occur in 2021 due to COVID-19, therefore soil sampling was conducted by OGNZL staff. The 2021 report forms Appendix B and pasture monitoring locations are shown in Figure 11 below.

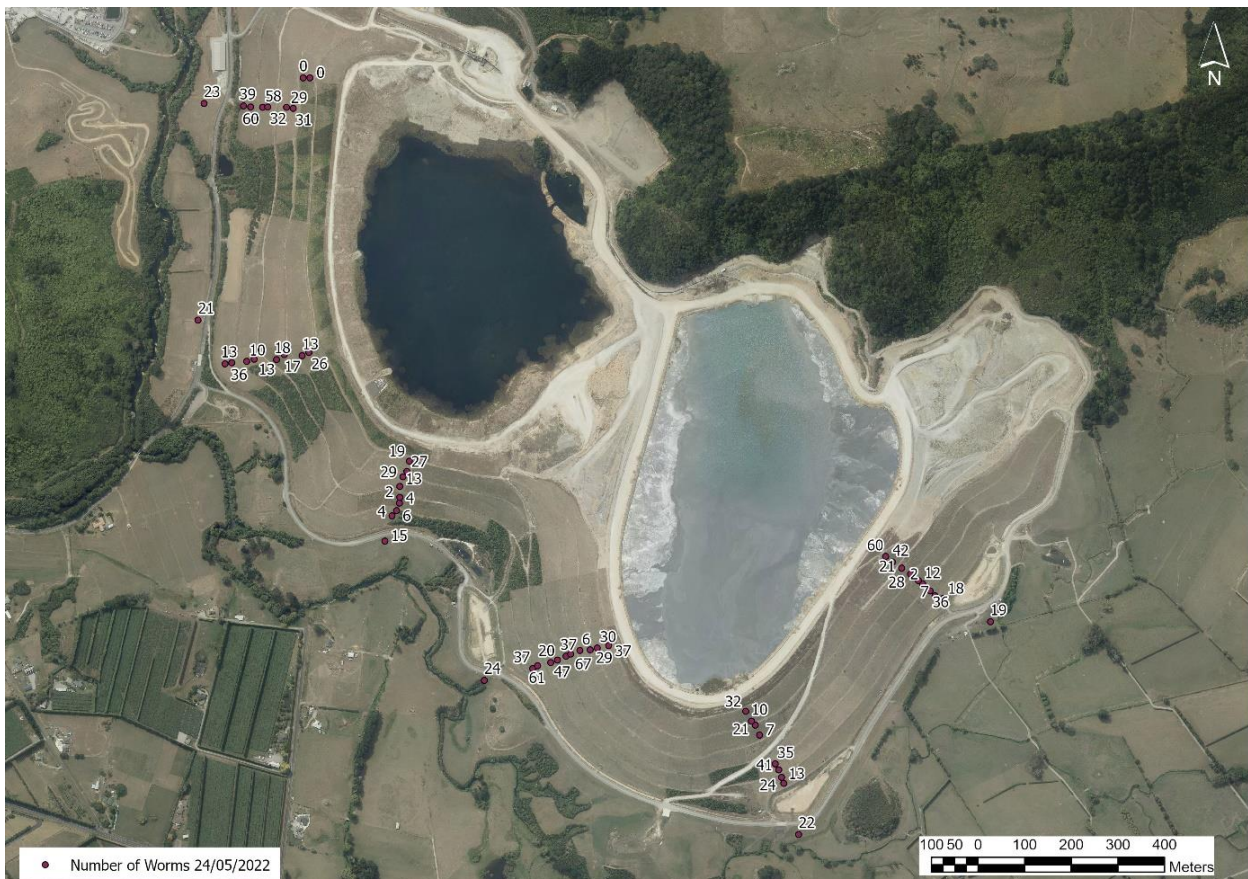
Figure 12: Earthworm Survey Locations and Results 2022.

An earthworm survey to assess the success of earthworm spread and persistence in the TSF batter pastures was undertaken in May 2022. Sods measuring 20x20x20cm were collected from six rows around the TSFs. Worms were found in all but two of the sods sampled and in areas where they weren't seeded. This indicates that earthworms are persisting in and spreading throughout the embankments (Figure 12).

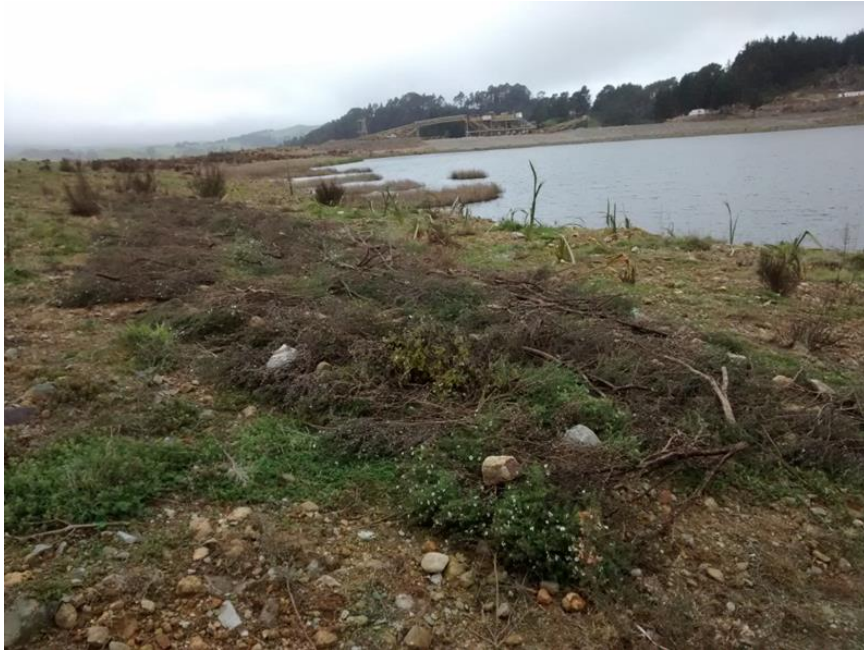
Figure 14: Manuka Slash and Flax on Ignimbrite Capping.

OGNZL is continuing to trial flax and manuka slash laid directly on the ignimbrite capping that overlies the tailings as potential revegetation options for this area (Figure 14 and Figure 15). Manuka establishment on the capped area is slower than on bare ground within the open pit (due to grass competition), however the flax plants have established well.

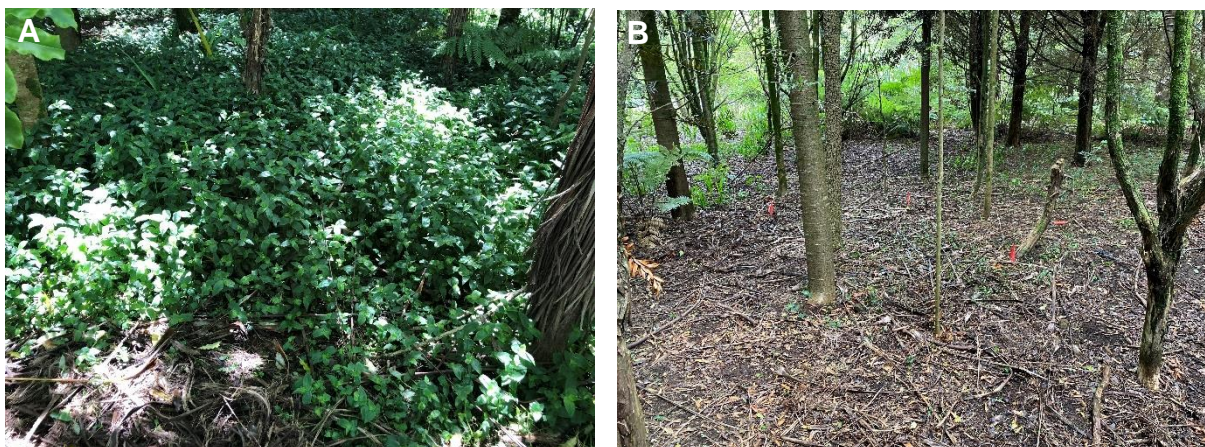
Figure 16: Tradescantia Infestation before (A; 2018) and after (B; 2021) the Introduction of Yellow Leaf Spot Fungus.

In 2018 Manaaki Whenua – Landcare Research supplied OGNZL nine tradescantia plants infected with yellow leaf spot fungus. These were planted among an infestation of tradescantia along the edge of the Ohinemuri River near the Baxter Road bridge (Figure 16A) in November 2018, on land owned by OGNZL. The infestation was classified as “moderate ($>100\text{m}^2$)” with the average height of tradescantia between 20-50cm at the time of planting. Within one year of introducing the fungus, it began to establish and slowly spread to infect healthy tradescantia nearby. Figure 17 shows the severity of yellow spot infection on leaves in 2019. After three years, the fungus was well established and widespread at this site, reducing the infestation to “minor ($<100\text{m}^2$)” with the average height of tradescantia $<20\text{cm}$ and nearly eliminating the weedy groundcover (Figure 16B). Regular monitoring of the spread and effects of tradescantia yellow leaf spot fungus is ongoing.

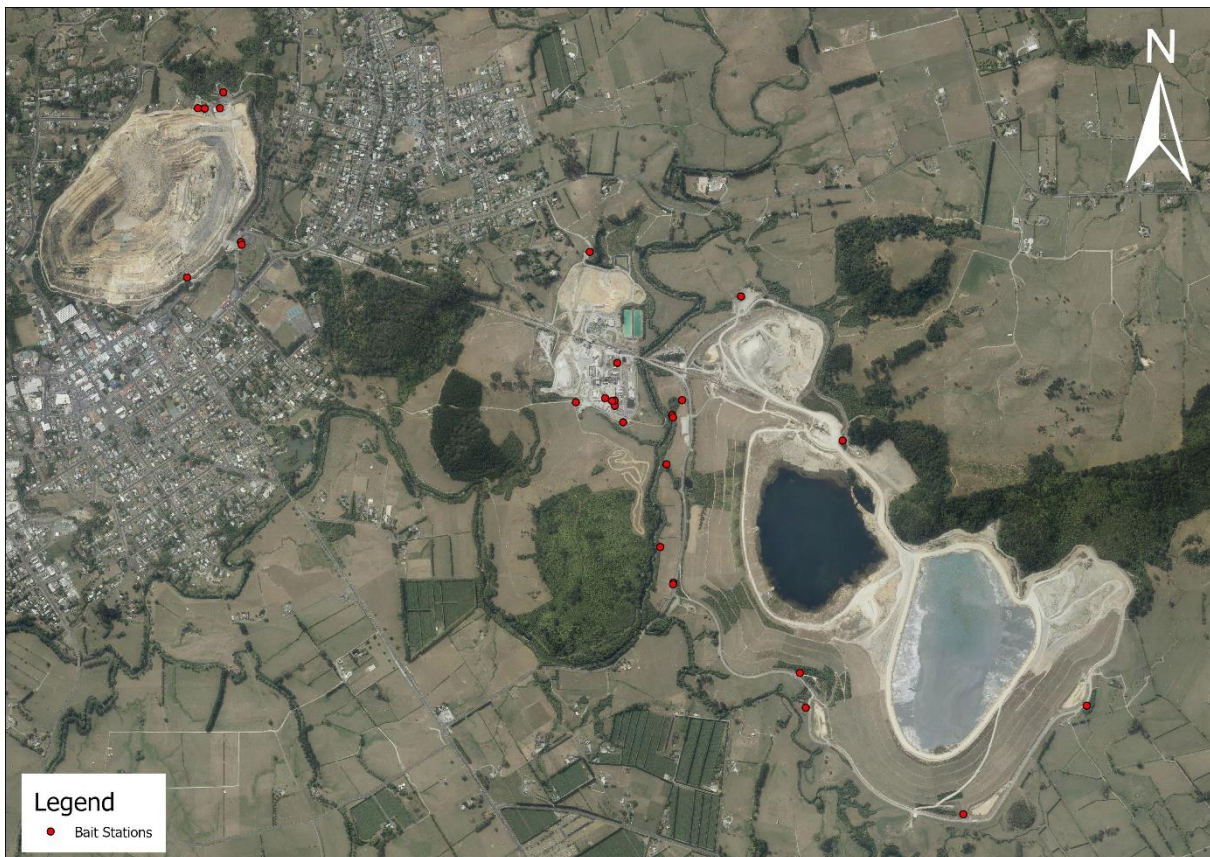
Figure 21: Bait Station Locations.

OGNZL undertakes pest animal control around the development site using a combination of methods including bait stations, traps and firearms. Bait stations containing brodifacoum blocks are maintained around key facilities such as workshops, offices and motor control centre locations. Bait stations are checked and refilled monthly. Locations of bait stations are shown in Figure 21.

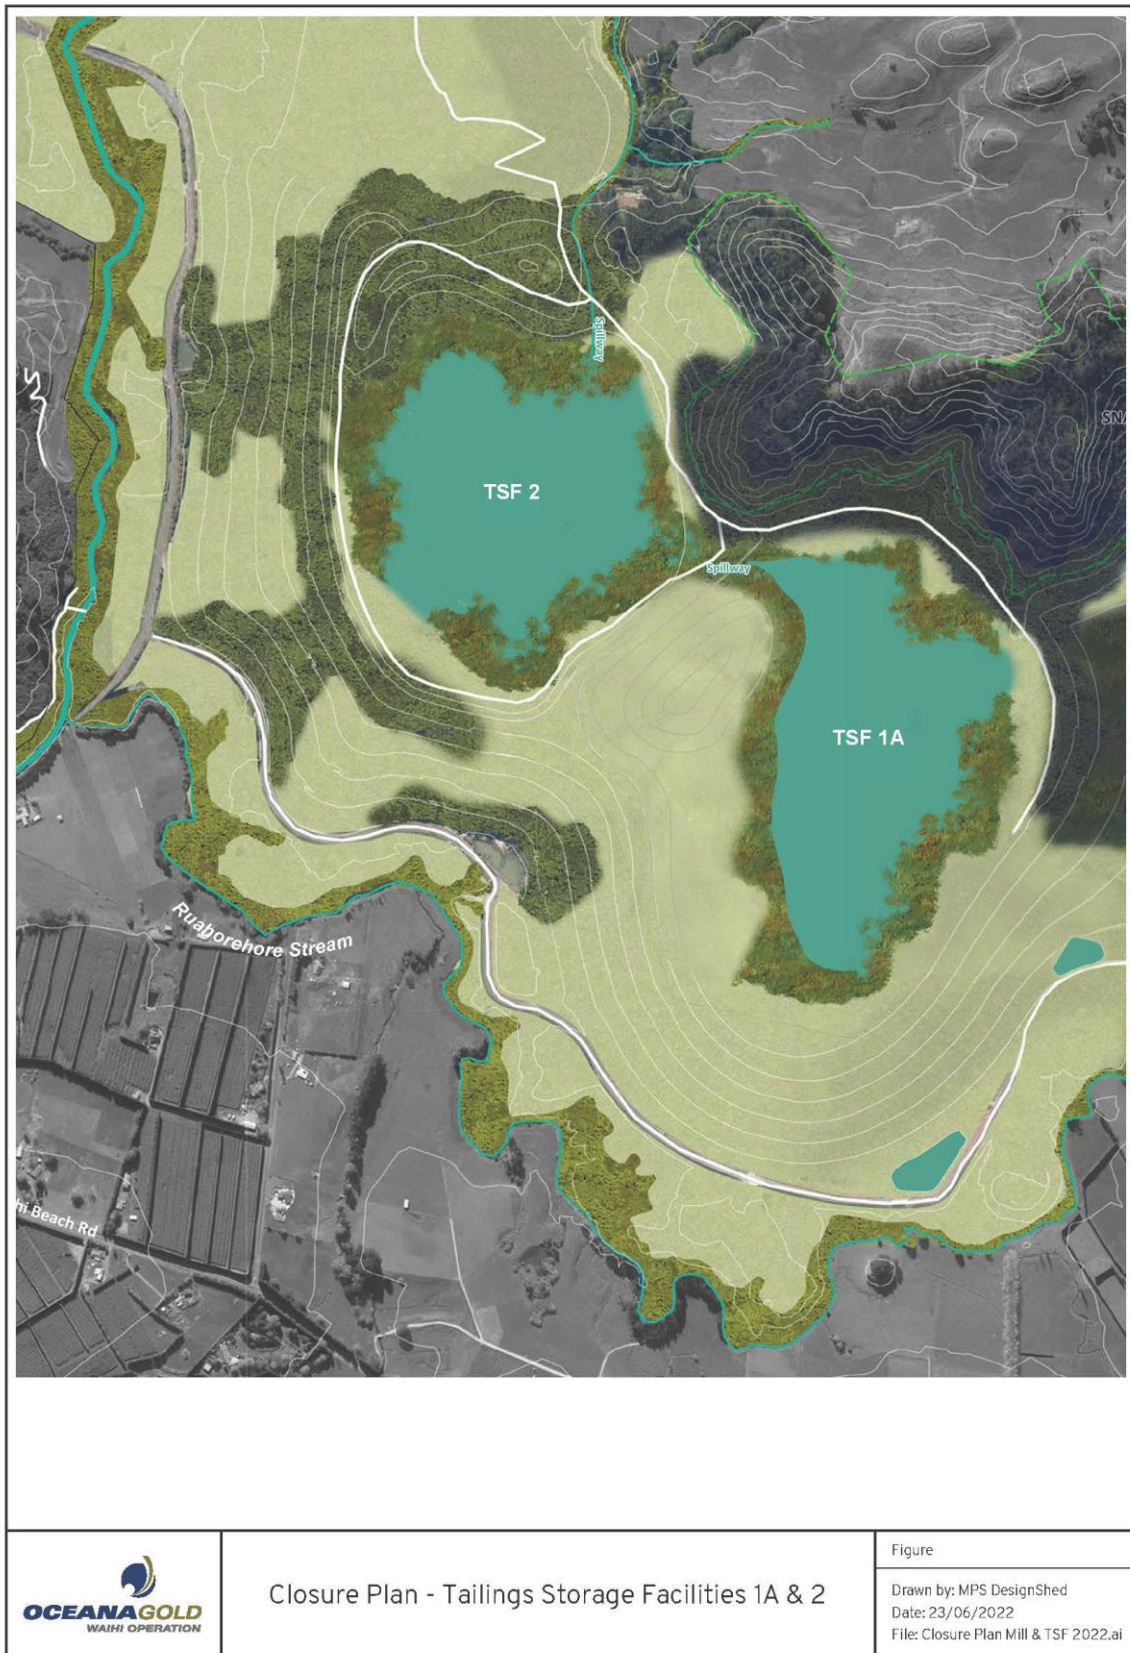
Figure 5: TSF Rehabilitation Concept.

The conceptual closure plan for the tailings storage facilities (TSFs) initially prepared in 1998 remains fundamentally unchanged (refer Figure 5). It comprises a partial capping of the tailings against the embankment crest, retention of part of the impoundments as shallow ponds, and planting of the embankments and capping including a wetland littoral zone around the ponds. Spillways would be constructed to discharge into and from Storage 2.

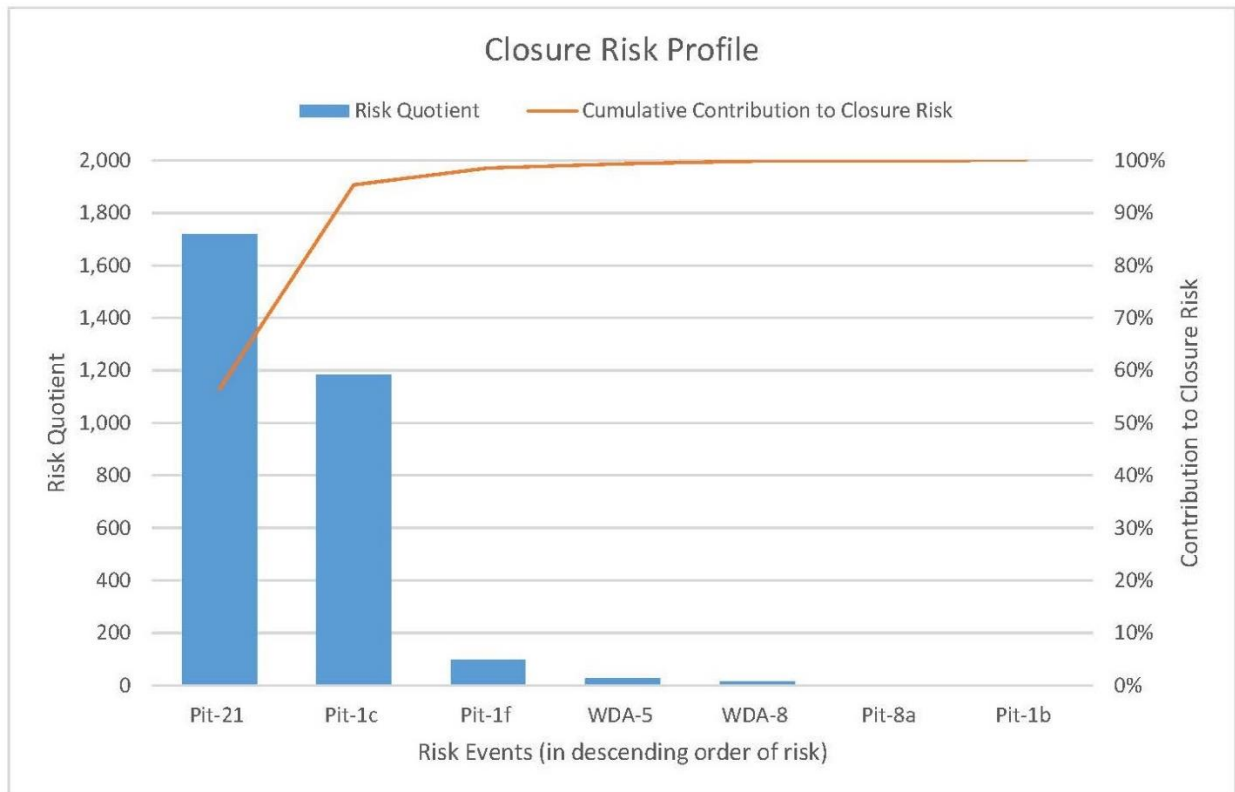
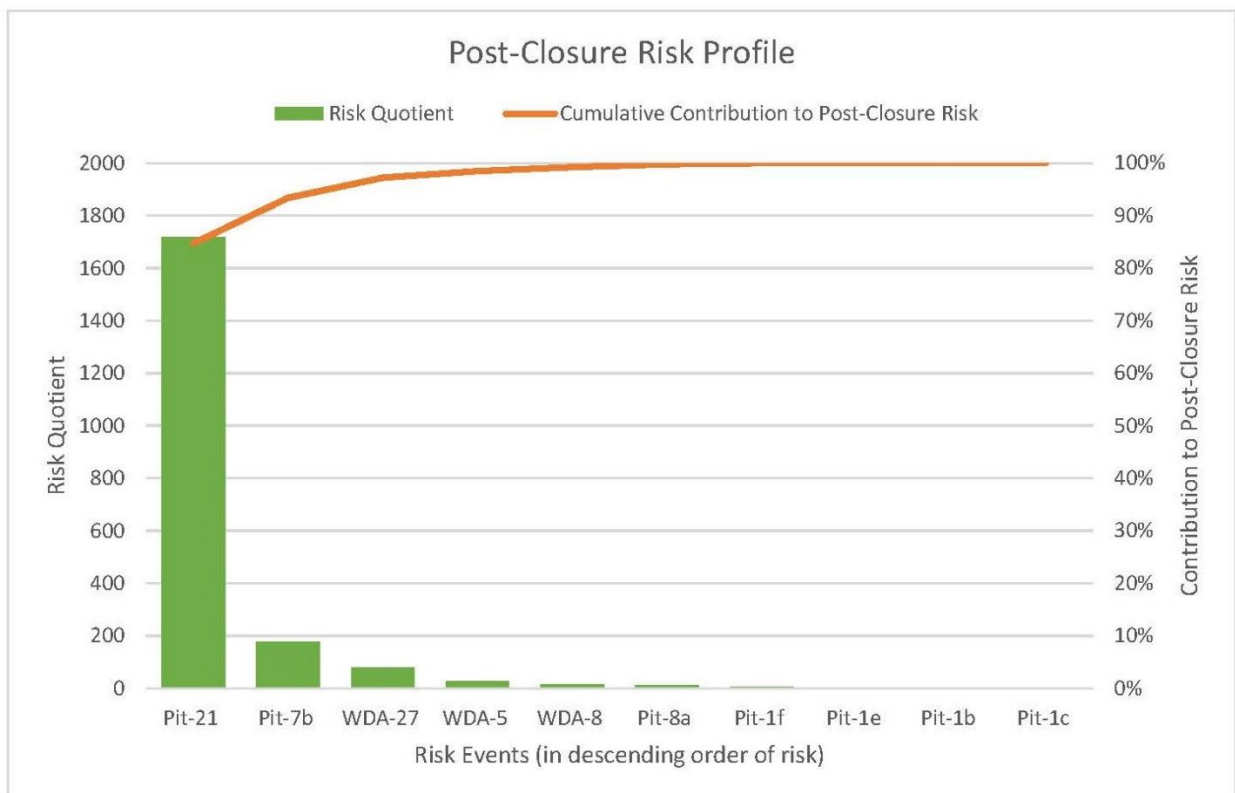
Figure 7: Risk Profiles.

The risk profile ranks all of the analysed risk events in descending order of risk quotient (the product of likelihood and consequence). It provides a clear focus on those events that pose the greatest risk. The risk profiles for both the closure and post-closure periods are shown in Figure 7.

Figure 7 shows that during closure the Pit-21 Hazard zone collapse and Pit-1c Pit wall failure – damage risk events dominate the profile.

The risk quotient provides a quantitative and directly comparable value of the risk each event poses during the closure period. For example, the second-highest ranked risk event (Pit1-c Pit wall failure – damage, risk quotient = 1,200) poses 70% of the closure risk posed by the top-ranked risk event (Pit-21 Hazard zone collapse, risk quotient = 1,700). The third-highest ranked risk event (Pit-1f Pit wall failure prevention) poses a little over 5% of the risk posed by Pit-21.
