Rehabilitation and Closure Plan

2023-24

Document Reference: WAI-200-PLN-011

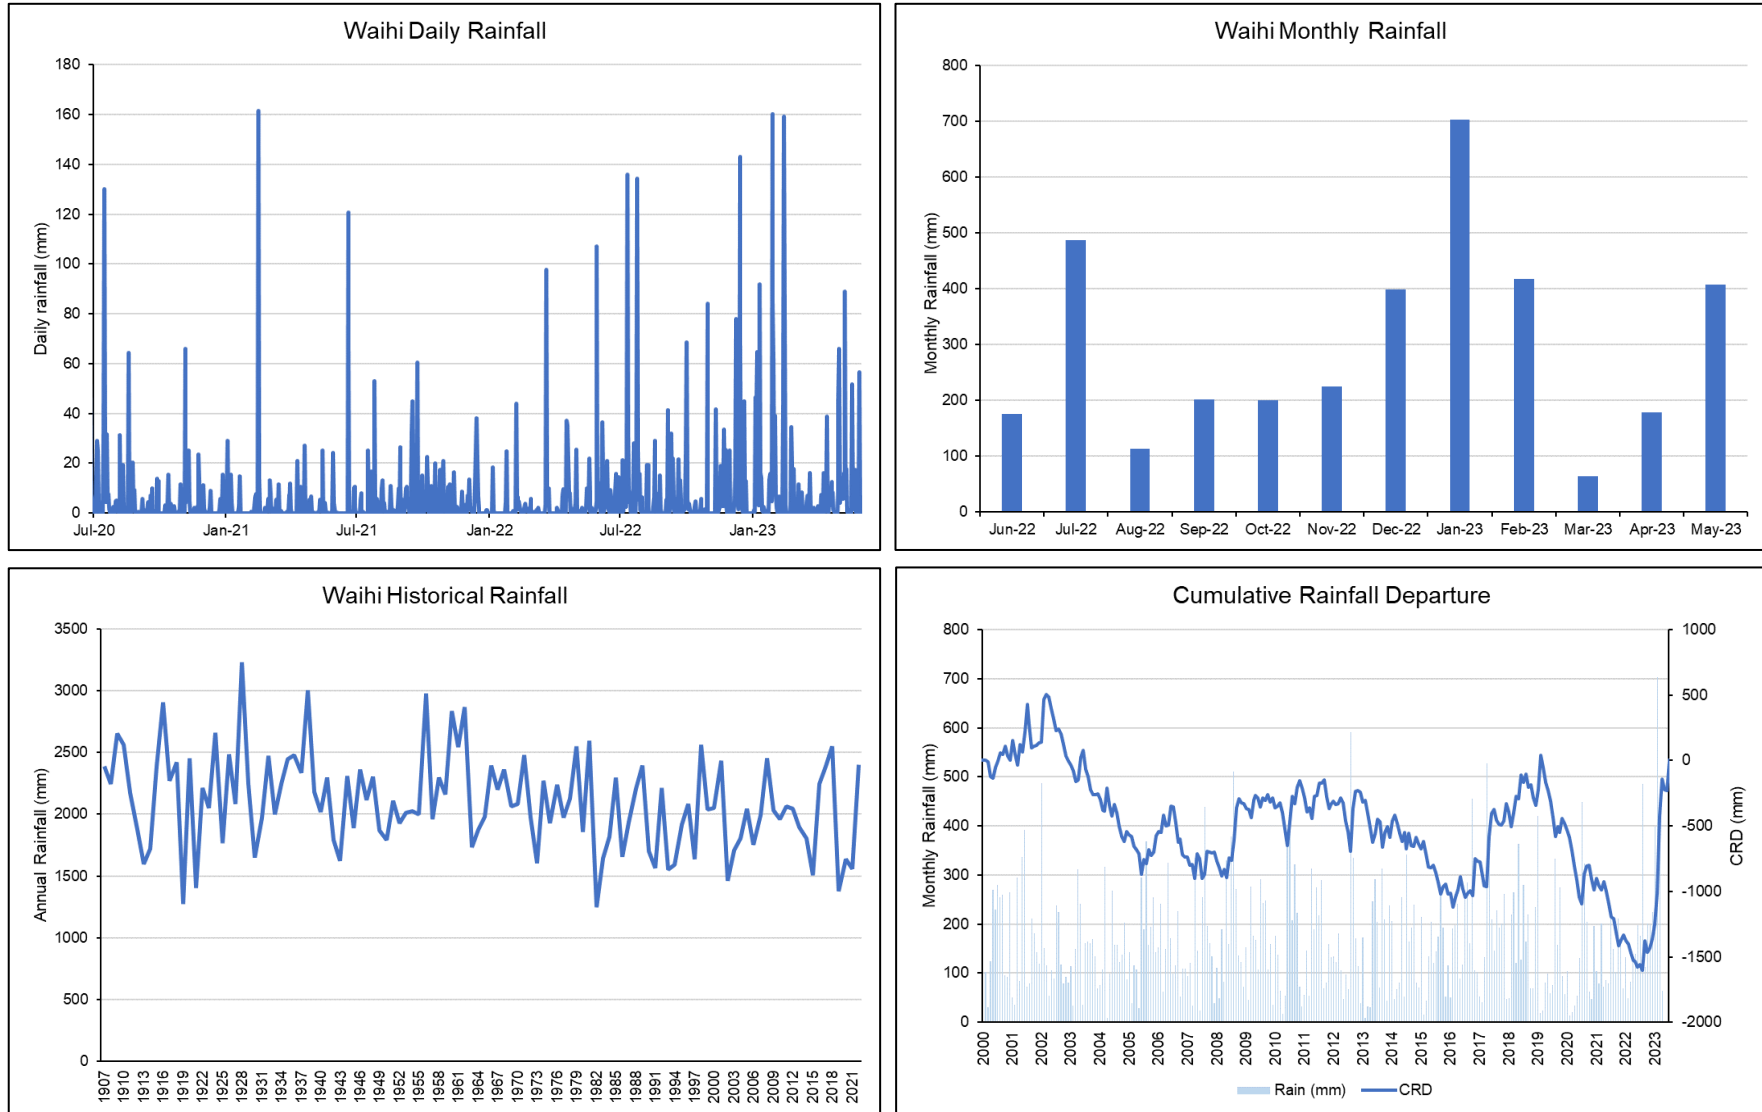
Figure 1: Waihi Rainfall Data

Annual and seasonal rainfall trends are displayed in Figure 1. The Cumulative Rainfall Departure (CRD) plot presents long term trends in rainfall since 2000, with a rising slope since July 2022, indicating above average rainfall in recent months. Historical rainfall data for Waihi has been collected since 1907, with annual rainfall ranging from 1249 – 3234 mm. The 2022 annual rainfall (2403 mm) was significantly more than the previous year (1560 mm in 2021), and more than the historical average of 2100 mm.

A total of 3567 mm of rain was recorded during the reporting period (June 2022 to May 2023), significantly more than the previous reporting period (1646 mm). The month with the highest rainfall during the reporting period was January 2023 (703 mm) followed by July 2022 (486 mm) and the driest month was March (64 mm) followed by August (113 mm).

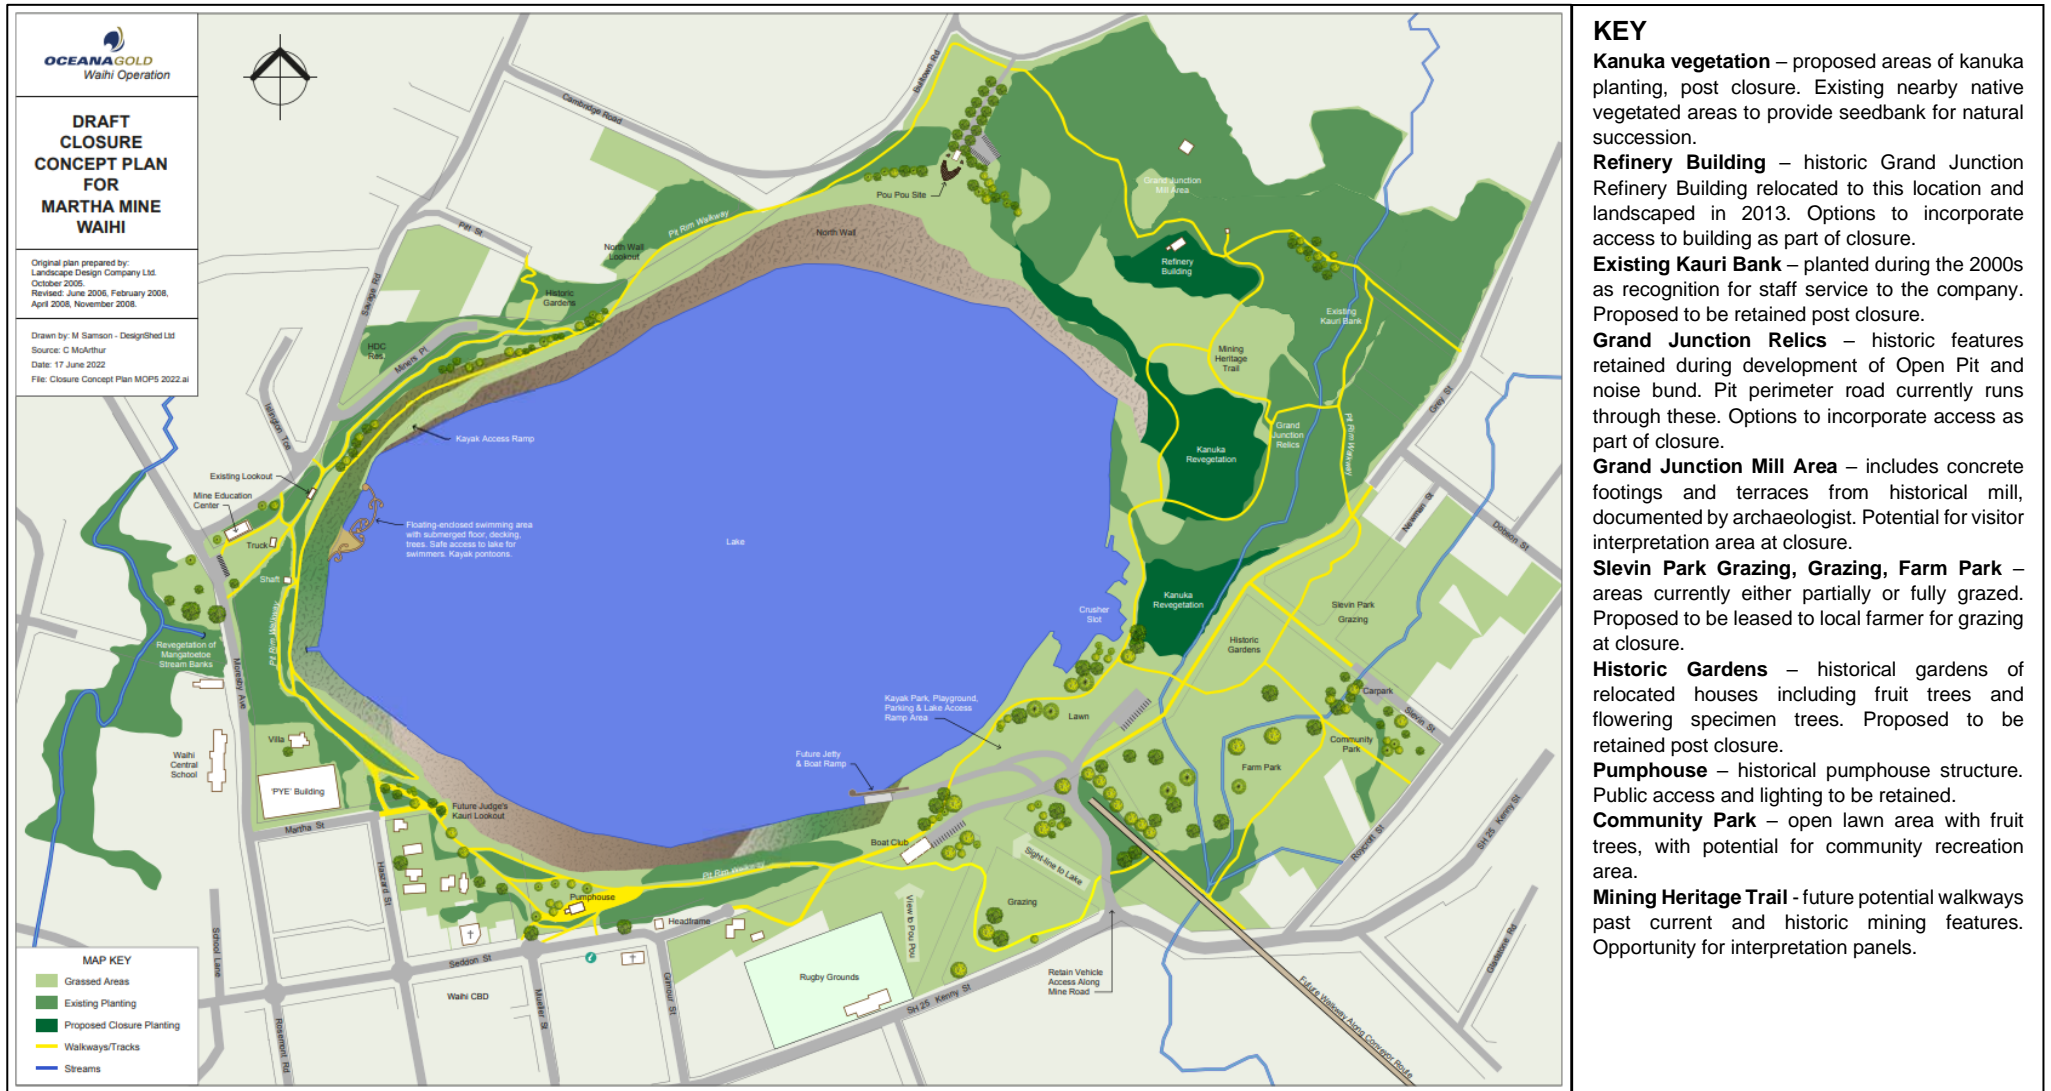
Figure 3: Current Closure Concept Plan for Open Pit and Surrounds

The Rehabilitation and Closure Concept Plan for the Martha Open Pit is considered a “work in progress” and is subject to change and more detailed landscape planning when the site nears closure. The 2006 Closure Concept Plan (Figure 2) was updated following the approval of the Martha East Layback. In 2016, changes were made to show the North Wall following remediation, including partial capping of the failed section. Other minor changes include widening of the lake to the north and southeast, an extension of the track network to accommodate the north wall remediation cutback, and minor amendments to the landscape and track network to the east of the pit. This updated plan is included as Figure 3.

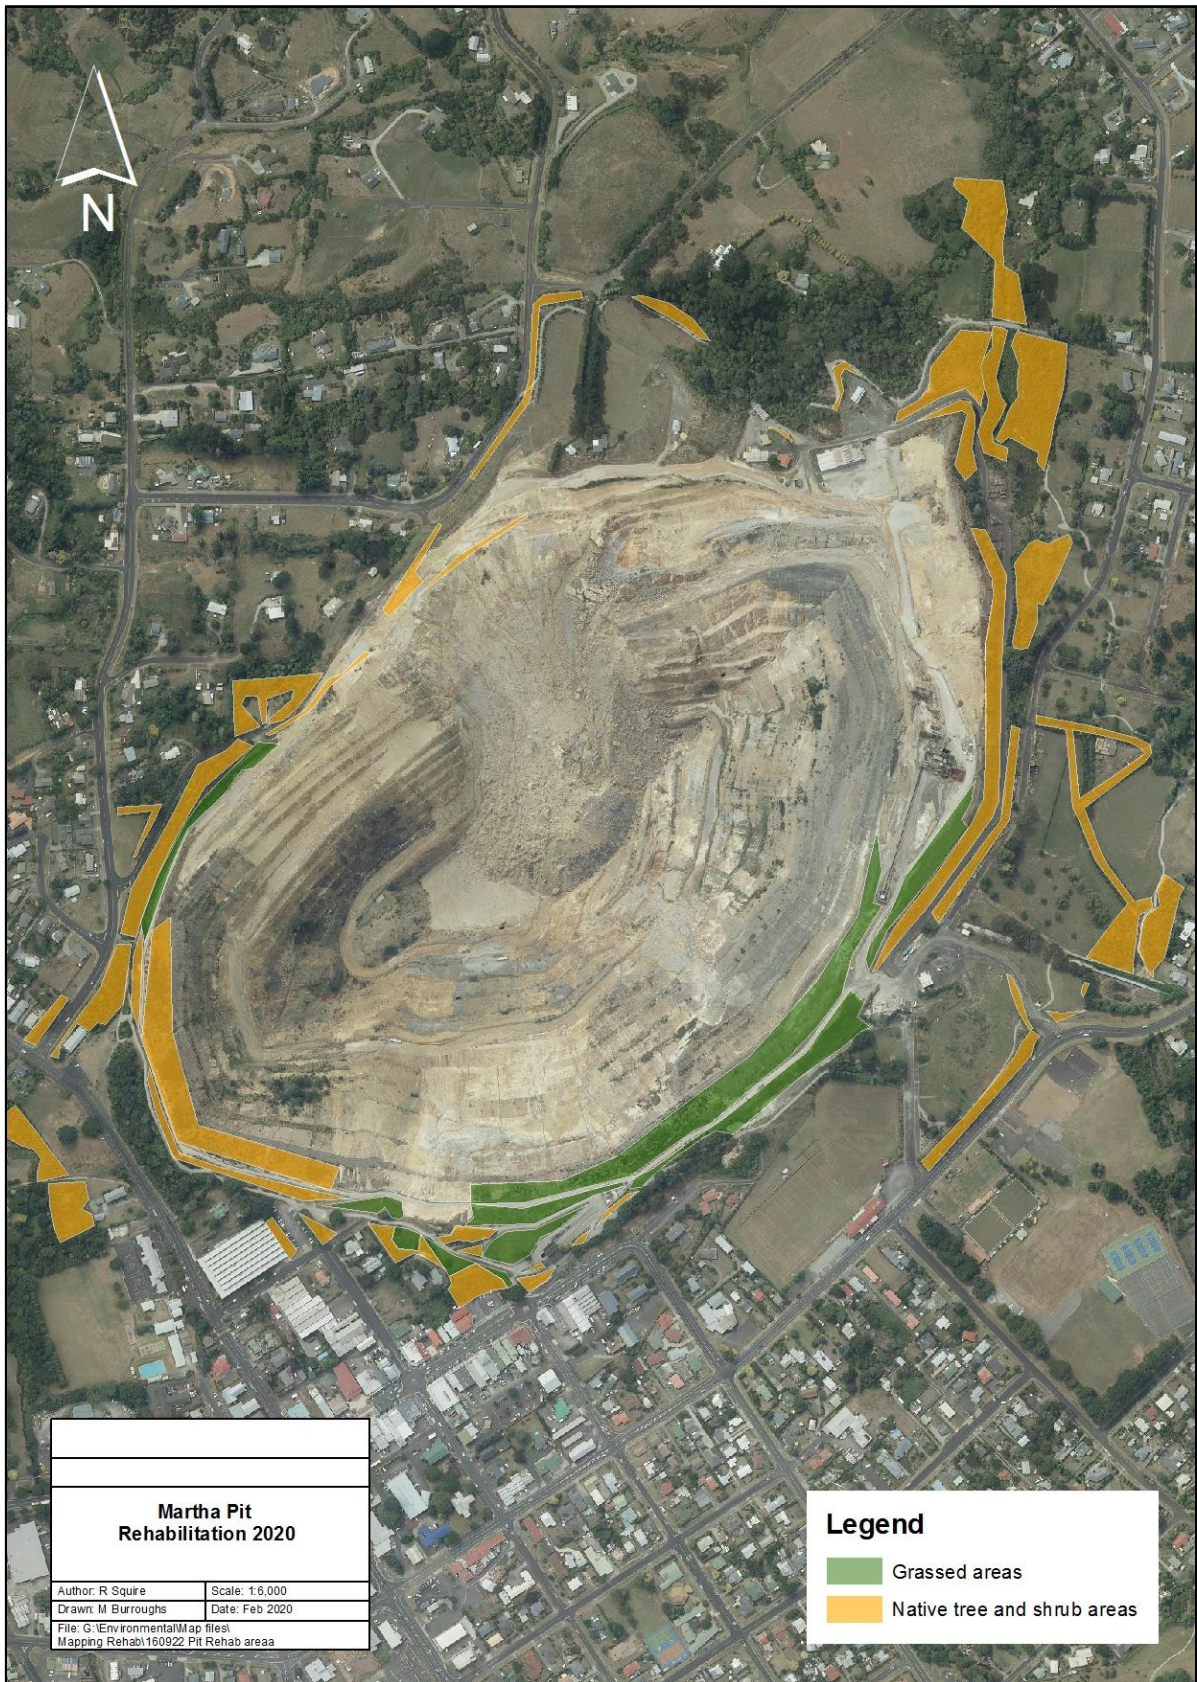
Figure 4: Rehabilitation of Open Pit and Surrounding Areas

Rehabilitation undertaken to date around the Open Pit is included as Figure 4.

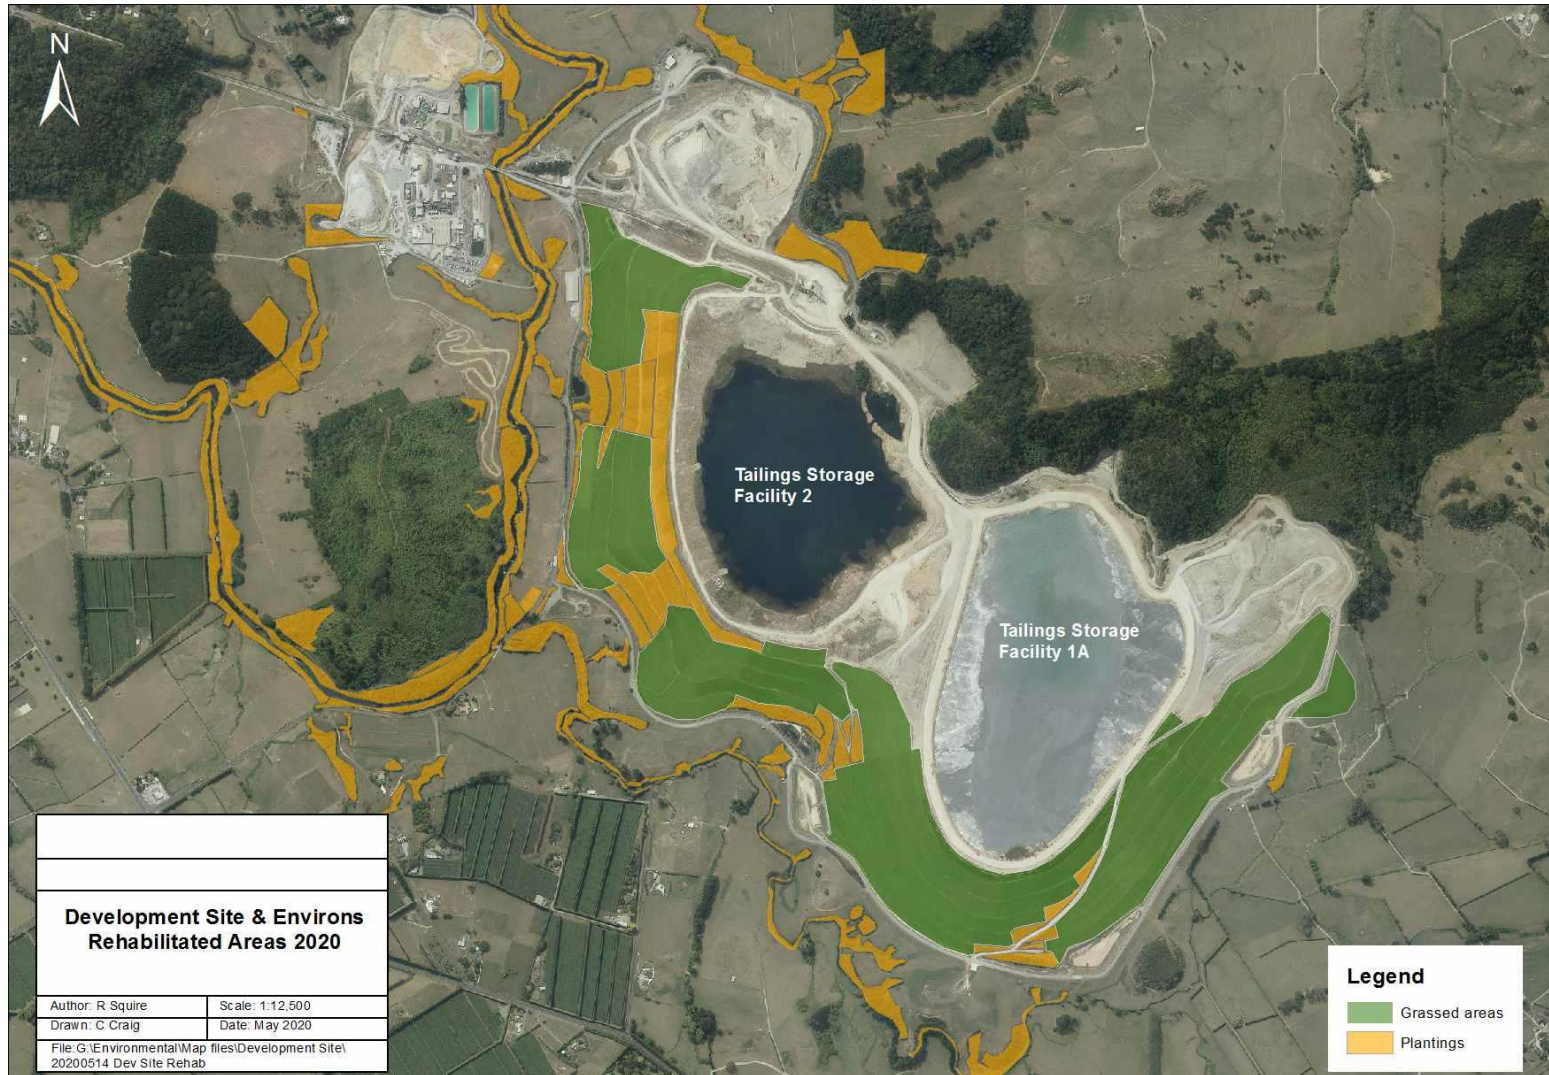
Figure 7: Rehabilitation of Waste Disposal Area to Date

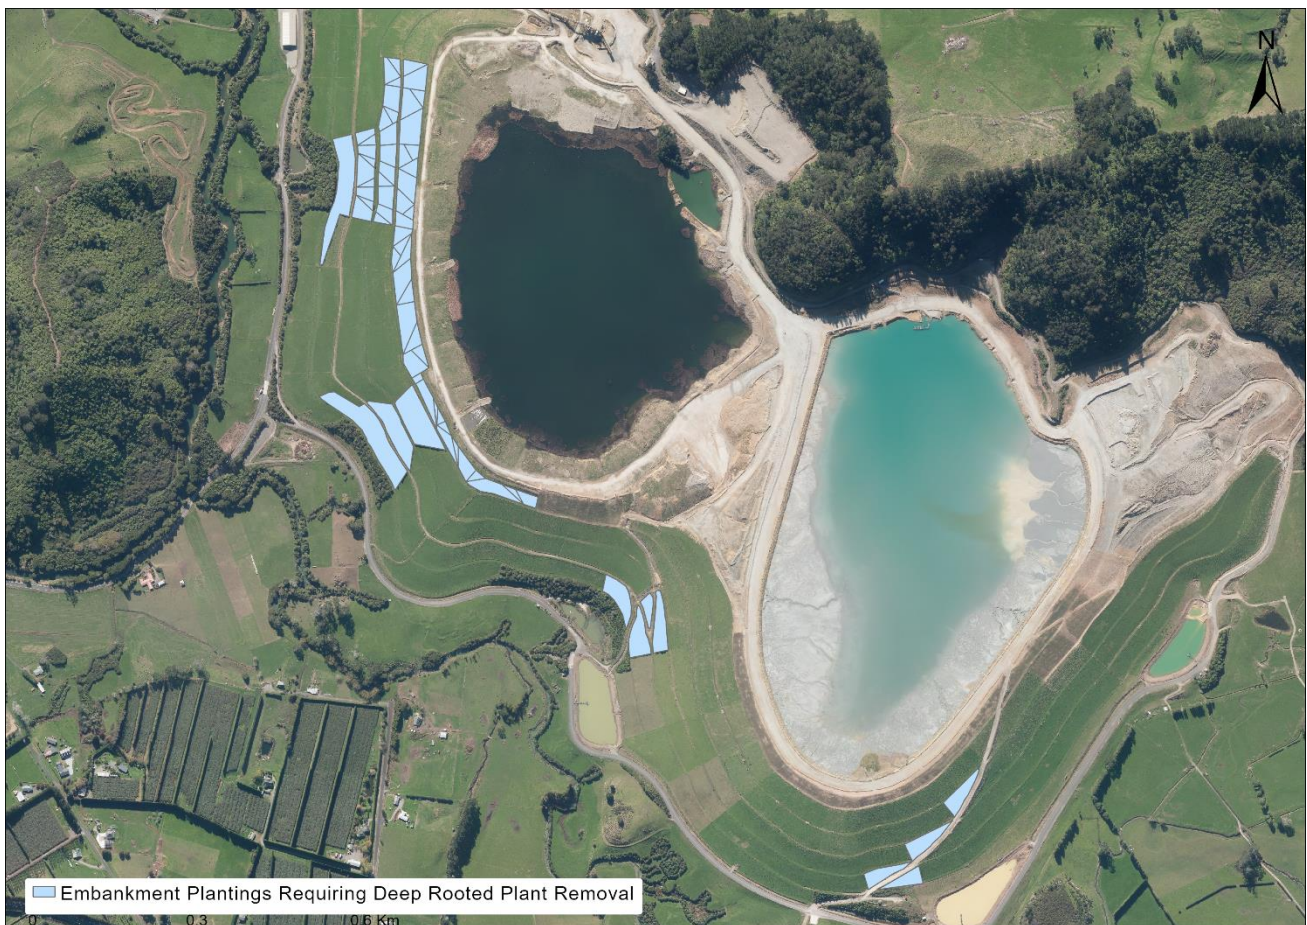
Figure 9: Embankment Plantings Requiring Deep Rooting Tree Removal

than 20 m tall) are at greater risk of wind throw than shrub and small tree species². The taller species therefore were not preferred on the embankment as at maturity any wind throw could create local disturbance of the cover materials with the possibility of exposing Zone G to erosion. The overlying Zone H provides protection for Zone G; this condition must be maintained. It is also important to ensure that tree seedlings are not root bound when planted to reduce the likelihood of wind throw caused by spiralled roots. OGNZL has made the decision to remove cabbage trees from areas of the embankment where there is a risk that the tap root could damage the Zone G cap. The areas of embankment plantings where this is required are shown in Figure 9; this includes any native plantings on the second batter of the embankment or higher, but not the top of the embankment structure.

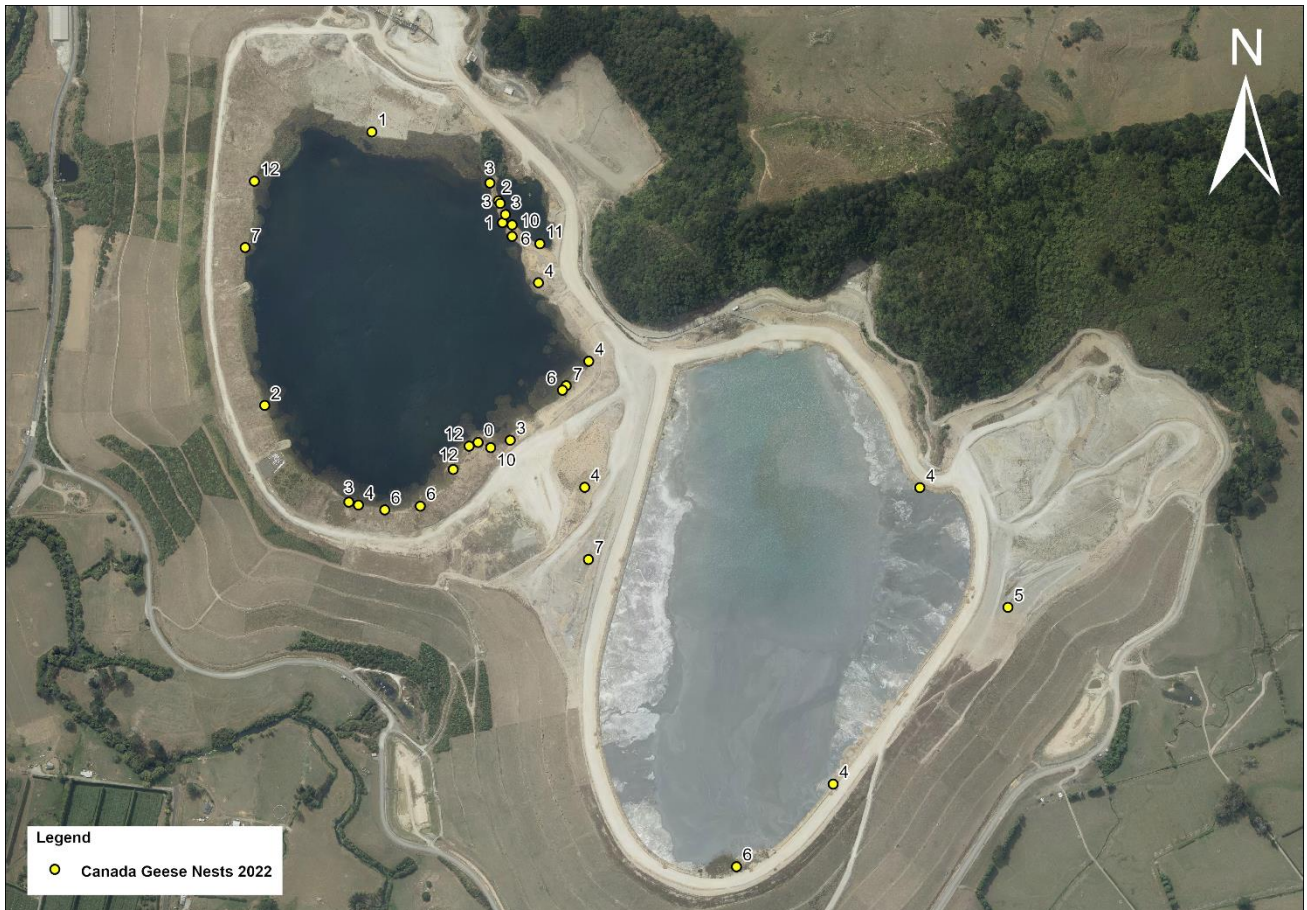
Figure 11: Canada Goose Nest Locations 2022

Turkeys and Canada geese have flocked on TSF embankments and the TSF2 lake in increasing numbers in 2021 and 2022. Turkey control was undertaken on site in the second half of 2022. Approximately 70 turkeys were removed from site by herding them into cages. A programme of Canada goose control by egg adding was implemented in spring 2022 to prevent recruitment to the adult population. A total of 168 eggs were added across the Development Site (Figure 11). Note that the number next to nest locations denotes the number of eggs added at each nest location. Pest control of adult turkeys and Canada geese using a firearm was also undertaken in early 2023 with limited success; eleven adult geese and four turkeys were shot and removed from site.

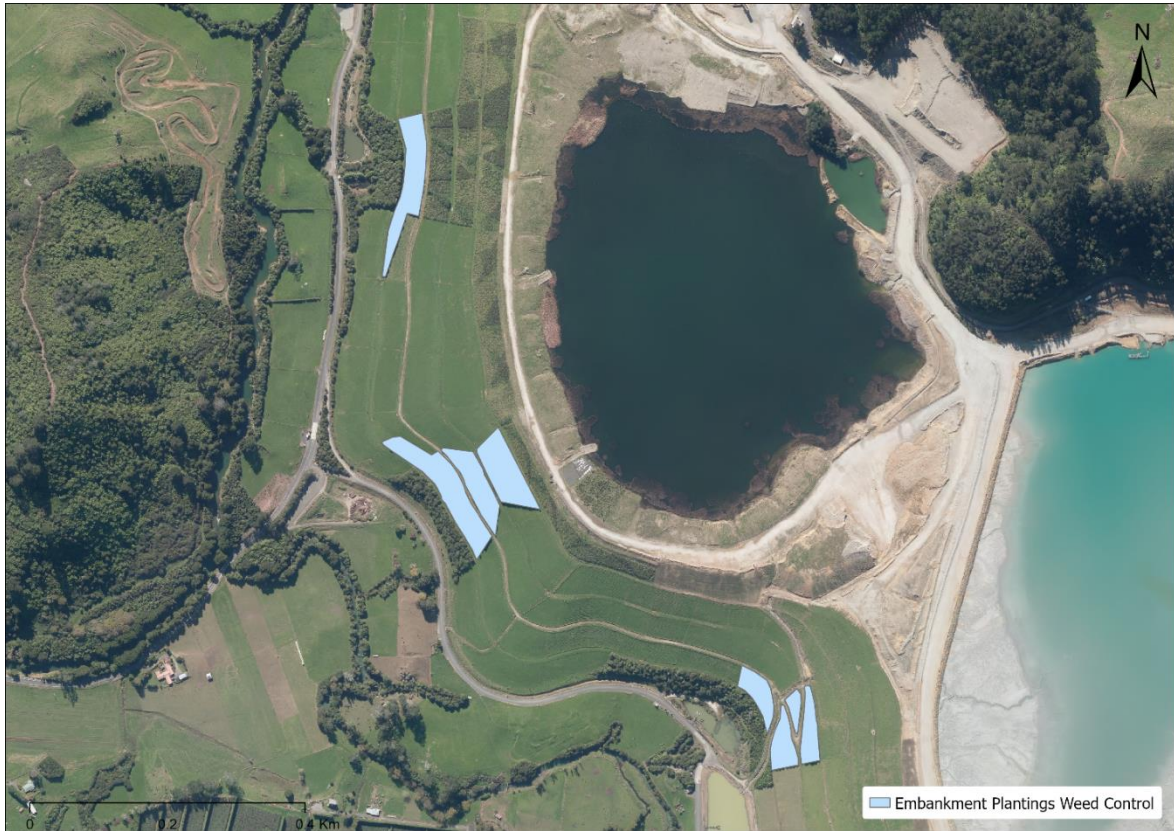
Figure 13: Embankment Plantings with Weed Control Undertaken in 2022/2023

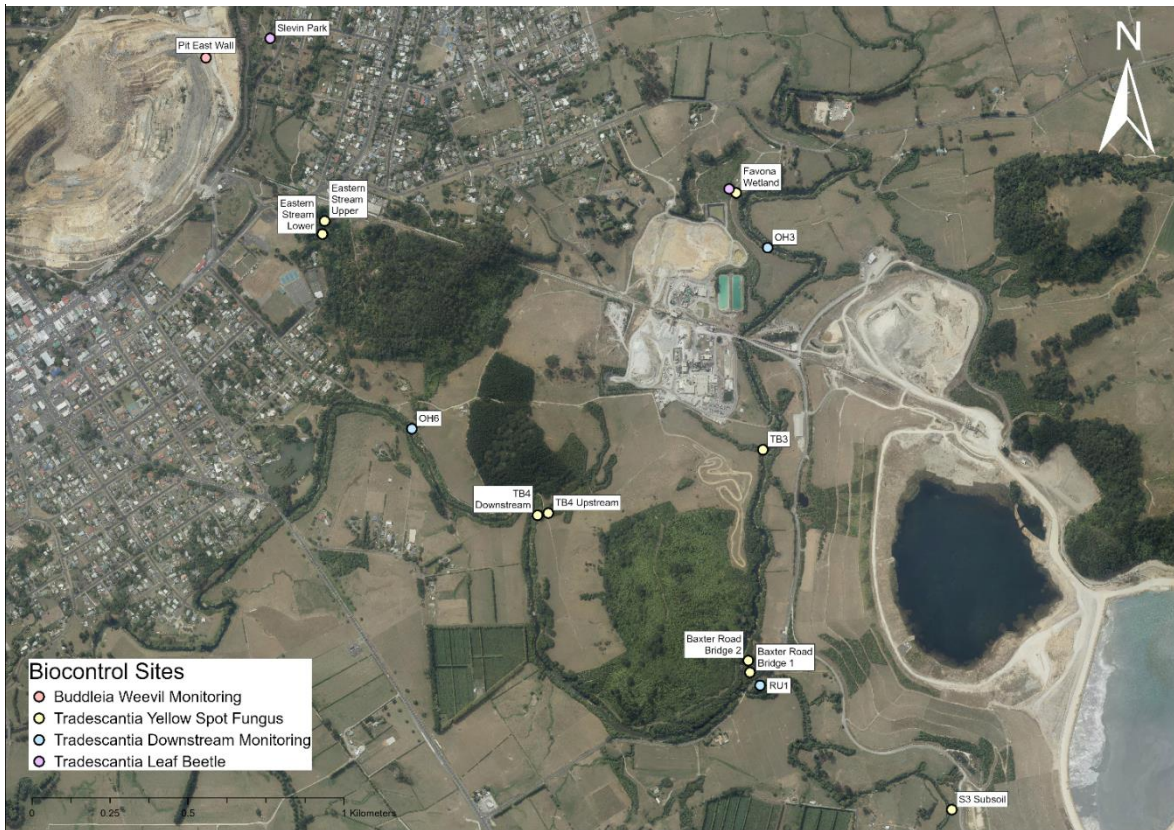
Figure 12: Biological Control Introduction and Monitoring Sites

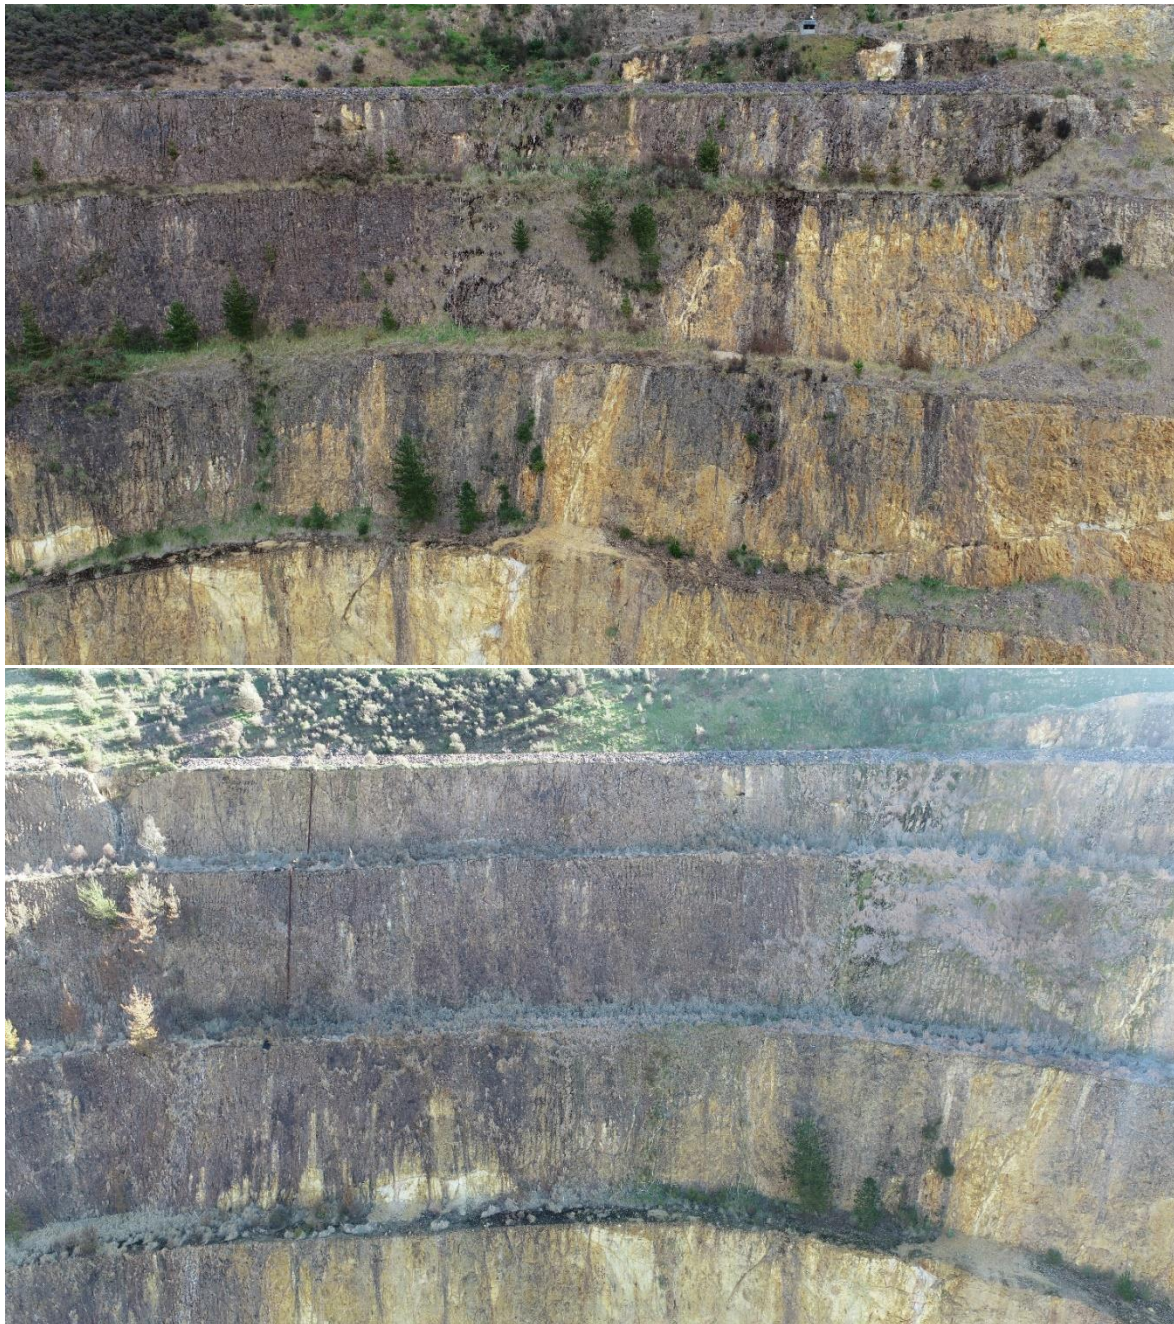
Figure 14: Open Pit North West Wall, Before and After Drone Spraying (upper image October 2022, lower image May 2023)

Aerial spraying using a drone was trialled during this reporting period. The top two batters of the Open Pit were treated in November 2022 and February of 2023 to target gorse, wilding pine, and pampas. Approximately one third of the pit rim circumference from the rip rap level down two batters was sprayed. This proved to be a successful and safe method to control pampas, although some refinement is required in the next round of spraying. Figure 14 shows a before and after views of the area treated.

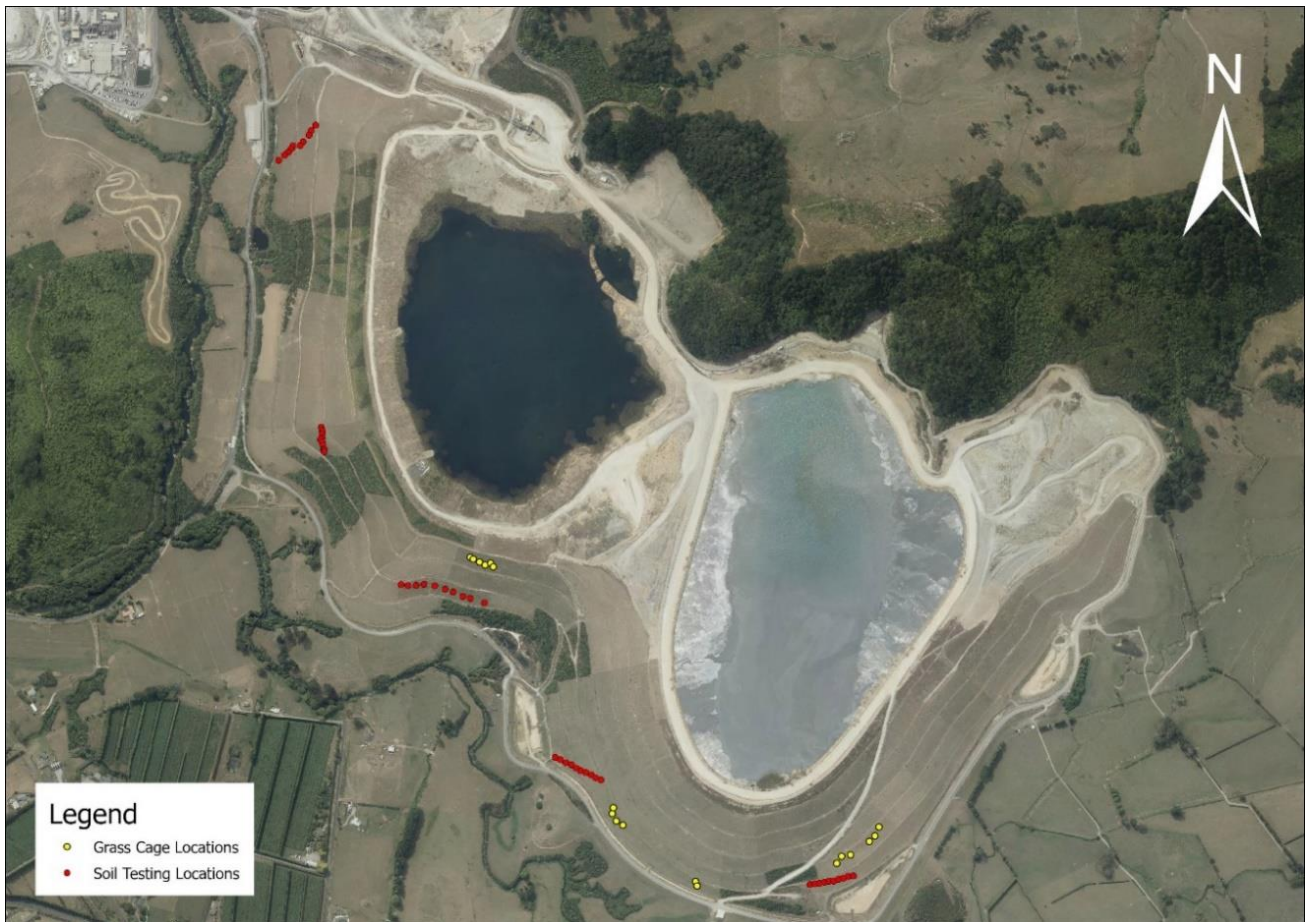
Figure 17: Pasture Monitoring Locations

The 2022 report forms Appendix D and pasture monitoring locations are shown in Figure 17 below. It should be noted that the 2022 report is based on soil sampling data collected and analysed in June 2022 and drone footage and photos from the same time. A site visit by Bob Stewart occurred in July 2022 but observations from this site visit will inform the 2023 report.

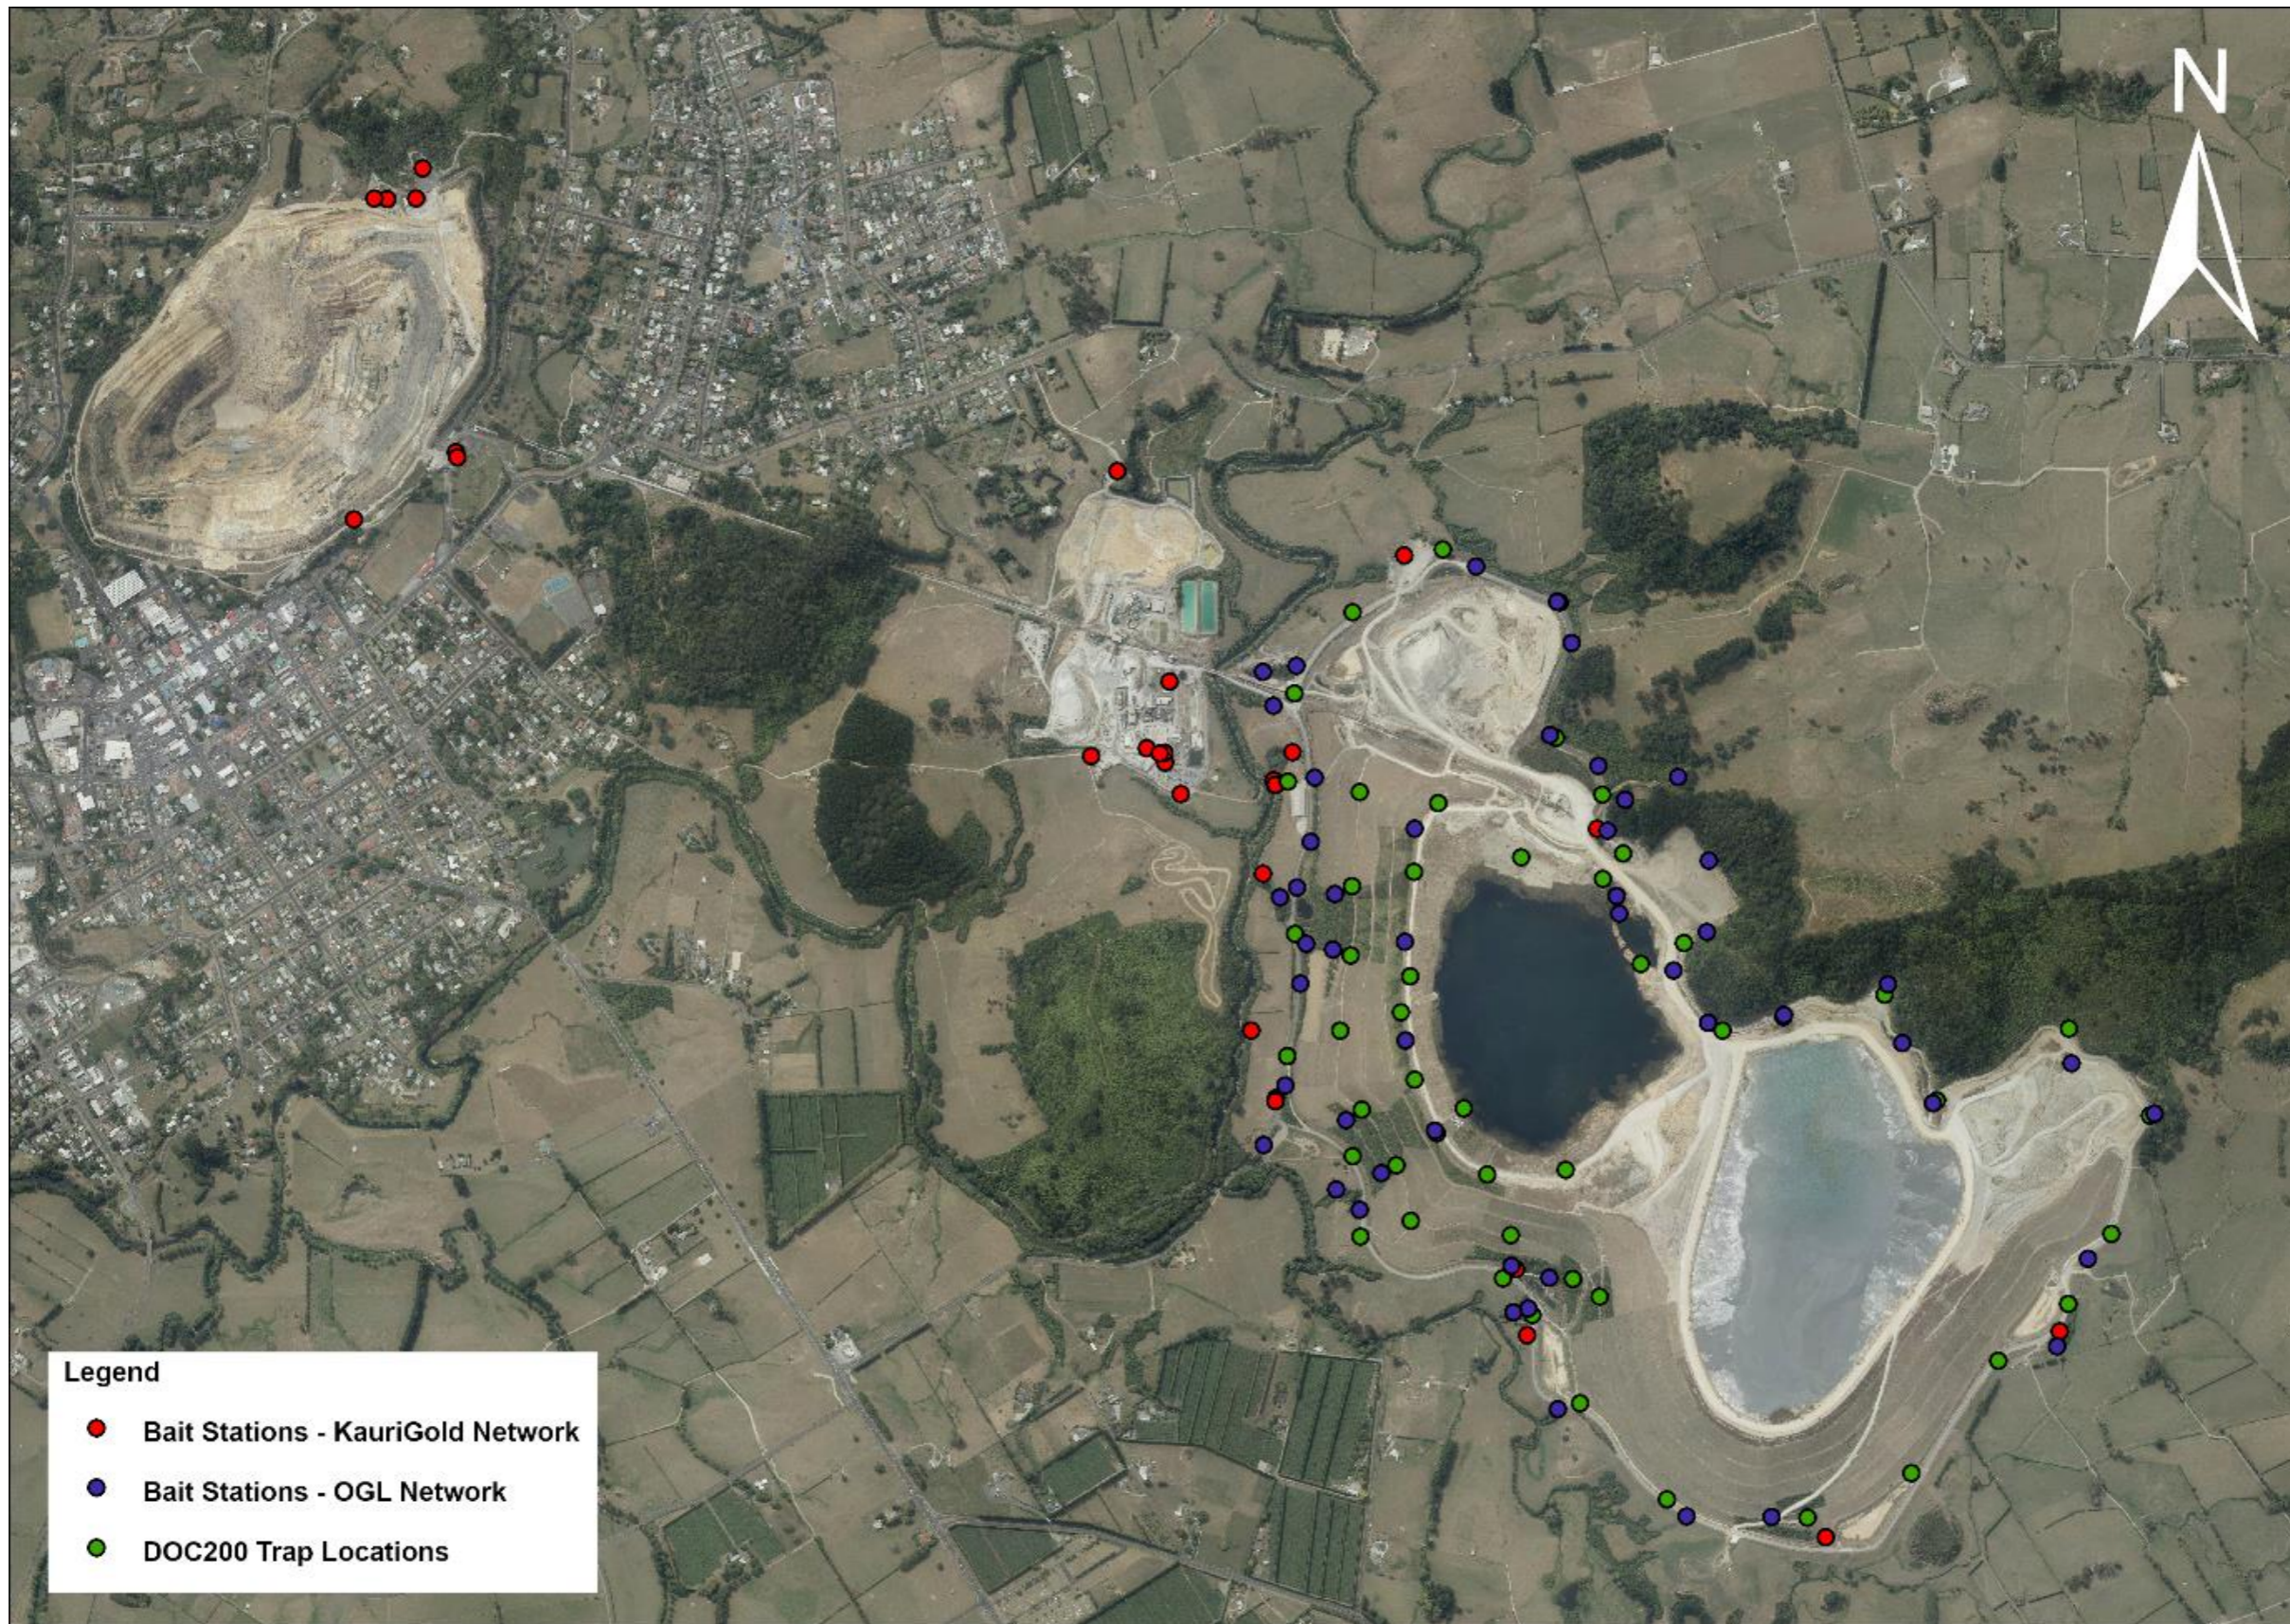
Figure 1: OceanaGold Waihi Trap and Bait Station Network.

Rats and mustelids are controlled around the Development Site by a network of 50 DOC200 style traps (Figure 1). Traps are installed to protect native plants and birds within the Development Site area. Traps are checked and reset monthly by the OGNZL Environmental Officer using dried rabbit or eggs as lure. Trap catch data is updated in the field on the TrapNZ app and is stored on the TrapNZ website: <https://www.trap.nz/node/16172116>

A network of 50 Philproof bait stations were installed around the site in 2022 to control possums, rats, and mice (Figure 1). The station locations are selected to protect native plants and birds, and OGNZL facilities within the Development Site area. The bait stations are currently baited with DoubleTap pellets (diphacinone and cholecalciferol toxin) on a monthly schedule by the OGNZL Environmental Officer. Bait take and resupply is recorded using the TrapNZ app and website: <https://www.trap.nz/node/16172116>.
