Rehabilitation and Closure Plan

2023-24

Document Reference: WAI-200-PLN-011

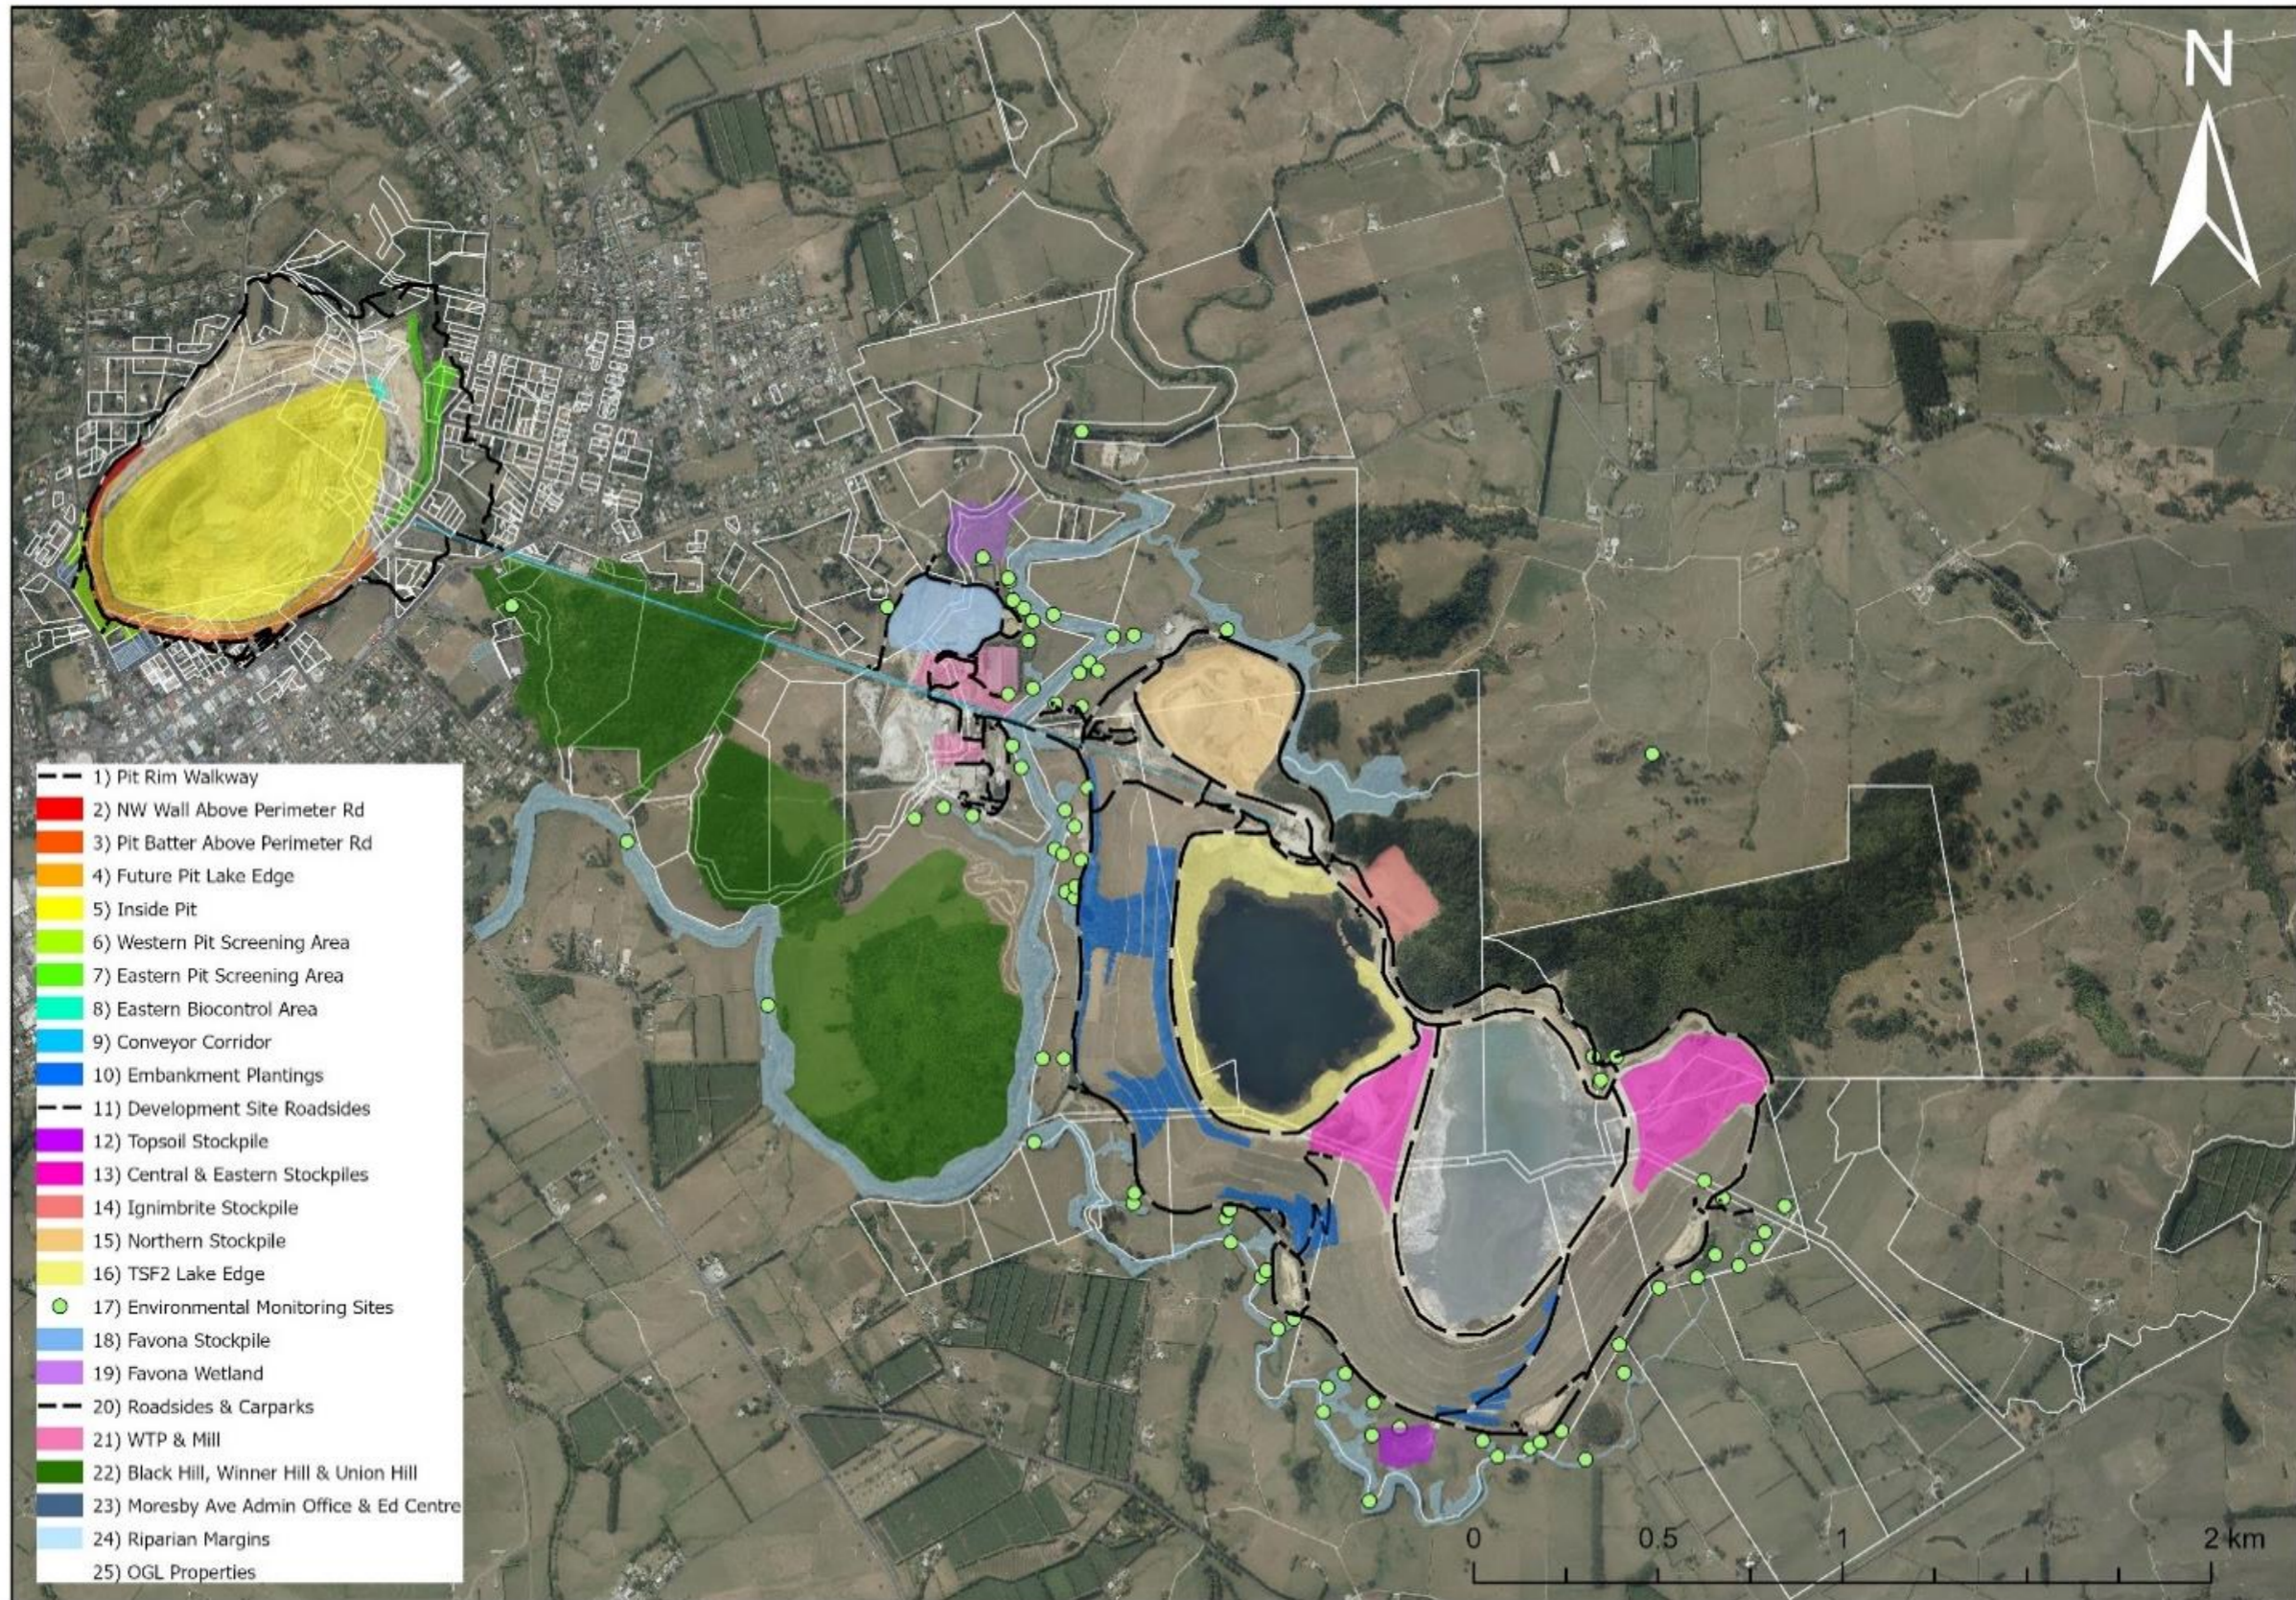
Figure 2: Weed Control Zones

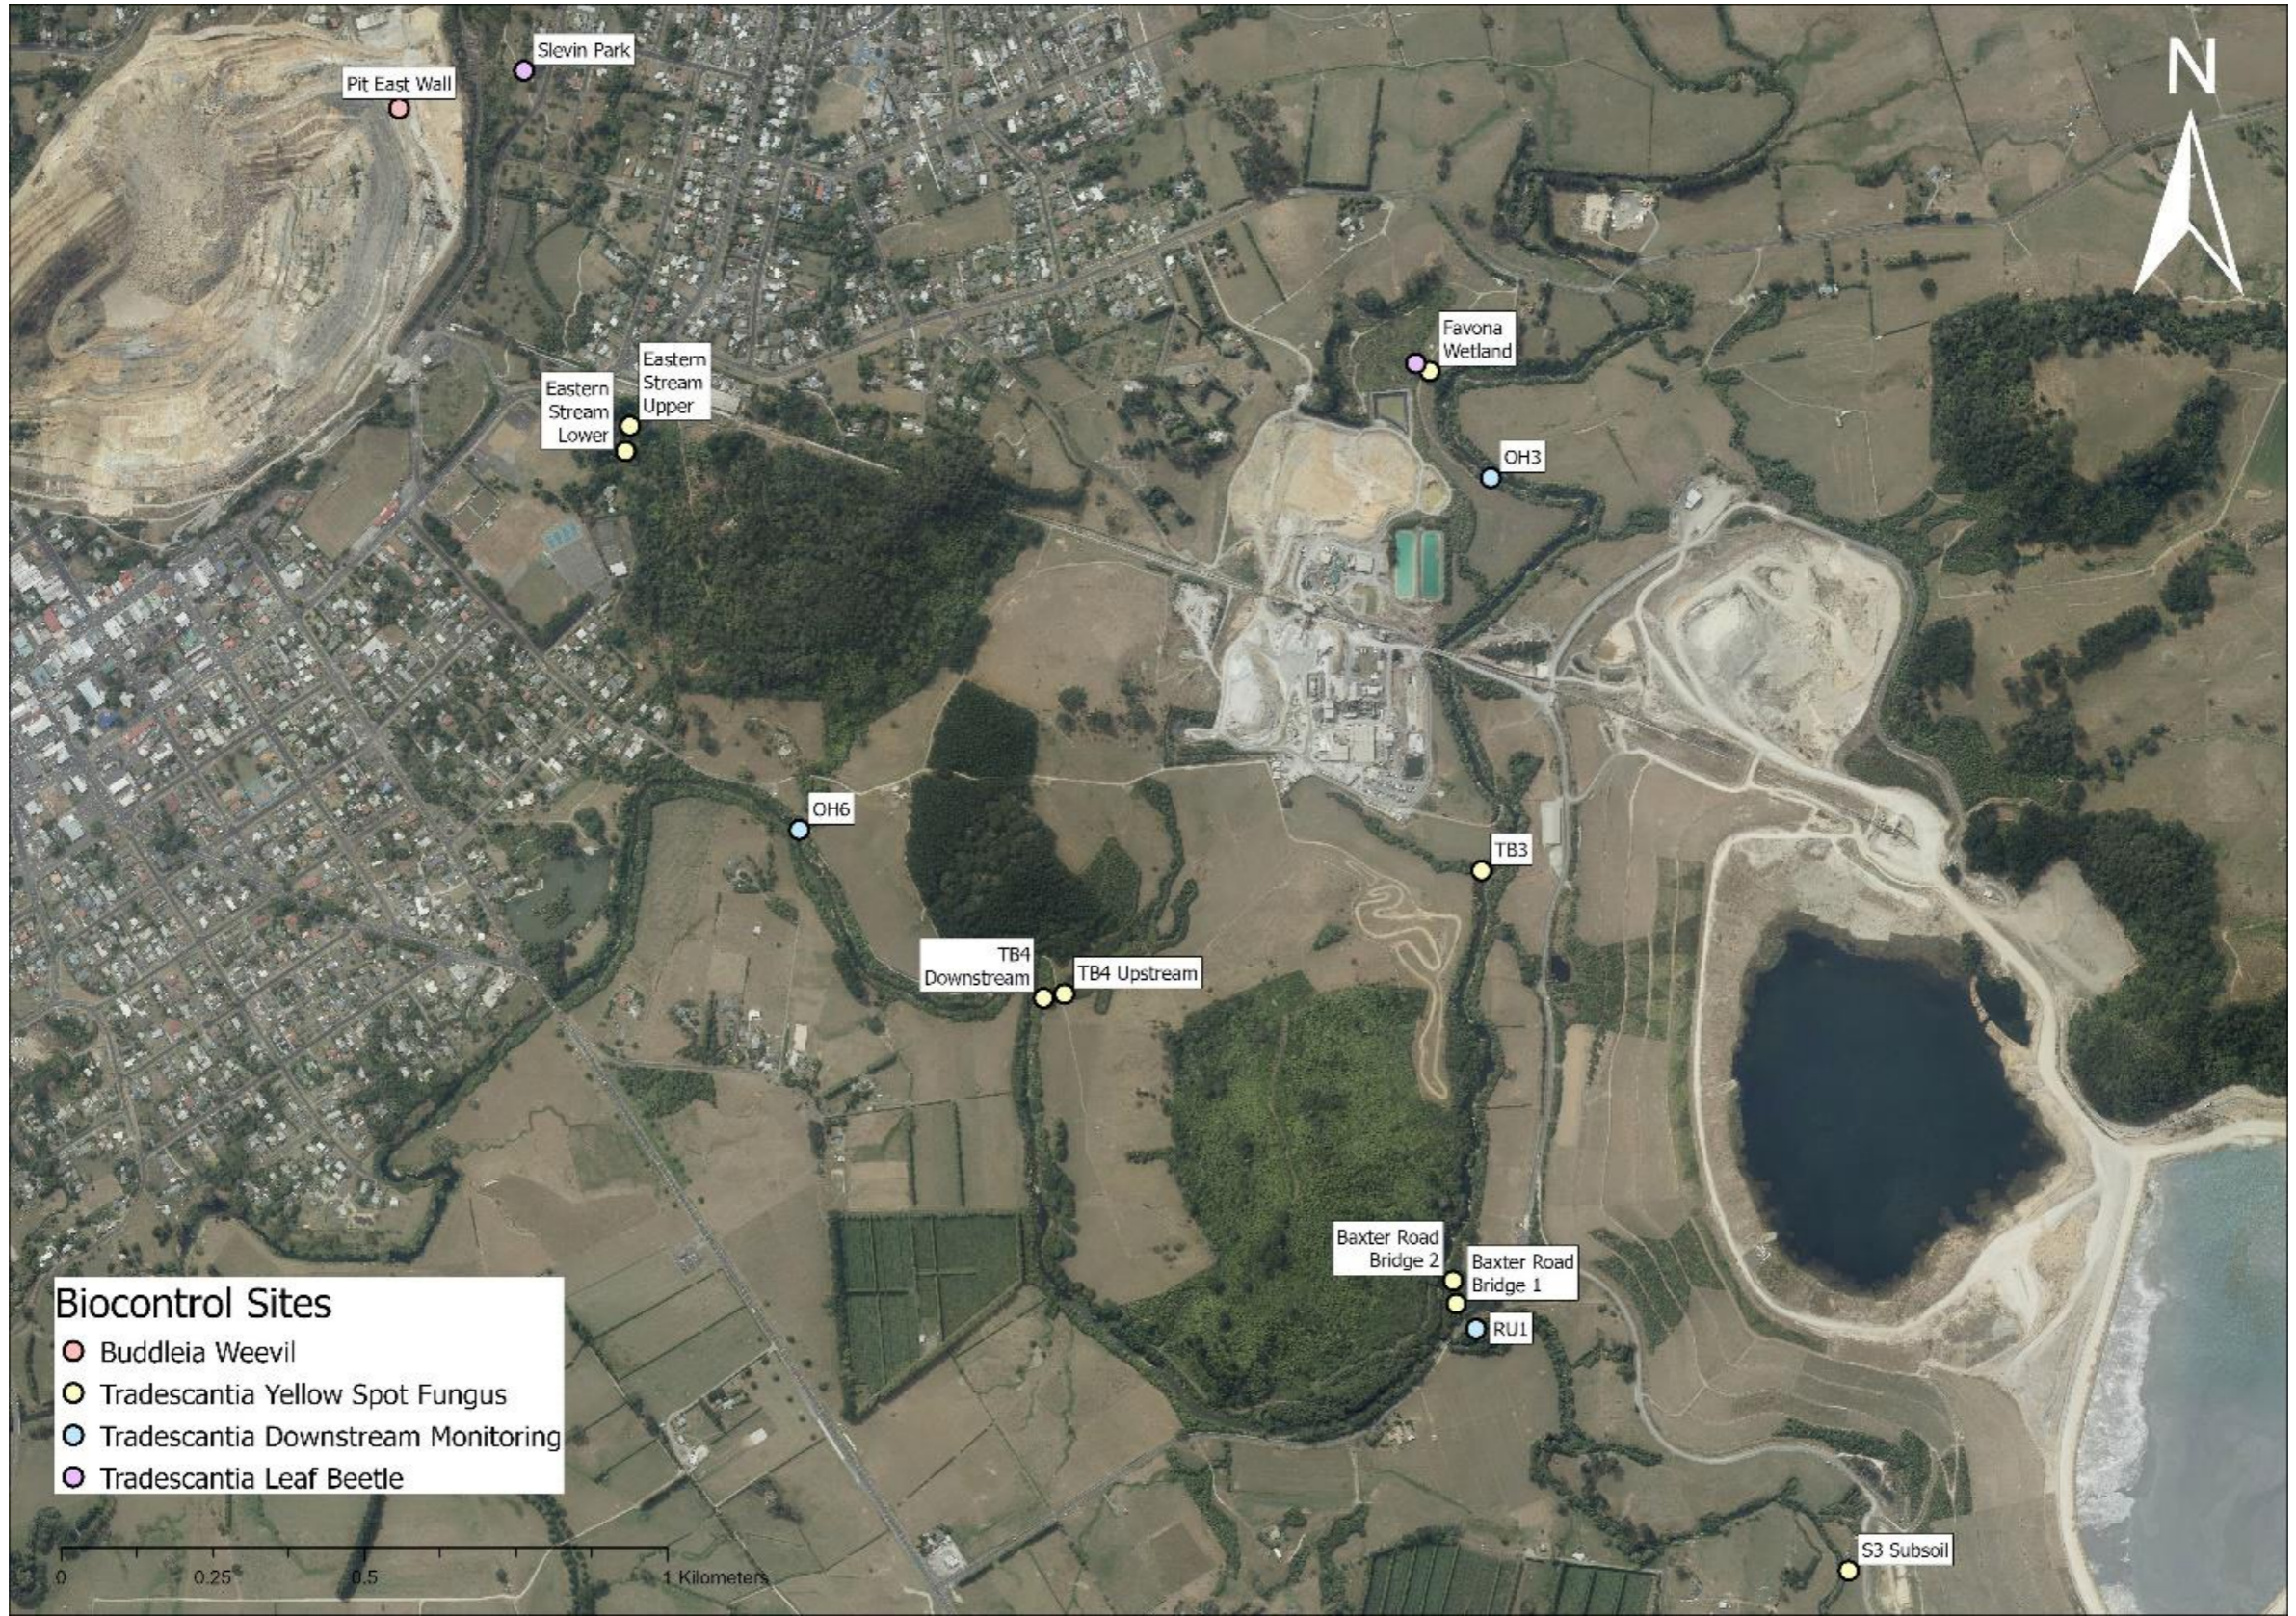
Figure 3: Biocontrol Sites

The use of biological control agents has been explored by OGNZL as an alternative option to chemical and mechanical weed control. It uses the pest’s natural predators in controlling their population to minimise their environmental impact. This specifically targets certain weed species, reducing the impact on non-target species and requires minimal maintenance effort to sustain. OGNZL has introduced buddleia leaf weevil to the Martha Pit and Development Site, trialled tradescantia yellow leaf spot fungus as biocontrol along the riverbank, and observed the impacts of Nodding Thistle Receptacle Weevil which naturally arrived on site. Additionally, in 2023 WRC supplied OGNZL tradescantia leaf beetles to trial as supplementary biocontrol. See Figure 3 below for the current biocontrol sites.

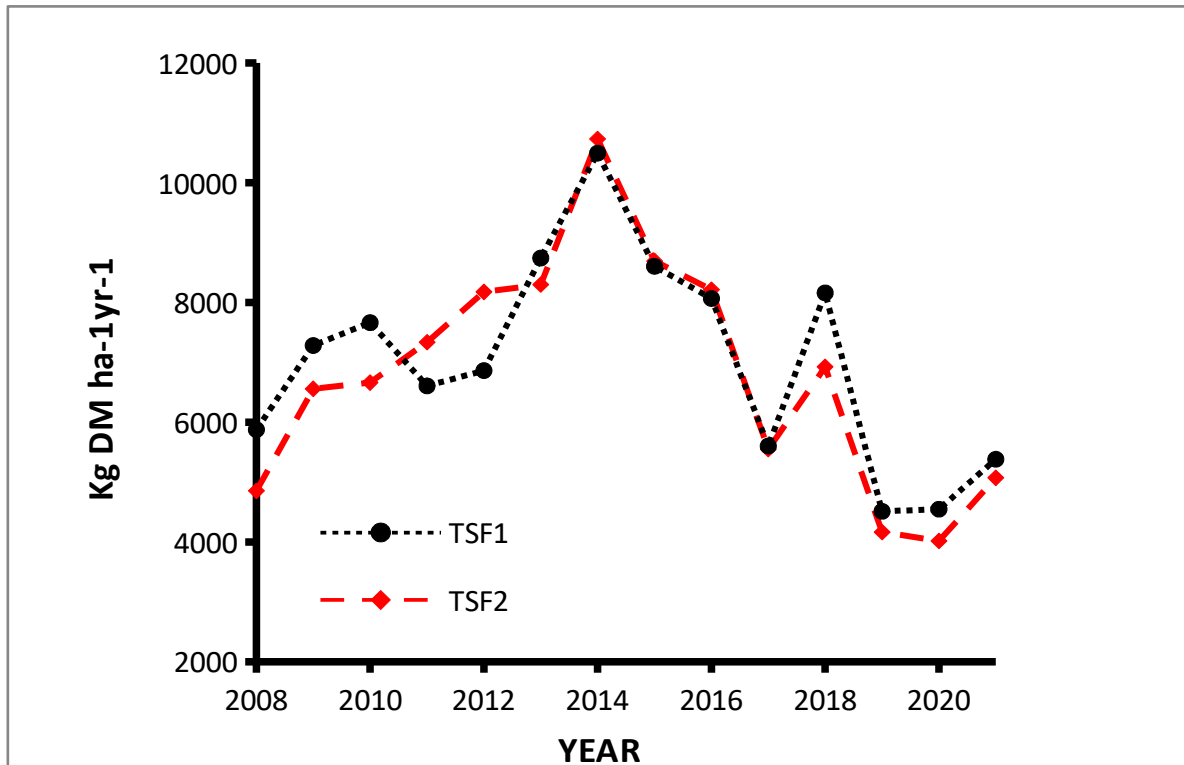
Figure 1: Pasture growth data for 2008 – 2021. There is no statistically significant difference between the annual yields from TSF1A and TSF2. The variation from year to year usually reflects climate differences, particularly rainfall.

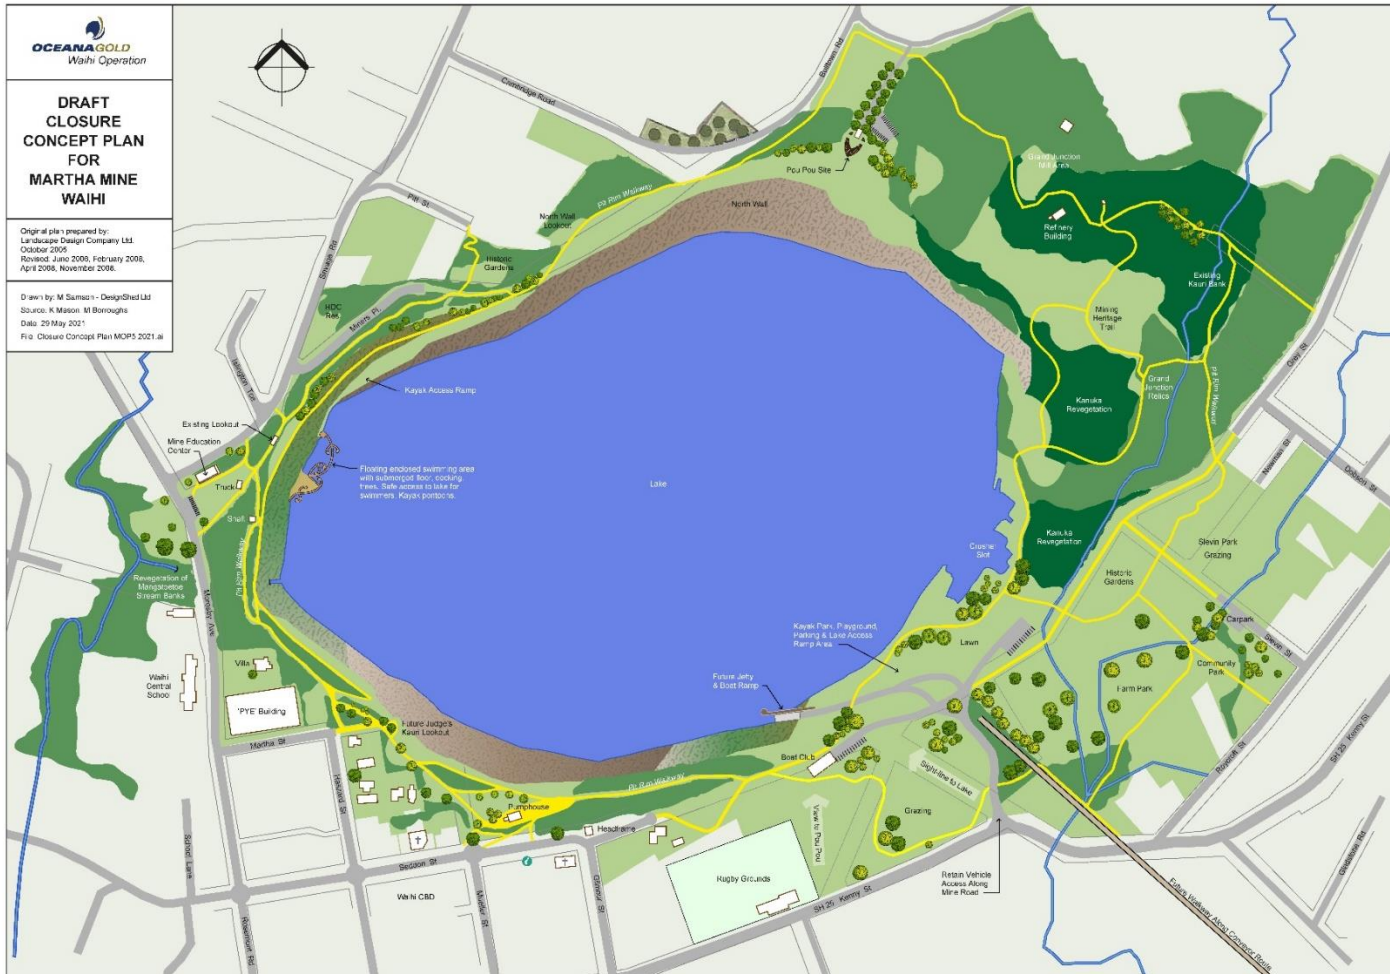
Figure 3: Project Martha Closure Plan

Some further planting may be necessary in the surface facilities area only. The assumption is to plant around 1.2ha of kanuka vegetation as shown in Figure 3, plus some other individual trees.

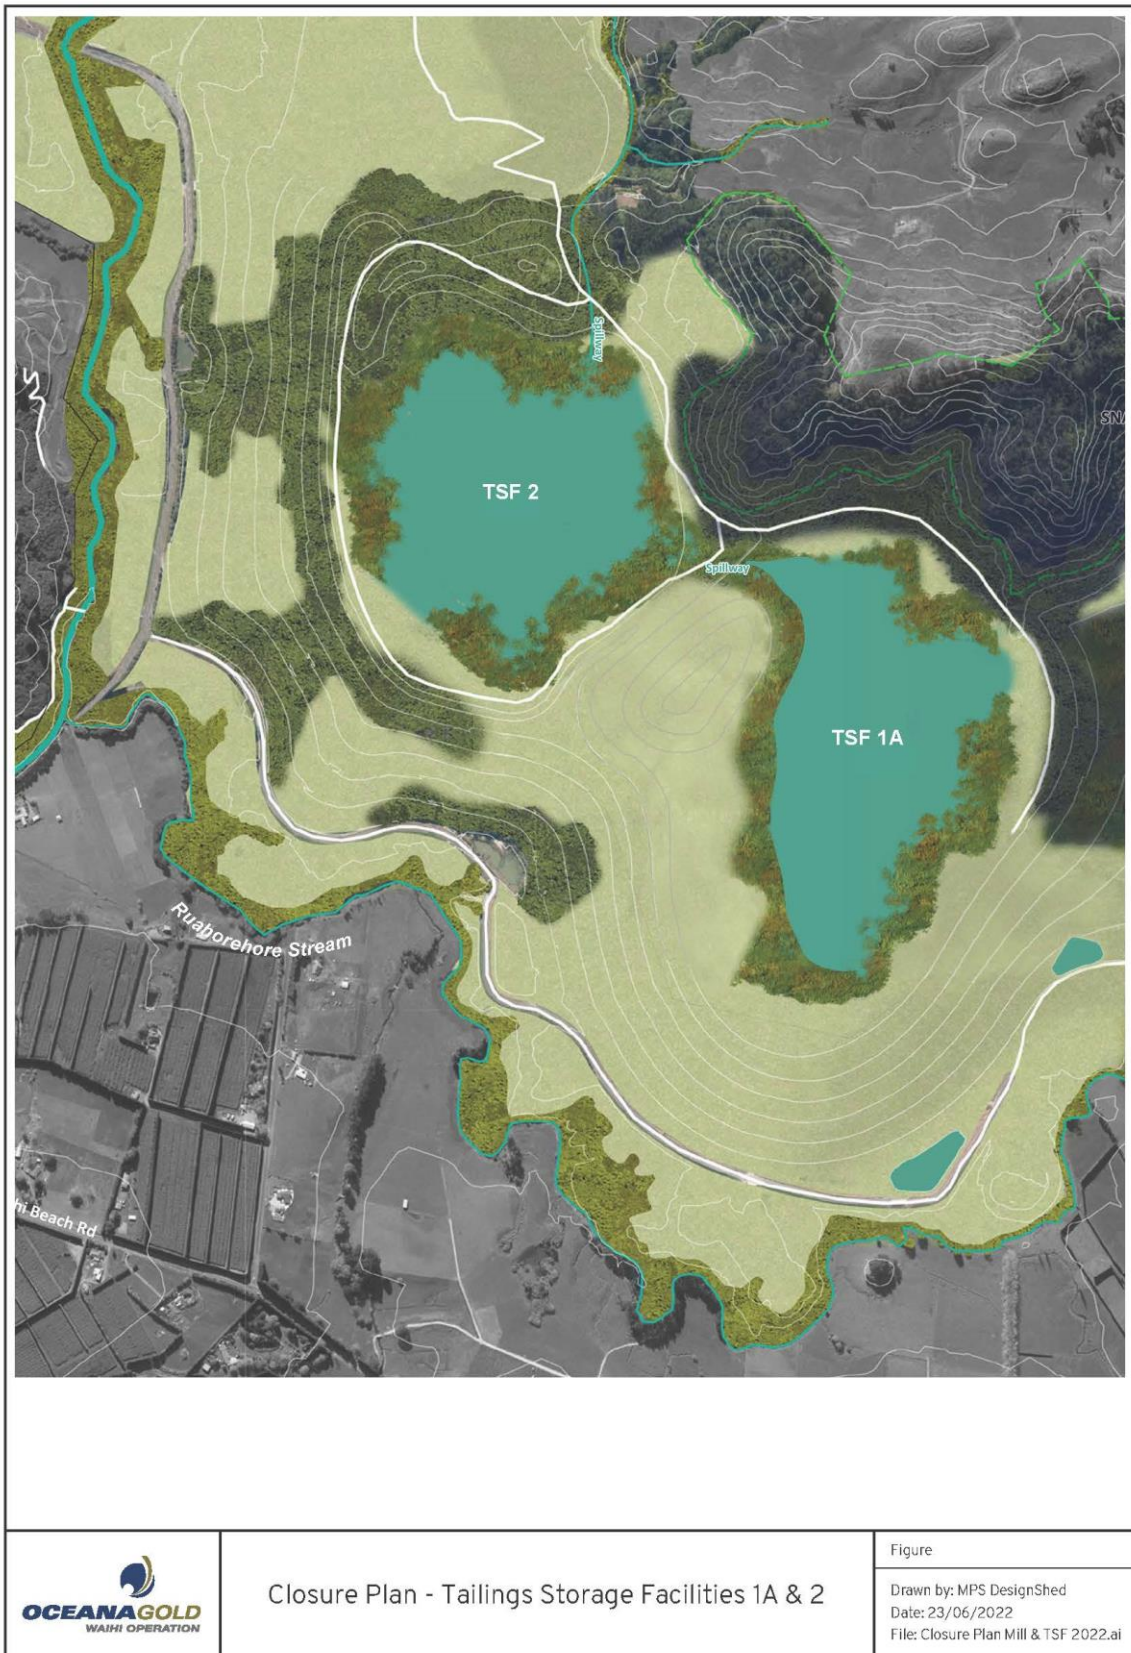
Figure 5: TSF Rehabilitation Concept

The conceptual closure plan for the tailings storage facilities (TSFs) initially prepared in 1998 remains fundamentally unchanged (refer Figure 5). It comprises a partial capping of the tailings against the embankment crest, retention of part of the impoundments as shallow ponds, and planting of the embankments and capping including a wetland littoral zone around the ponds. Spillways would be constructed to discharge into and from Storage 2.

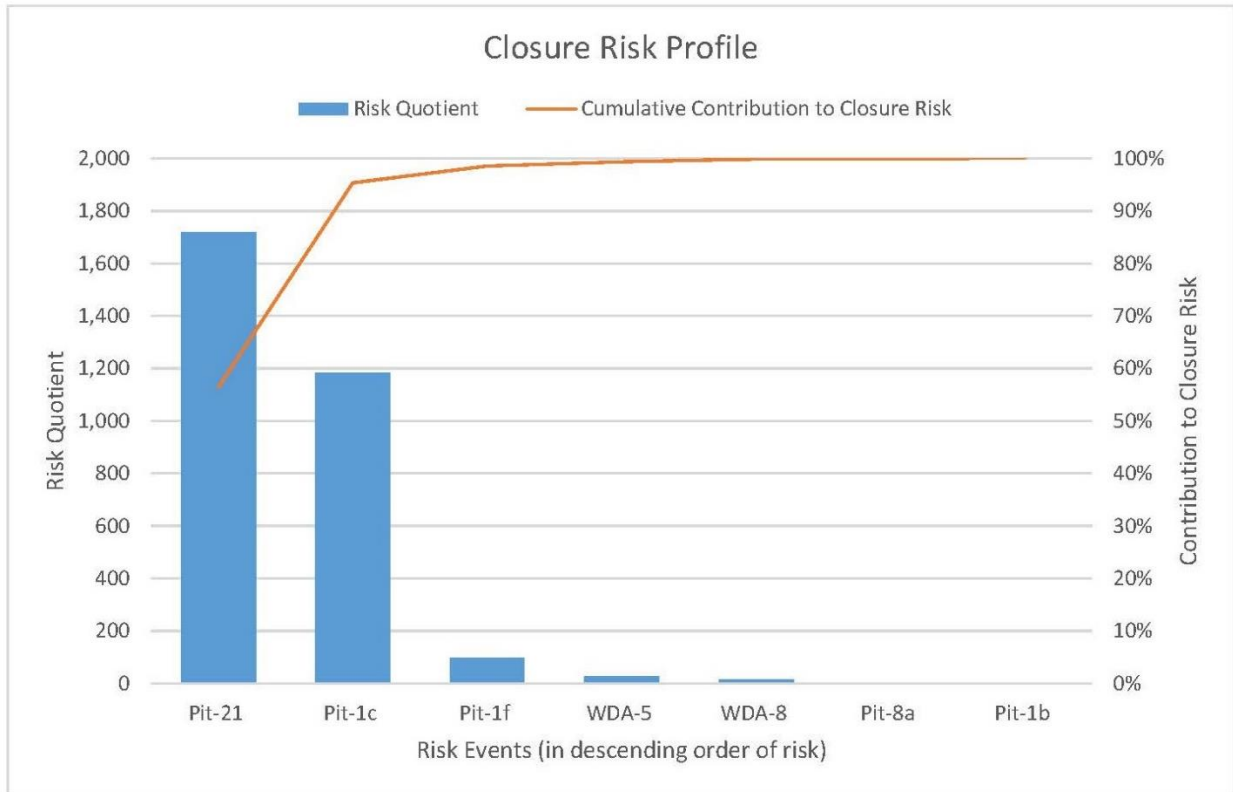
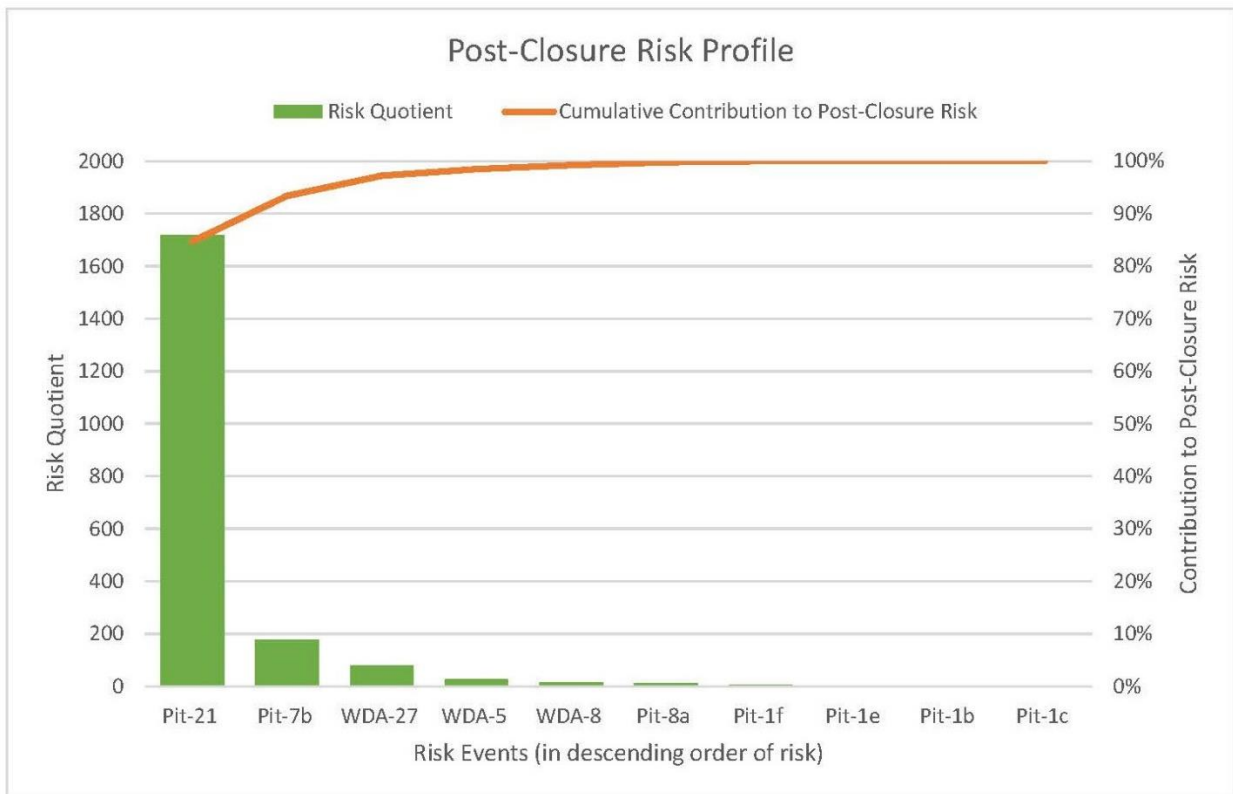
Figure 7: Risk Profiles.

The risk quotient provides a quantitative and directly comparable value of the risk each event poses during the closure period. For example, the second-highest ranked risk event (Pit1-c Pit wall failure – damage, risk quotient = 1,200) poses 70% of the closure risk posed by the top-ranked risk event (Pit-21 Hazard zone collapse, risk quotient = 1,700). The third-highest ranked risk event (Pit-1f Pit wall failure prevention) poses a little over 5% of the risk posed by Pit-21.
