# **Rehabilitation and Closure Plan**

2025-2026

Document Reference: WAI-200-PLN-011

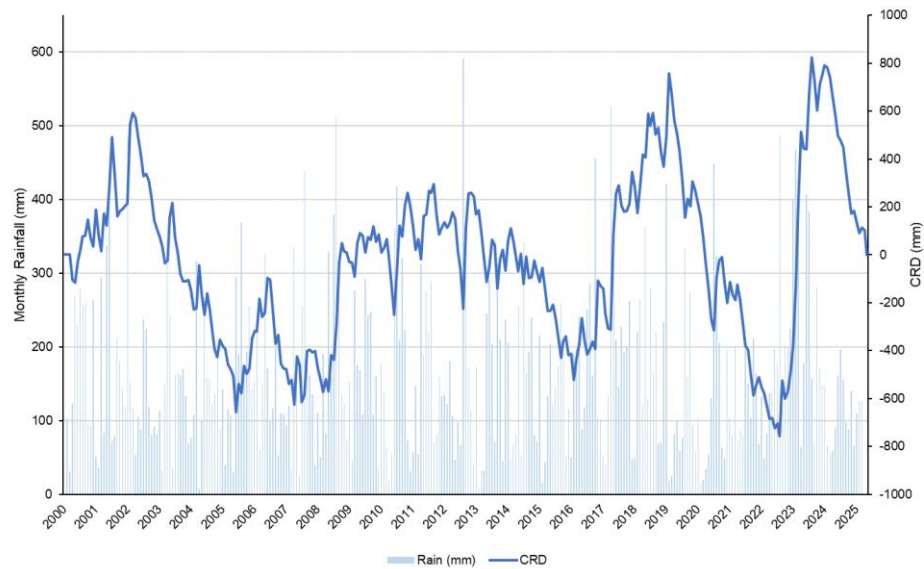
Figure 2 Waihi historical rainfall data.

Annual and seasonal rainfall trends are displayed in Figure 2. The Cumulative Rainfall Departure (CRD) plot presents long term trends in rainfall since 2000. Historical rainfall data for Waihi has been collected since 1907, with annual rainfall ranging from 1249 – 3234 mm.

A total of 1191 mm of rain was recorded during the reporting period, down from the previous reporting period (2215.6 mm). The month with the highest rainfall during the reporting period was June 2024 (406 mm) followed by June 2023 (196.6 mm) and the driest month was March 2025 (57 mm) followed by November 2024 (64.80 mm).

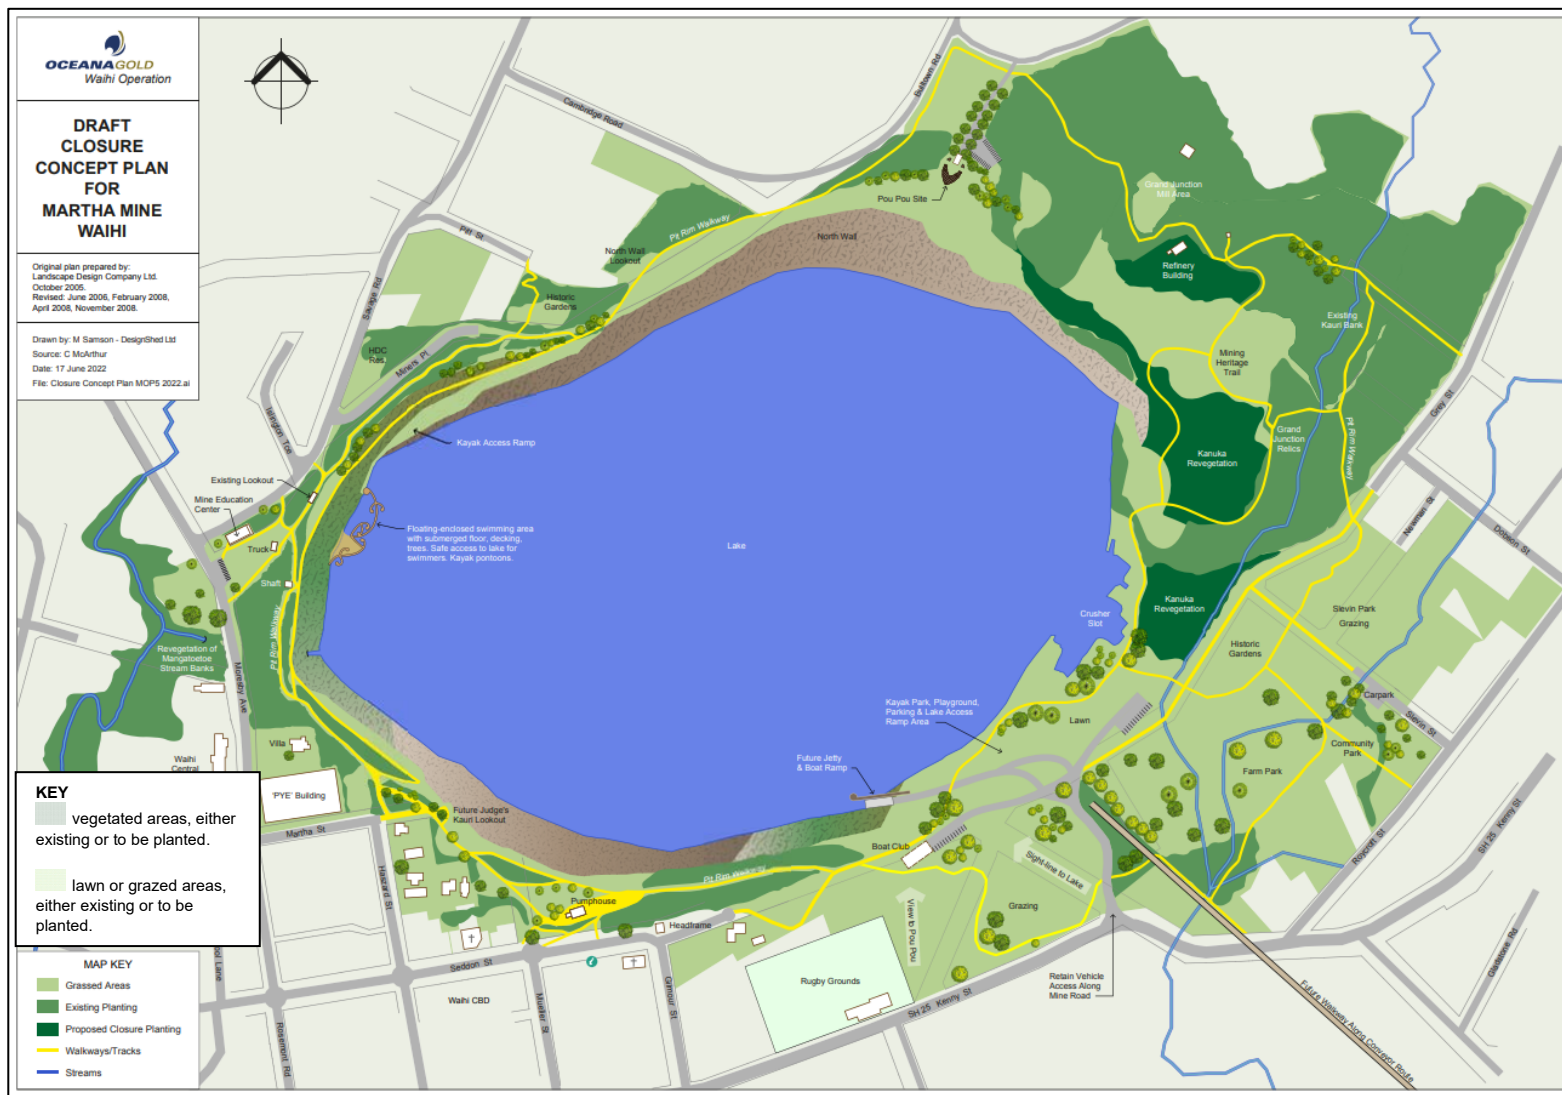
**Kanuka vegetation** – proposed areas of kanuka planting, post closure. Existing nearby native vegetated areas to provide seedbank for natural succession.

**Historic Gardens** – historical gardens of relocated houses including fruit trees and flowering specimen trees. Proposed to be retained post closure.

Figure 7: Current Closure Concept Plan for Open Pit and Surrounds updated 2022

The Rehabilitation and Closure Concept Plan for the Martha Open Pit is considered a “work in progress” and is subject to change and more detailed landscape planning when the site nears closure. The 2006 Closure Concept Plan (Figure 6) was updated following the approval of the Martha East Layback. In 2016, changes were made to show the North Wall following remediation, including partial capping of the failed section. Other minor changes include widening of the lake to the north and southeast, an extension of the track network to accommodate the north wall remediation cutback, and minor amendments to the landscape and track network to the east of the pit. This updated plan is included as **Figure 7**.

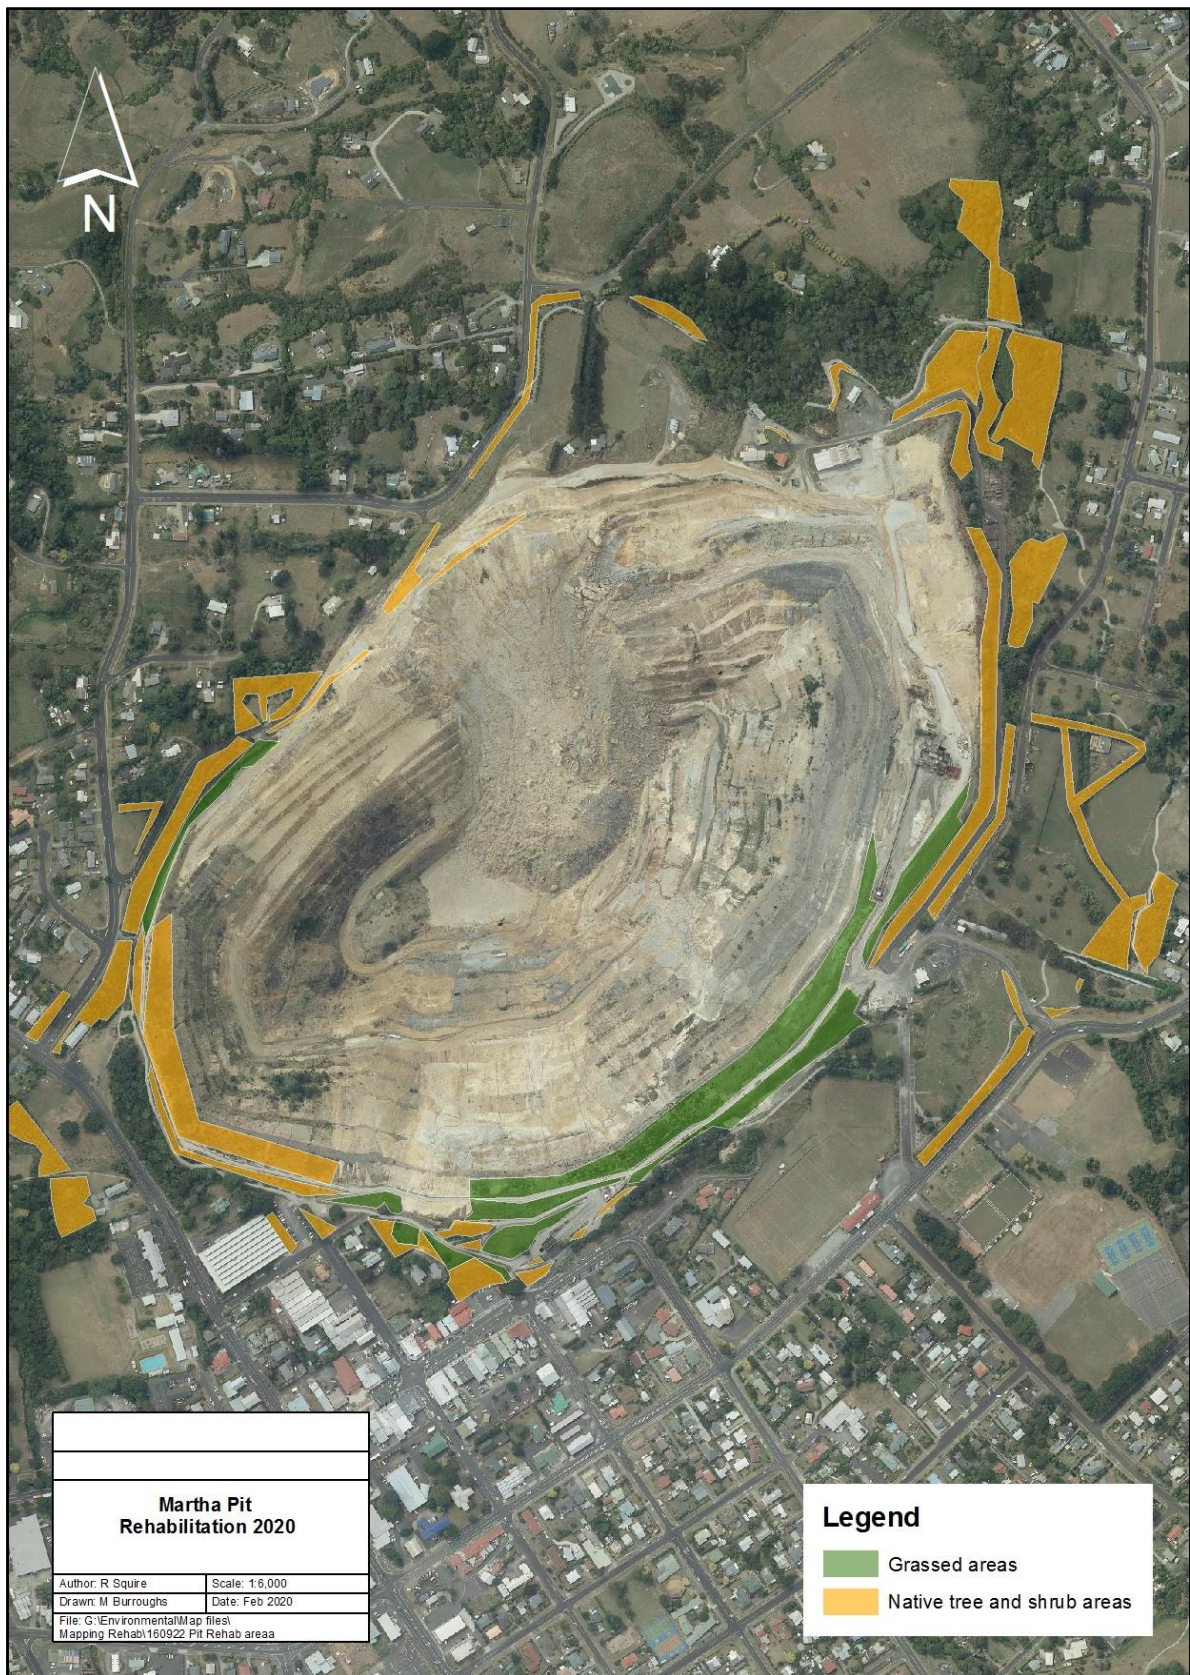
**Figure 8: Rehabilitation of Open Pit and Surrounding Areas**

Rehabilitation undertaken to date around the Open Pit is included in Figure 8.

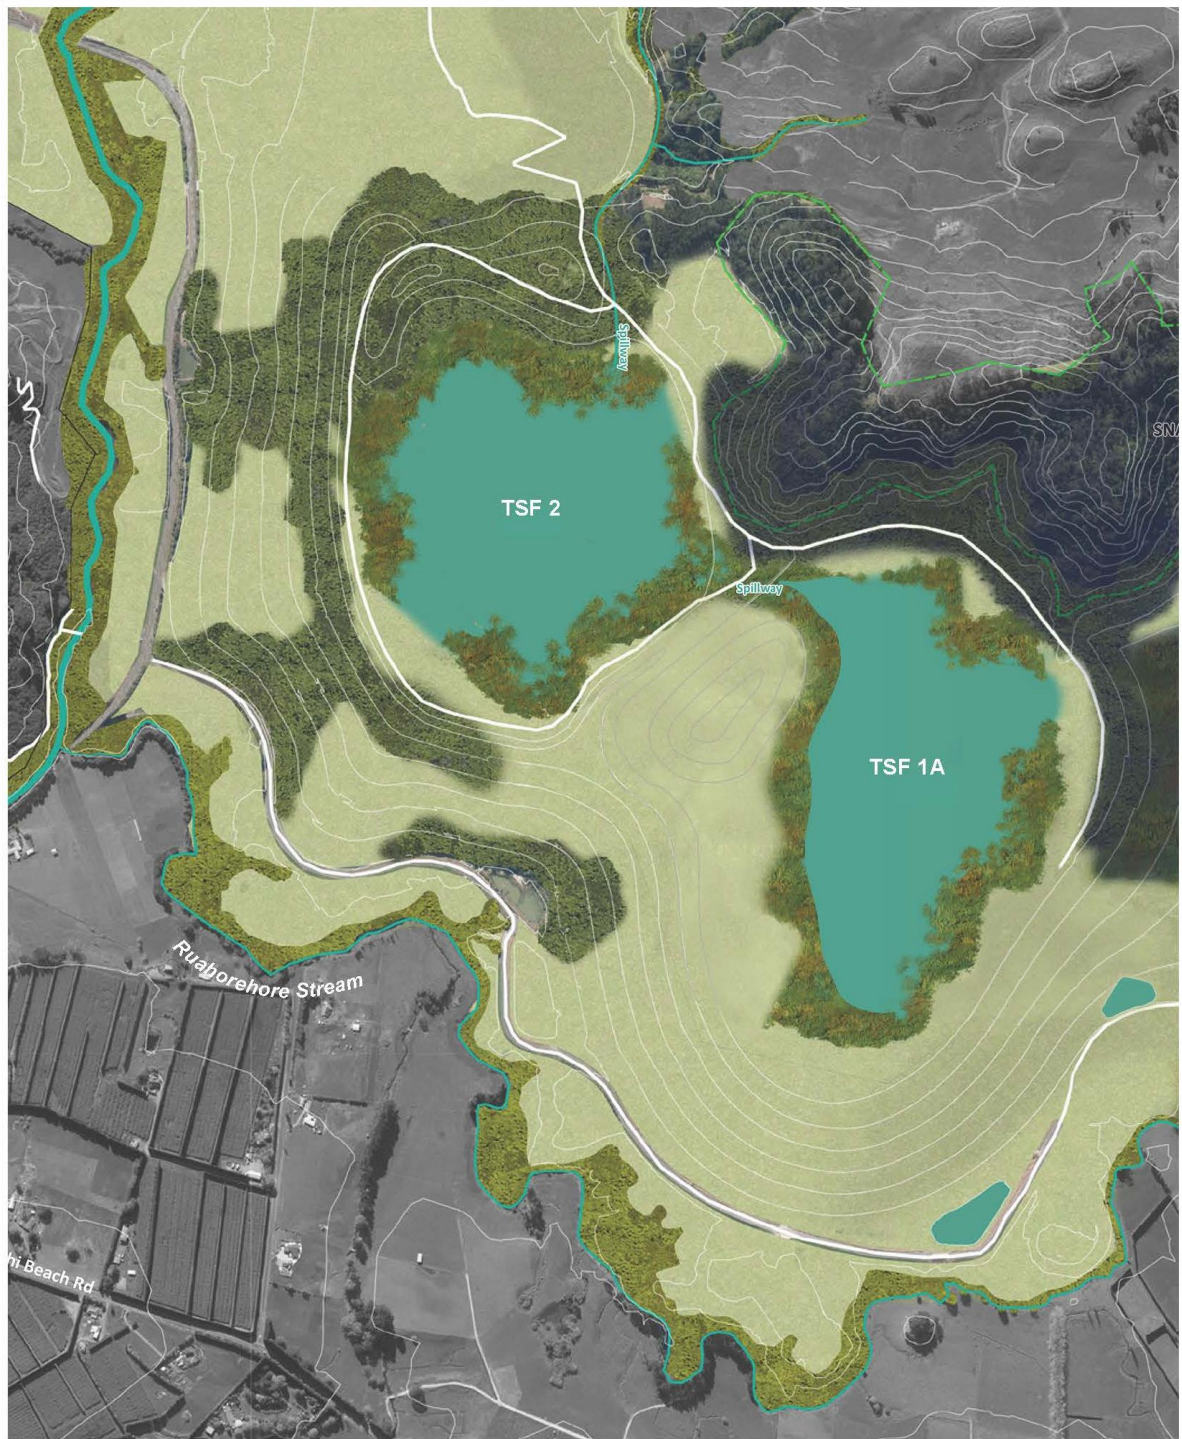
Closure Plan - Tailings Storage Facilities 1A & 2

**Figure 10: Current Closure Concept for Tailings Storage Facility**

The overall original concept plan for the rehabilitation of the Tailings Storage Facility (Figure 9) remains generally unchanged. Figure 10 provides an updated version of Figure 9. Slight differences include the possibility of more embankment native vegetation and the presence of walking or cycling tracks. These have yet to be defined and given the time until closure, further detail will be added in future years. Figure 11 shows a summary of rehabilitation completed at the Tailing Storage Facility to date.

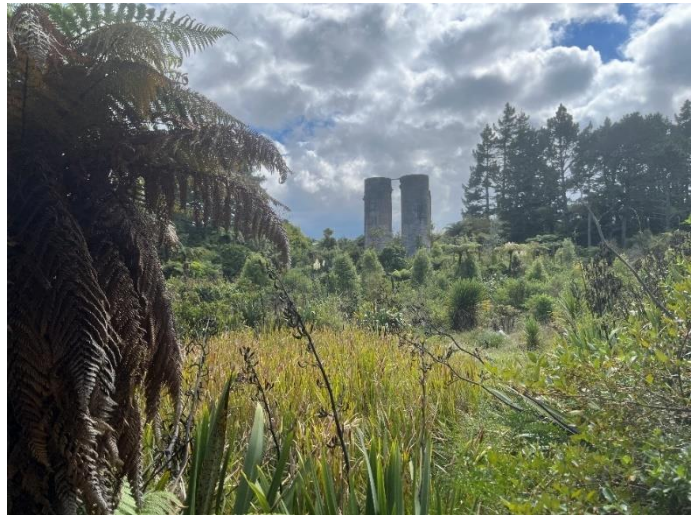
**Figure 12 Decommissioned cyanide tanks at Union Hill with native planting in the foreground**

Native plantings around the site complement and soften the visual impact of the remaining structures, whilst providing wider biodiversity and soil benefits (Figure 12). Living ecosystems are also showing evidence of becoming established on the structures themselves. The naturally established 'living roof' on top of a concrete relict (Figure 13) provides a suitable medium for orchids and native ferns.

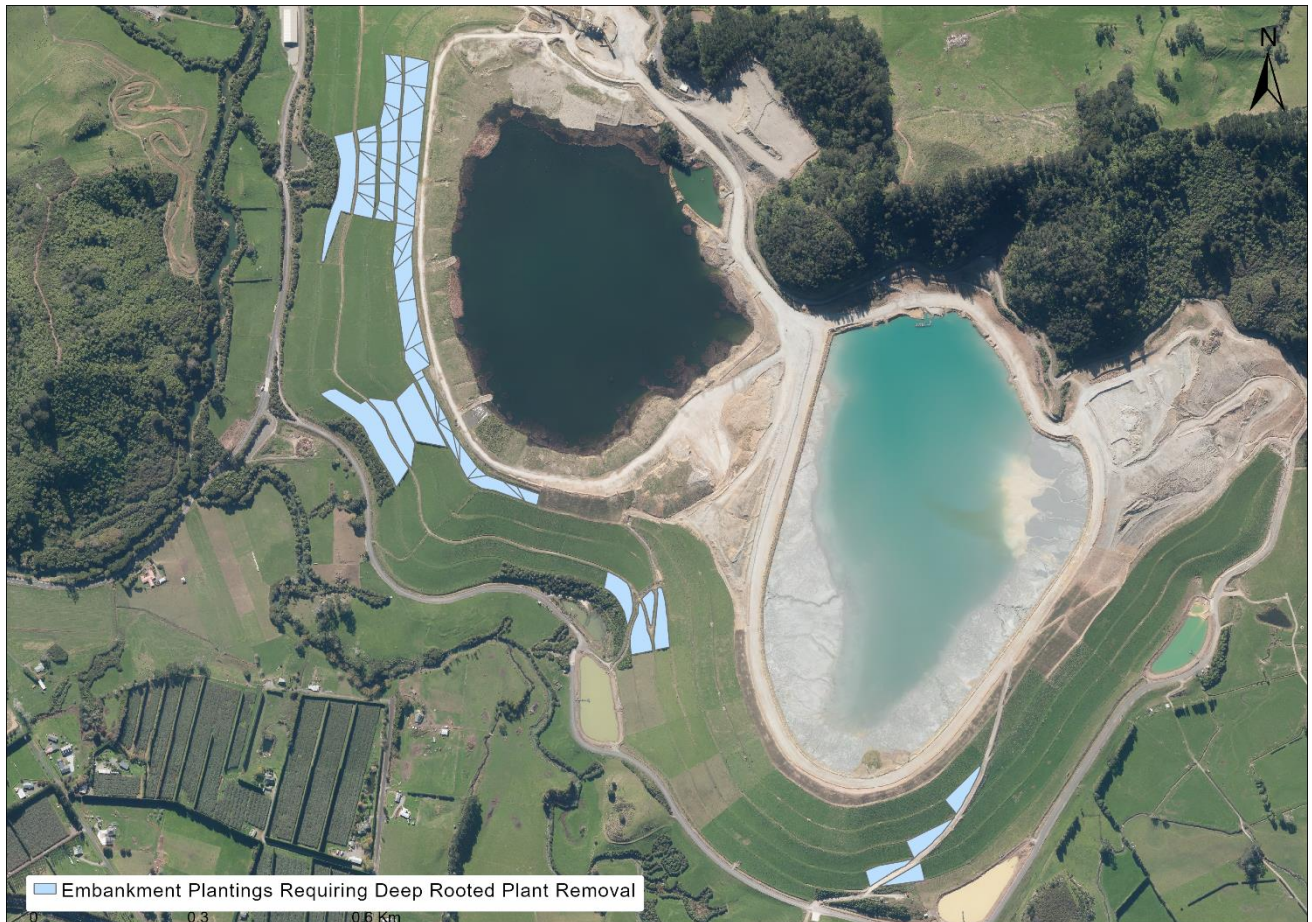
**Figure 16: Embankment Plantings Requiring Ongoing Deep Rooting Tree Removal**

OGNZL made the decision to remove cabbage trees and tōtara from areas of the embankment where there was risk that the tap root could damage the Zone G cap. The areas of embankment plantings where this is required are shown in Figure 16. This includes any native plantings on the second batter of the embankment or higher, but not the top of the embankment structure. Any of these species that are naturally regenerating are targeted through an annual maintenance sweep for weeds.

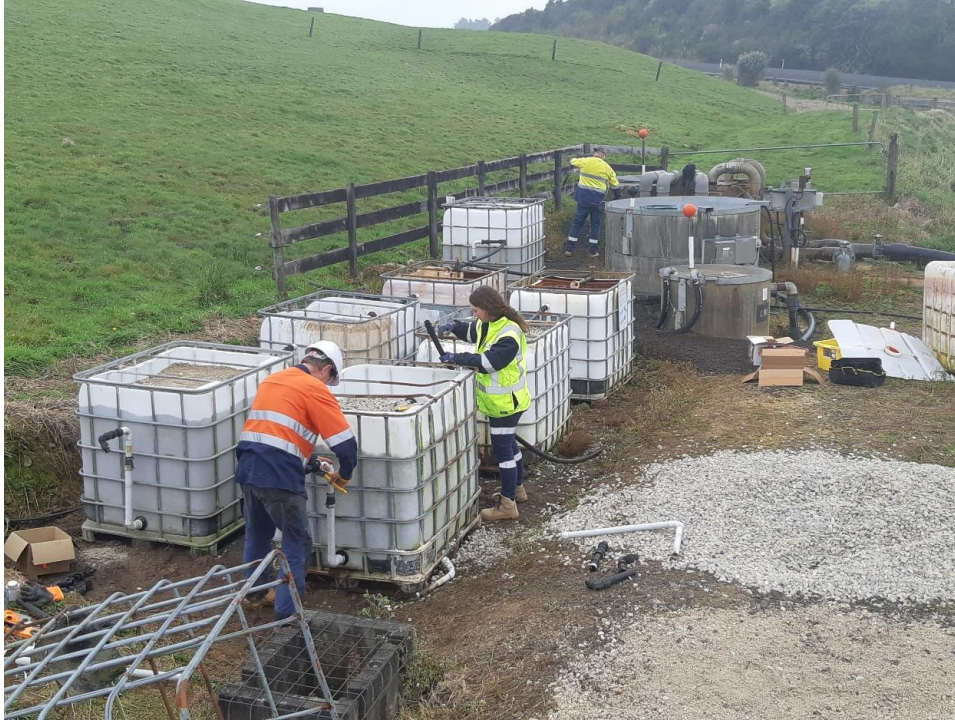
These trials proved to be effective and potential solutions to treat TSF drainage, however further exploration was required to ensure all factors were completely understood. Factors that influence the effective removal of Fe, Mn, Co, Zn and Ni for discharge include flow rates, residence times, oxygenation requirements and different types of treatment media (pumice, limestone, steel slag, wetland).

**Figure 17 Installation of passive treatment trial at TU site.**

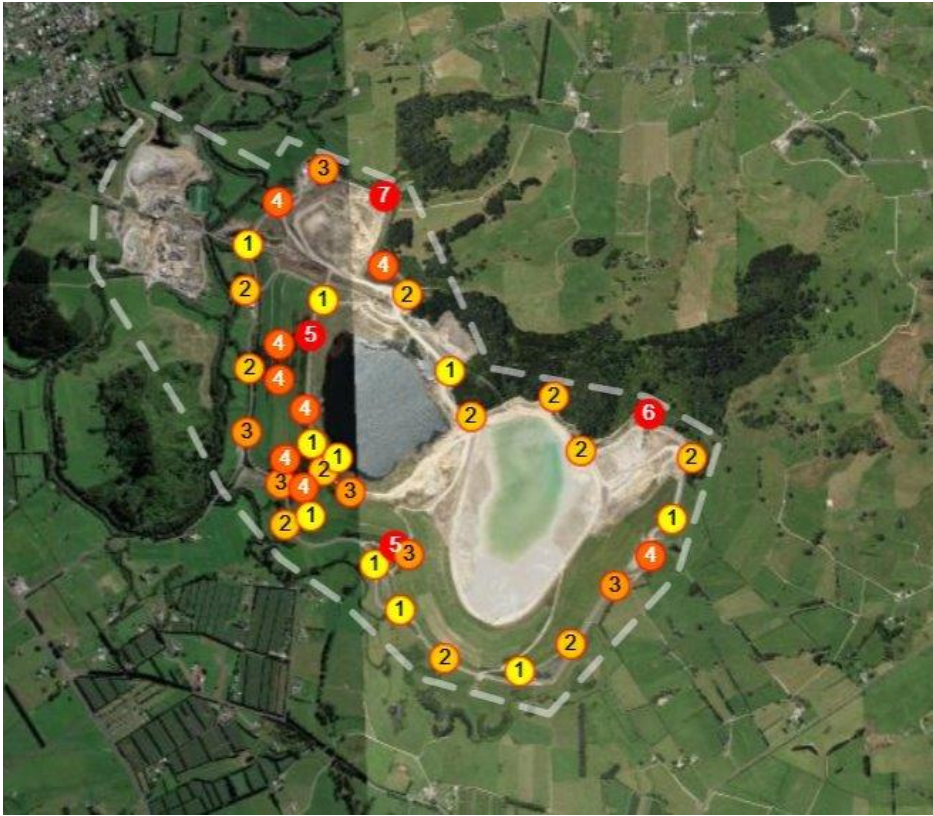
**Figure 21 Map showing number of predators caught at each trap during 2024/25**

Table 4 shows predator trap catch data for the past 3 years to the end of March 2025. For the 2024/25 period and moving forward to results for the Development Site network and Pit/compost site will be differentiated. Figure 21 and Figure 22 overleaf demonstrate catch results on a geographical and seasonal basis, which over time will be reviewed to assist adaptation of the trap servicing approach.

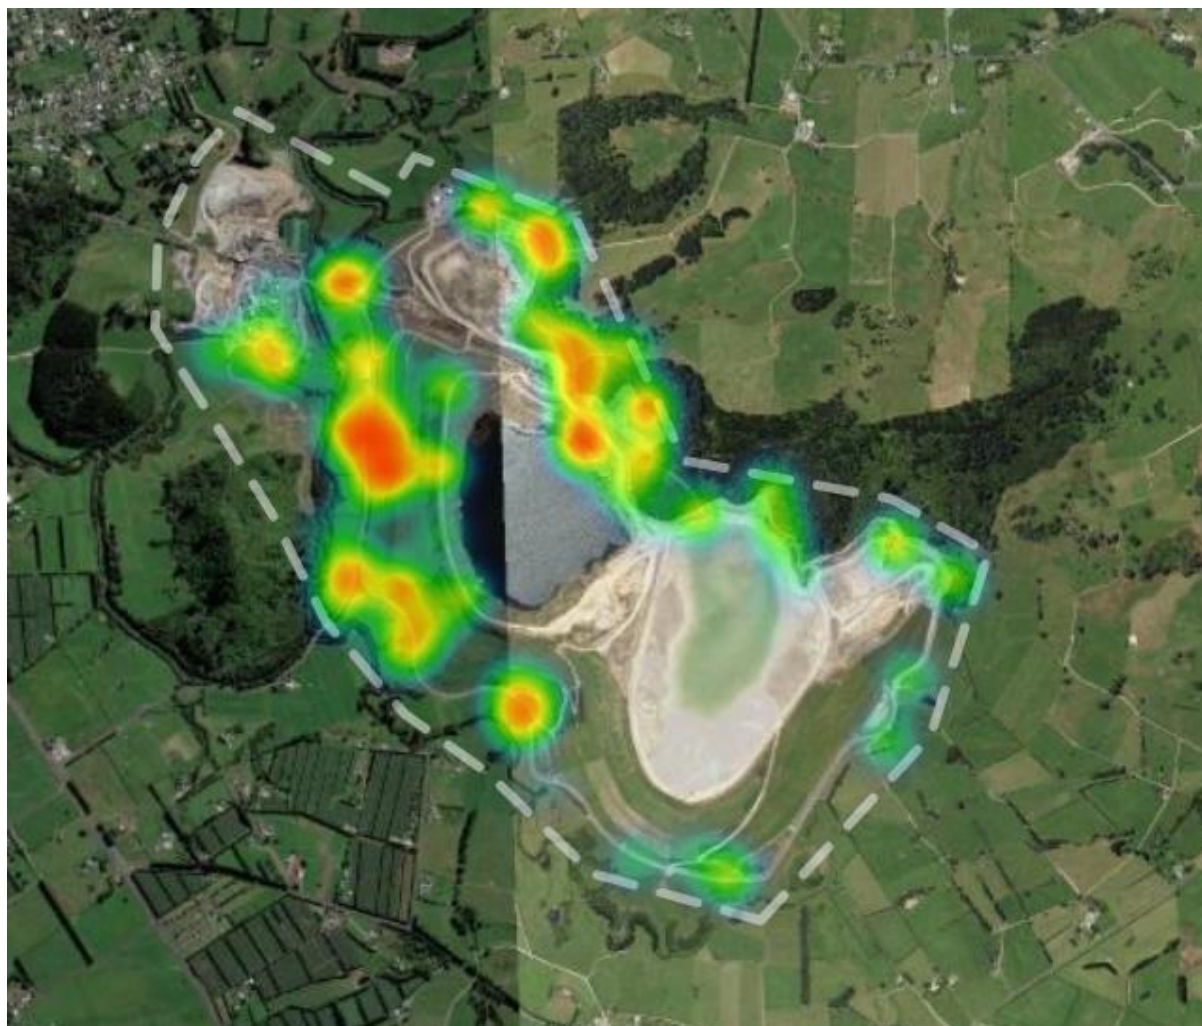
The exact number of predators targeted by the bait station network is unable to be demonstrated, however the volume of bait take (refer Figure 23 below) indicates that a large number of rats and

**Figure 23 Bait station heatmap demonstrating high bait take areas.**

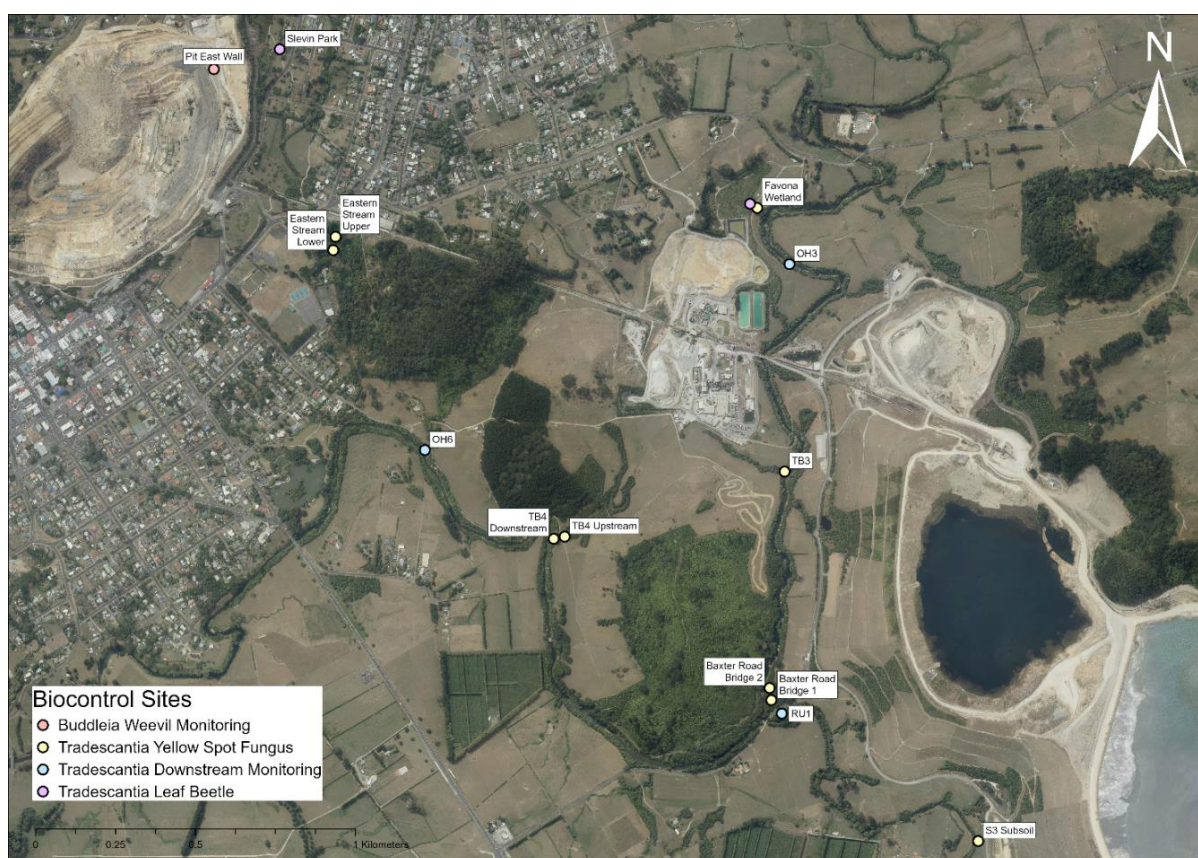
**Figure 30 Biocontrol introduction and monitoring sites**

Continued monitoring of existing biocontrol agents occurred during the reporting period (Tradescantia yellow spot fungus, Tradescantia leaf beetle and Buddleia weevil). Advice received from Waikato Regional Council suggested that the monitoring programme could be streamlined and the frequency reduced. Photo points have been established and will be retaken on an annual basis. Results are introduced in the Waihi Rehabilitation Monitoring Report. A map of original release locations is contained in Figure 30.

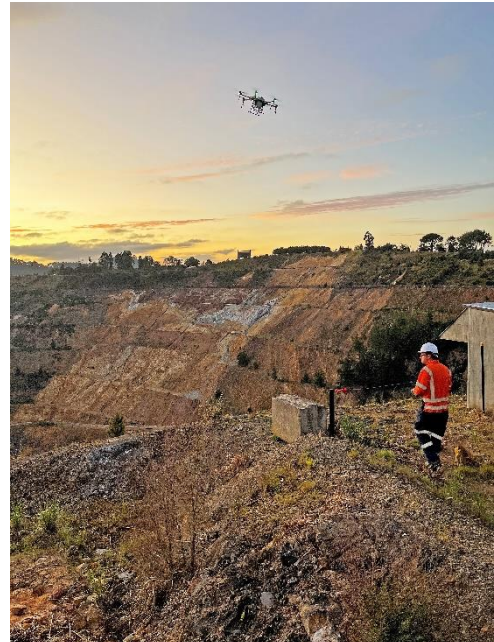
**Figure 32 Dronezap are able to spray the entire Pit from above.**

In March 2025, Dronezap completed a spray of the Favona stockpile, and a full pit spray - addressing weeds in the entire pit for the first time. A follow up spray is proposed for Spring 2025; and thereafter a less intensive approach is expected to be required.

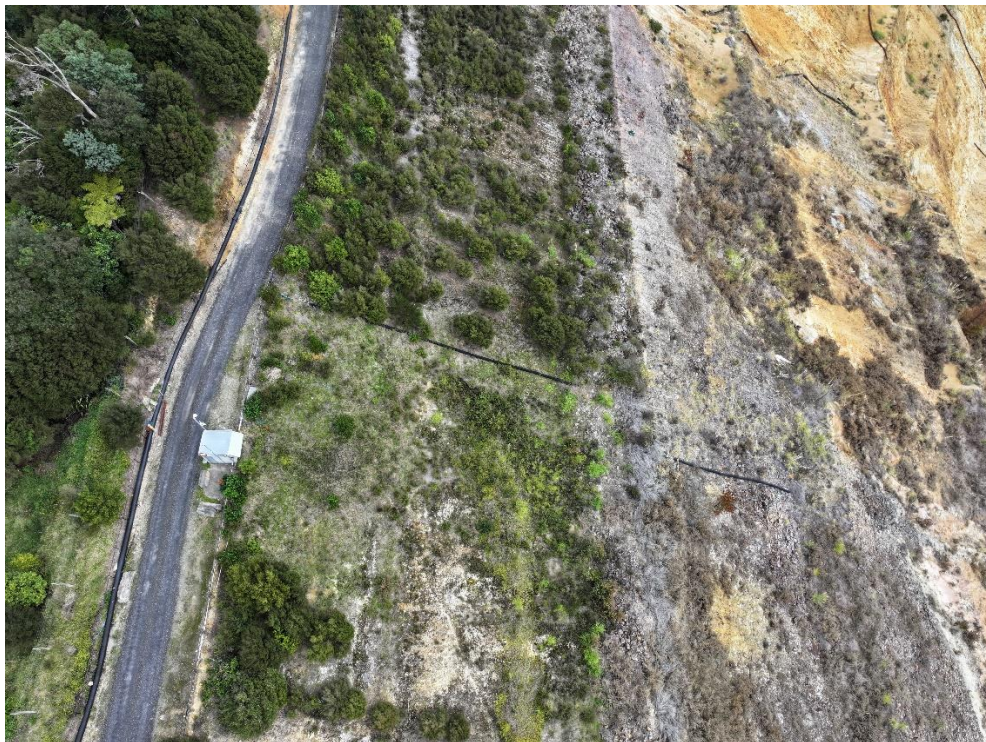
**Figure 33 Aerial photograph of Martha Pit demonstrating effective aerial herbicide application below rip rap.**

In August 2024, drone spraying focussing on the pit rim circumference from the rip rap level down three batters, and the Favona Stockpile.

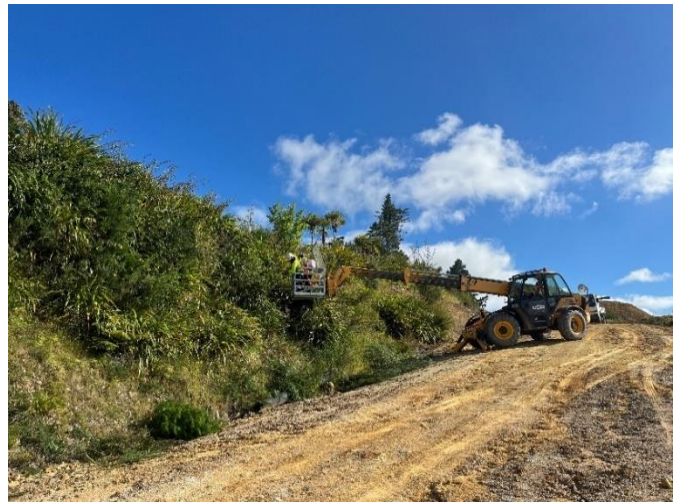
**Figure 34 Telehandler operating at the SW end of the Pit to access hard to reach areas safely.**

Undertaking weed control safely requires use of a telehandler, which is able to lift two personnel safely up to the wall with a pole saw and knapsacks.

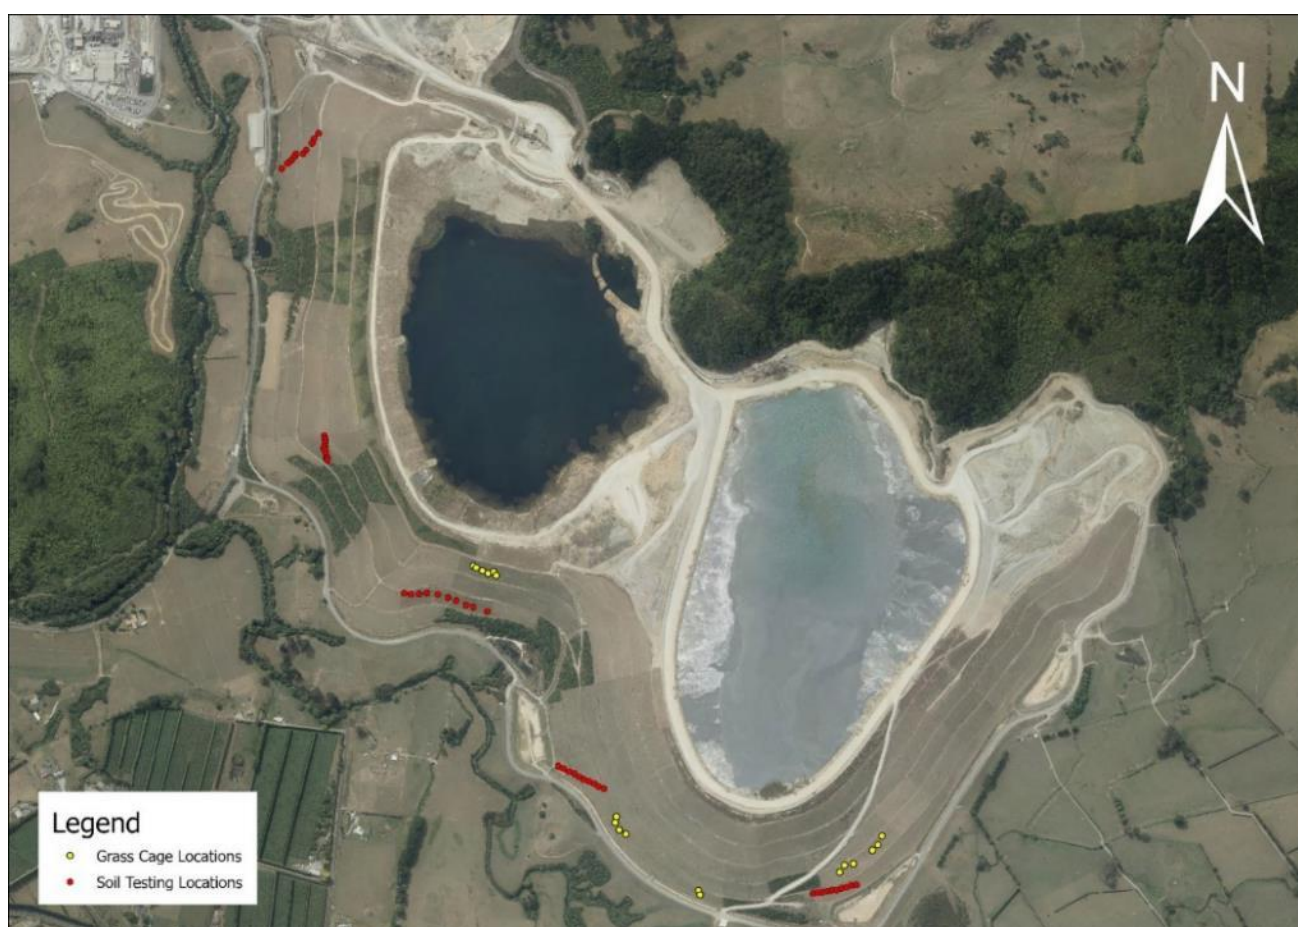
**Figure 37 Grass cage and soil testing locations 2024**

pasture production. The locations of soil sampling and grass cages are demonstrated in Figure 37. These results are presented below.

The procedure for monitoring grass cages is outlined in WAI-200-PRO-011. Figure 37 shows the locations of grass cages on the TSF embankments. Grass growth is measured on a monthly basis where grass within the cages is cut and sent to RJ Hill Labs for pasture dry weight analysis.

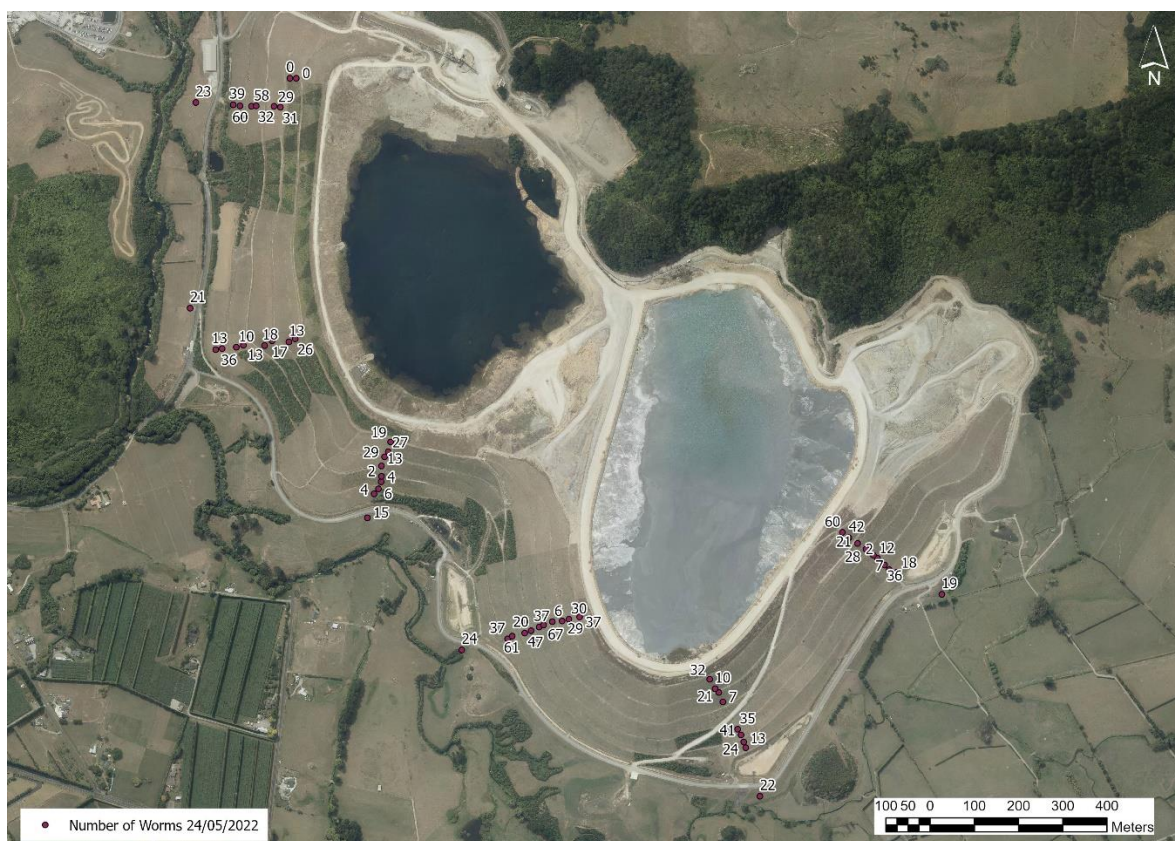
**Figure 39 Earthworm survey plot locations and 2022 results**

The methodology used to assess earthworm abundance has been based on the Ag Research 'Great Kiwi Earthworm survey' guidelines. A series of 200x200x200mm plots are established across the embankment pasture of TSF2 and TSF1A (Figure 39).

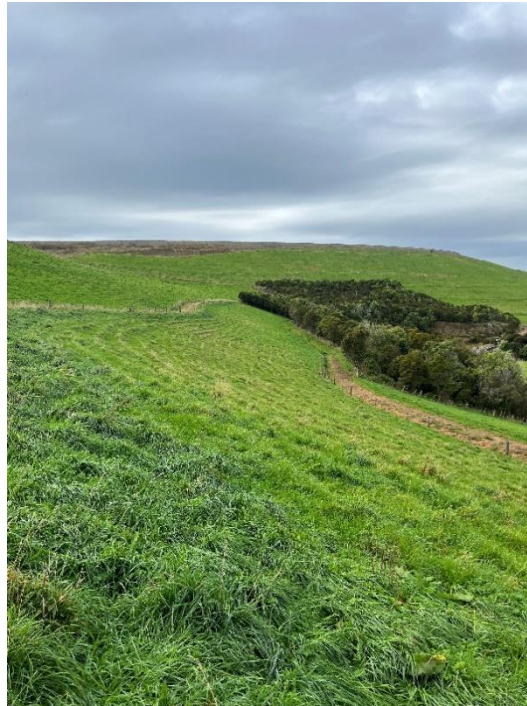
**Figure 40 TSF2 Site C**

TSF2 Site C (refer Figure 40 below) was retested due to three out of nine sites having less than 5 worms per sample in the 2022 survey. For the retest, the average earthworm abundance per sample was 14 with one sample having less than 5 worms present. This site is known as an area where the topsoil depth is low. The site is south facing, with moss under the grass which may indicate a low pH. Due to the site being steep, it has been unable to be fertilised, however it is expected that now aerial application of fertiliser is taking place, soil health and subsequently worm abundance should continue to increase. This site will be revisited in 2025/26 to recount worms.

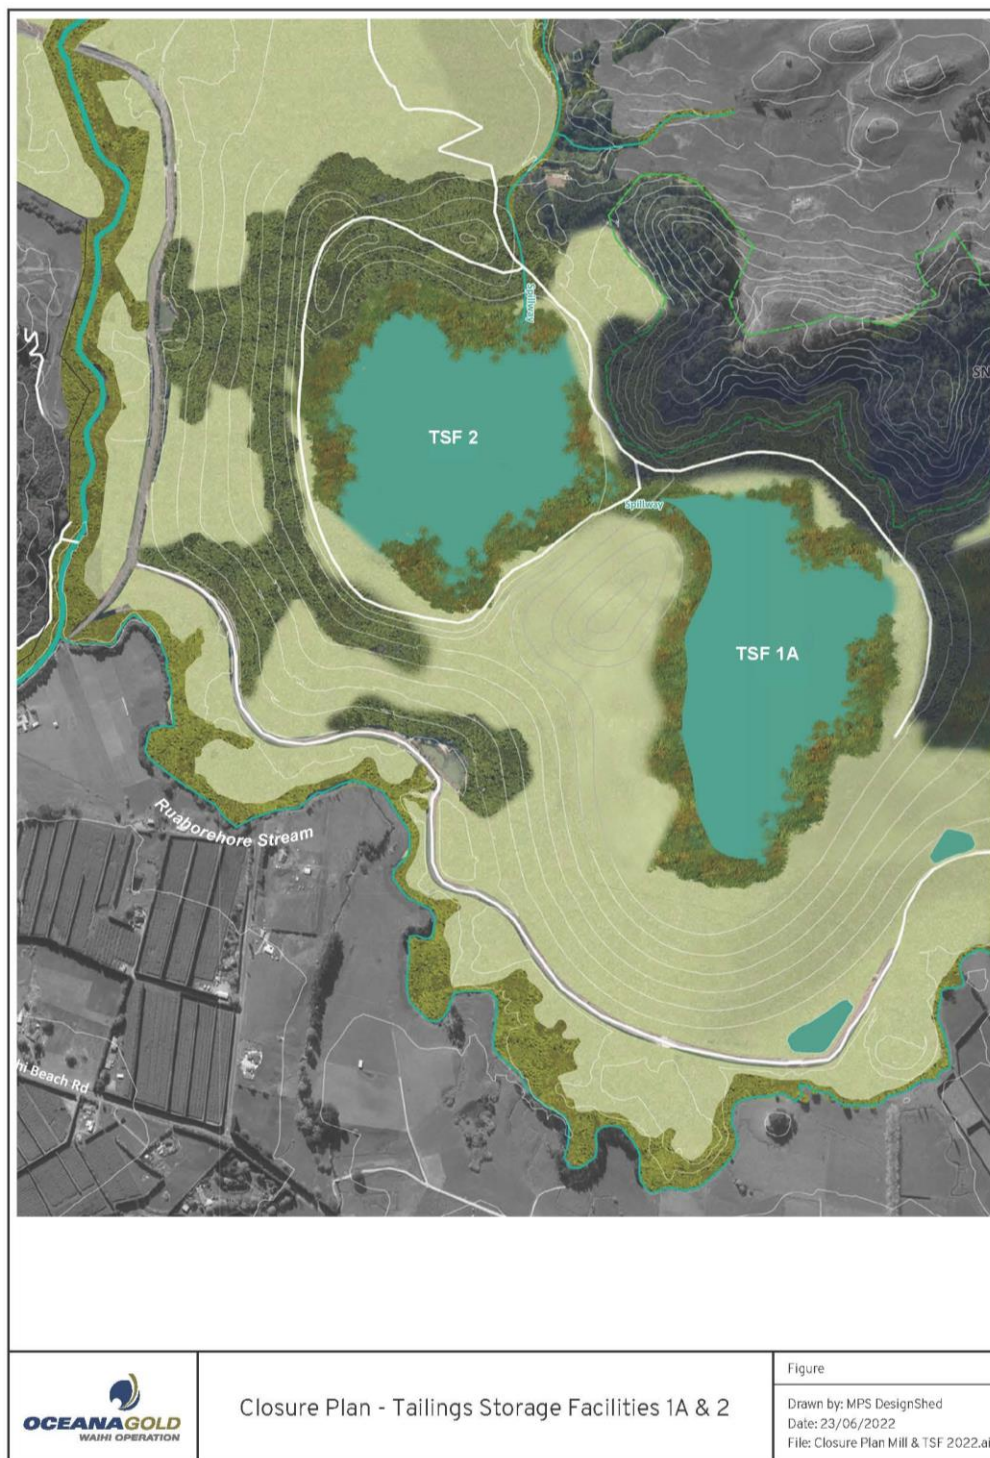
**Figure 48: TSF Rehabilitation Concept**

The conceptual closure plan for the tailings storage facilities (TSFs) initially prepared in 1998 remains fundamentally unchanged (refer **Figure 48**). It comprises a partial capping of the tailings against the embankment crest, retention of part of the impoundments as shallow ponds, and planting of the embankments and capping including a wetland littoral zone around the ponds. Spillways would be constructed to discharge into and from Storage 2.

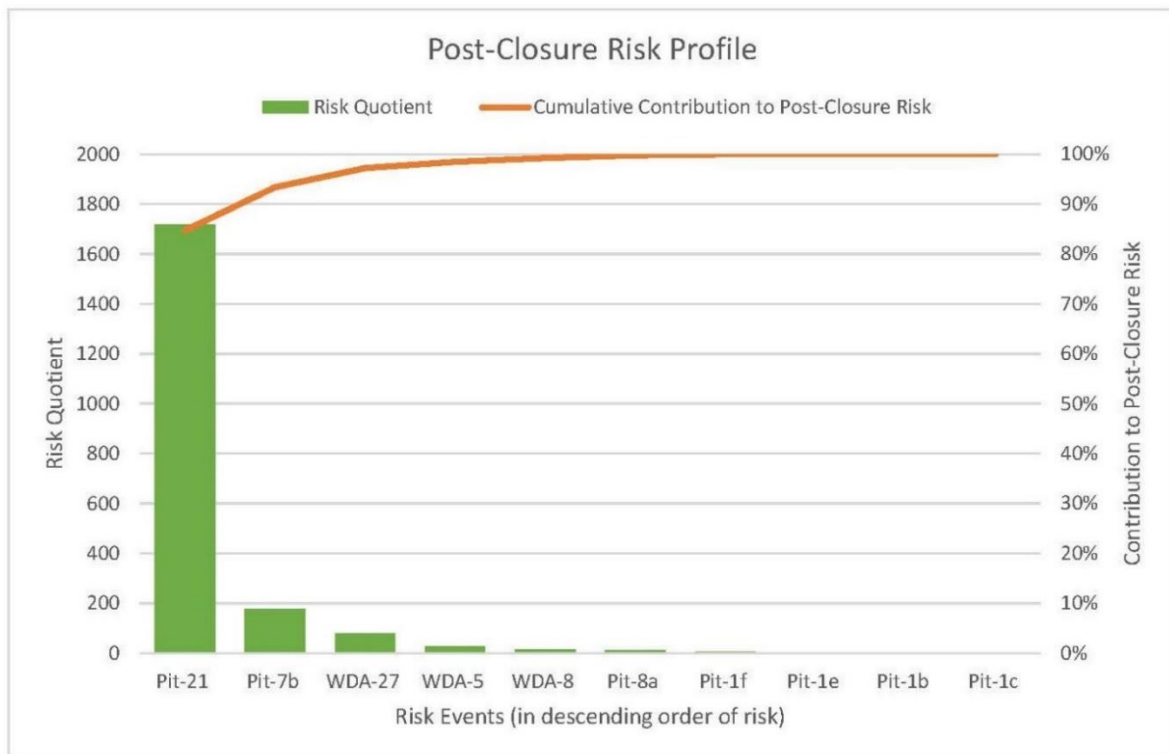
**Figure 49: Risk Profiles.**

The risk profile ranks all of the analysed risk events in descending order of risk quotient (the product of likelihood and consequence). It provides a clear focus on those events that pose the greatest risk. The risk profiles for both the closure and post-closure periods are shown in **Figure 49**.

**Figure 49** shows that during closure the Pit-21 Hazard zone collapse and Pit-1c Pit wall failure – damage risk events dominate the profile.

The risk quotient provides a quantitative and directly comparable value of the risk each event poses during the closure period. For example, the second-highest ranked risk event (Pit1-c Pit wall failure – damage, risk quotient = 1,200) poses 70% of the closure risk posed by the top-ranked risk event (Pit-21 Hazard zone collapse, risk quotient = 1,700). The third-highest ranked risk event (Pit-1f Pit wall failure prevention) poses a little over 5% of the risk posed by Pit-21.
