Rehabilitation and Closure Plan

Document Reference: WAI-200-PLN-011

The conditions of Mining Licence 32-2388 (which have been incorporated into the Hauraki District Plan) and consents granted for the Martha Mine Extended Project require an annual review of a Rehabilitation and Closure Plan ("the Plan"). The conditions of consent for the Favona, Trio, Correnso and SUPA Underground Mines also require the preparation of a Rehabilitation Plan. This is the nineteenth version of the Plan to be prepared since Extended Project activities commenced in 1999.

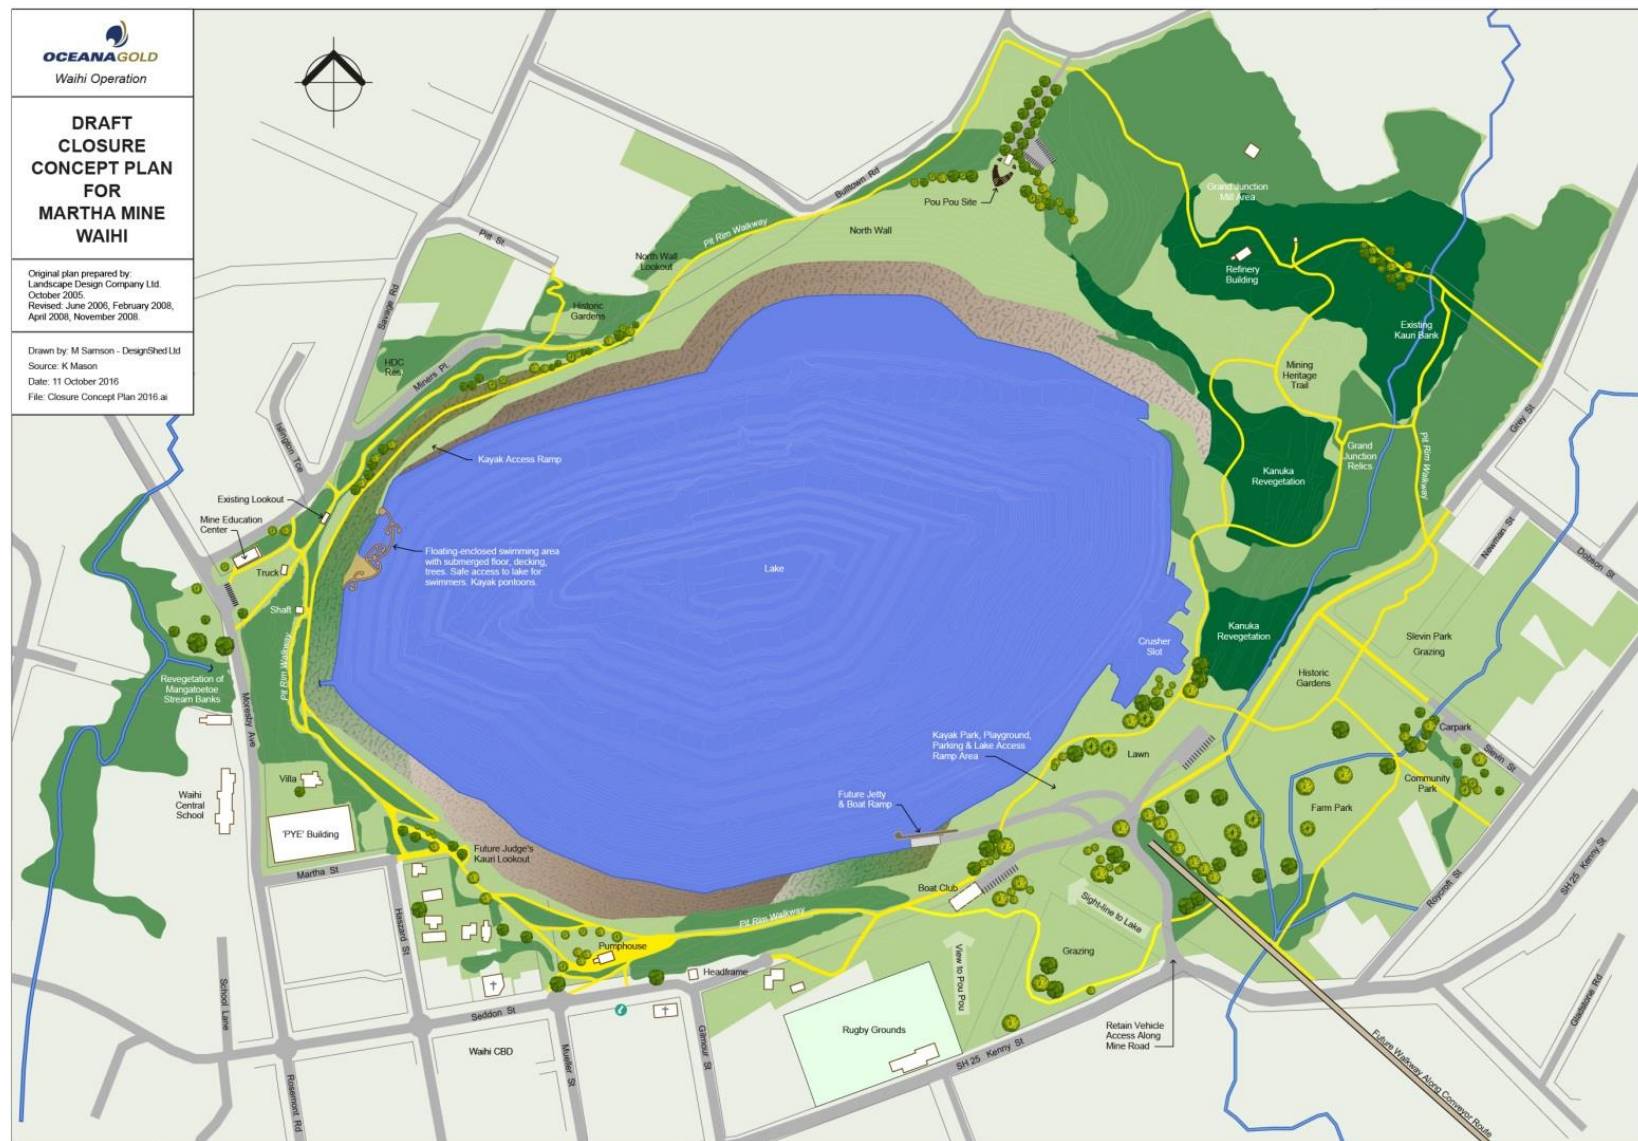
Figure 2 – Current Closure Concept Plan for Open Pit and Surrounds

The Rehabilitation and Closure Concept Plan is considered a “work in progress” and is subject to change and more detailed landscape planning. The Closure Concept Plan changed following the approval of the Martha East Layback. This year, changes have been made to show the North Wall following remediation and partial capping of the failed section. This updated plan is included as Figure 2.

In the event of sudden closure, a swimming pontoon is provided for, located at the western end of the pit. The shape of the pontoon approximates that shown in the pit closure concept plan (Figure 2) and includes a submerged swimming area.

Some further planting may be necessary in the surface facilities area only. The assumption is to plant around 1.2ha of kanuka vegetation as shown in Figure 2, plus some other individual trees.

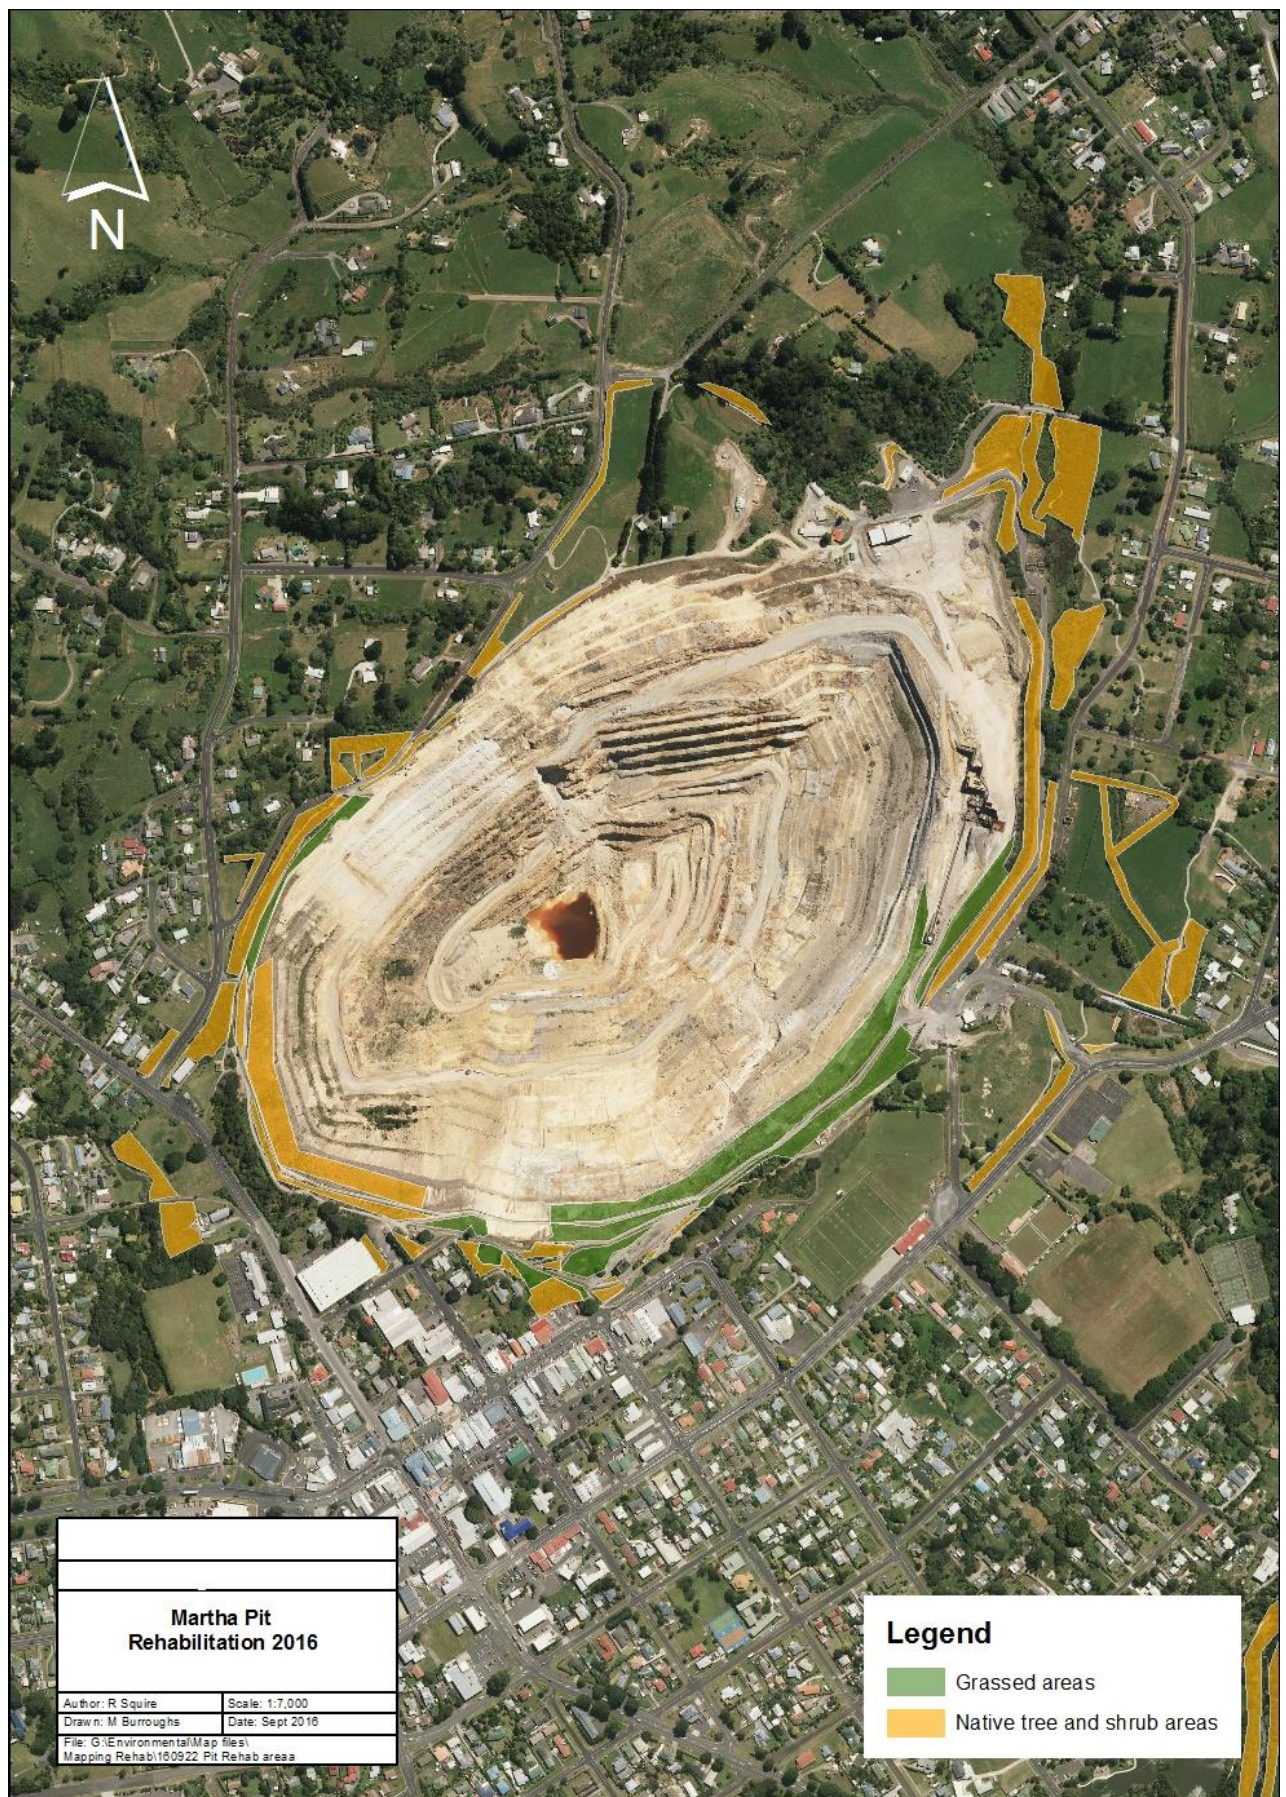
Figure 3 – Rehabilitation of Open Pit and Surrounding Areas

Figure 3 shows the areas that have been rehabilitated around the open pit and pit-rim walkway, as well as some adjacent areas that could be described as “discretionary”. In 2012 this included plantings along the Mangatoetoe Stream west of the pit.

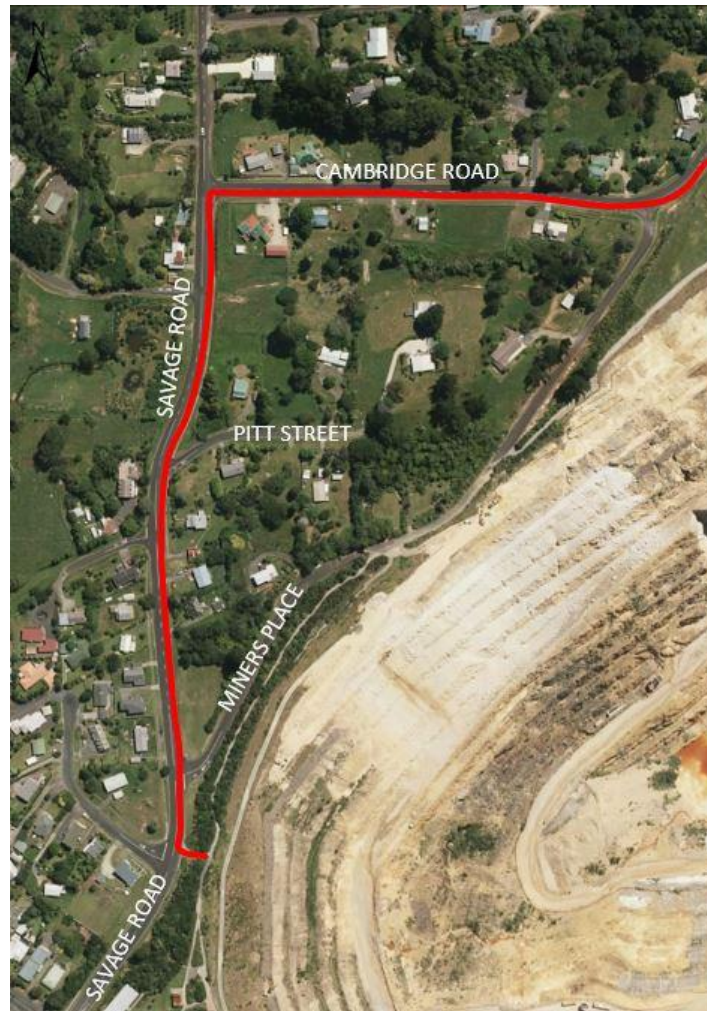
Figure 6 – Rerouted Pit Rim Walkway

A section of the walkway was re-routed due to the North Wall Slip (Figure 6). As described in the Annual Work Programme 2017, OGNZL has planted trees and shrubs adjacent to the new section of the pit rim walkway with a number of plantings to the east of the pit.

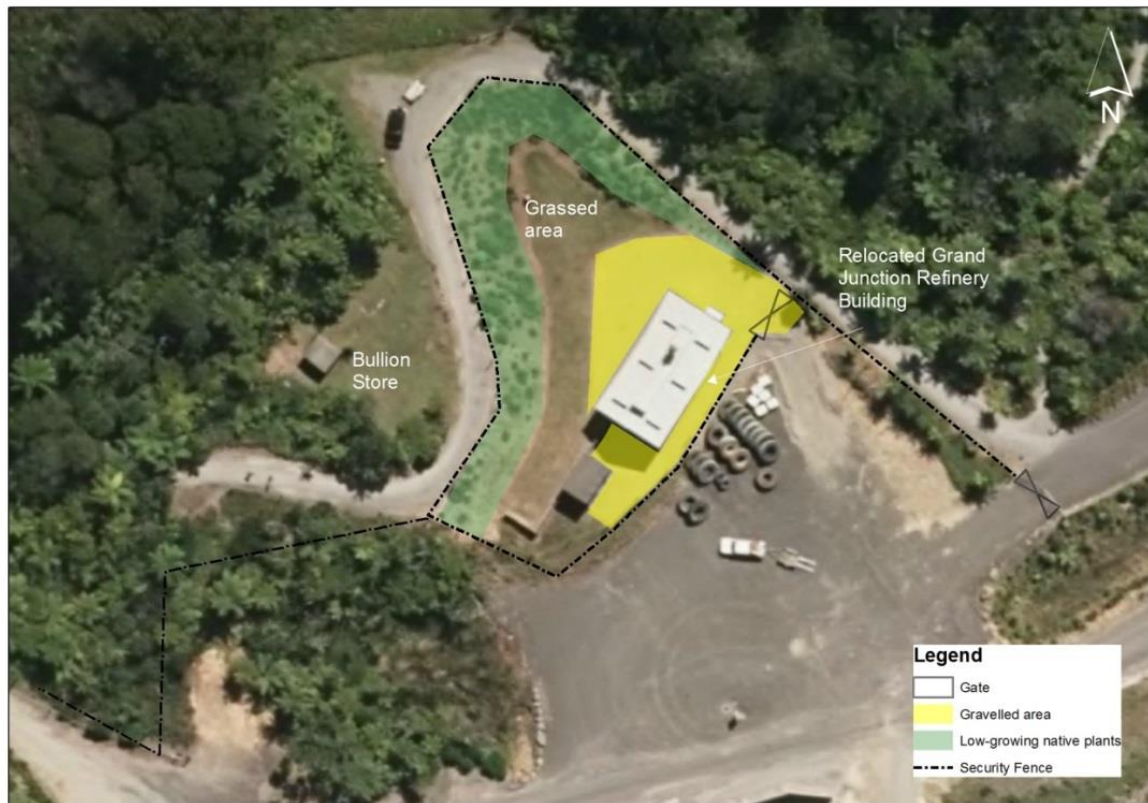
Figure 7 - Landscape Plan for Grand Junction Refinery Building

The Grand Junction Refinery Building was relocated in March/April 2010 and subsequently refurbished in accordance with the Conservation Management Plan (refer Figure 7 and Figure 8). Landscaping work has largely been completed although ongoing minor and agreed improvements to the building and curtilage continue (i.e. in 2017 an historic ore wagon, refurbished by a local resident was placed on display beside the building).

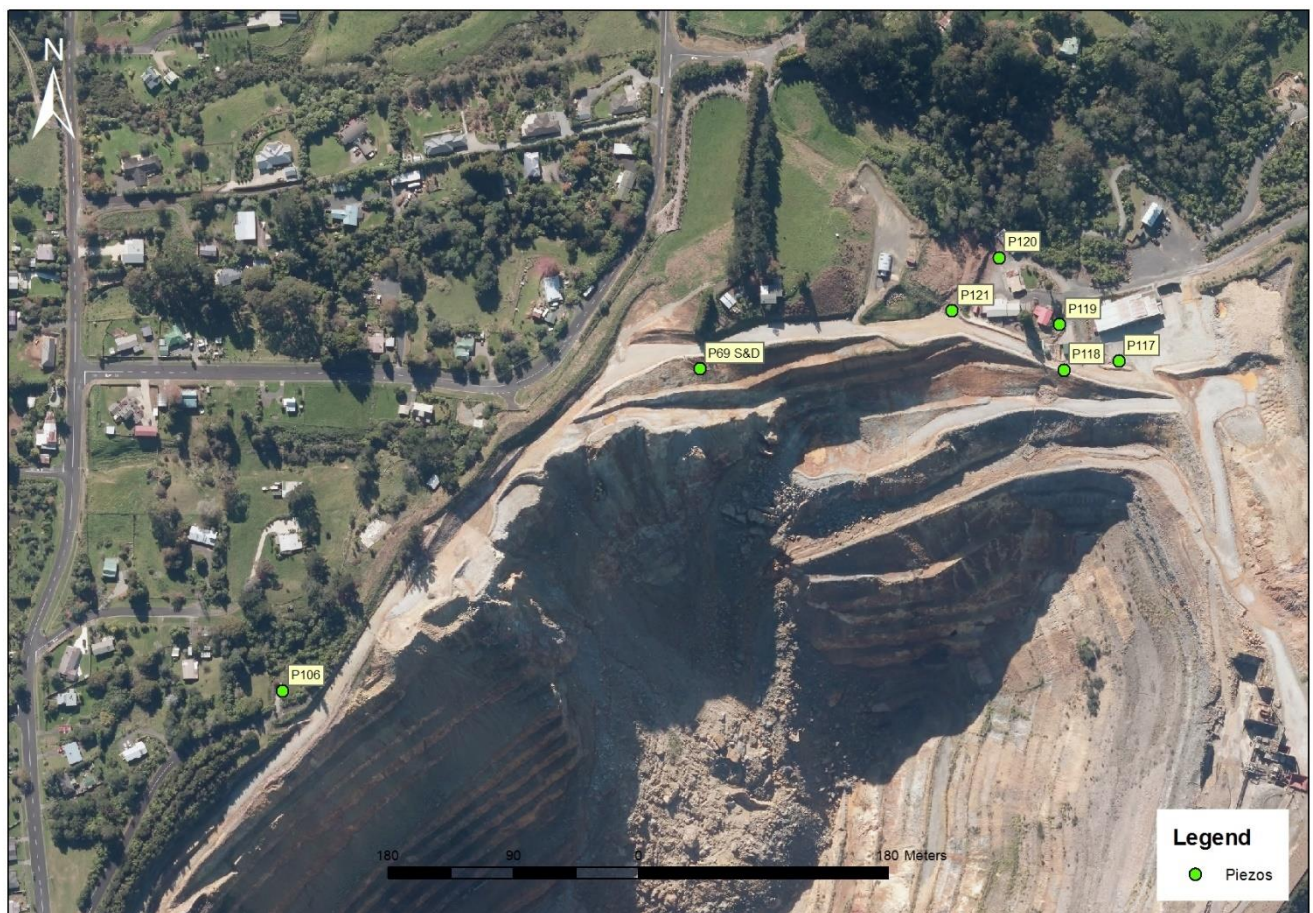
Figure 9 - Martha North Wall piezometers

At the time of writing five piezometers (P117 - P121) were being installed near the magazine ramp area on the North Wall (Figure 9). These are intended to assist monitoring water levels and the source of seepage on the upper east North Wall.

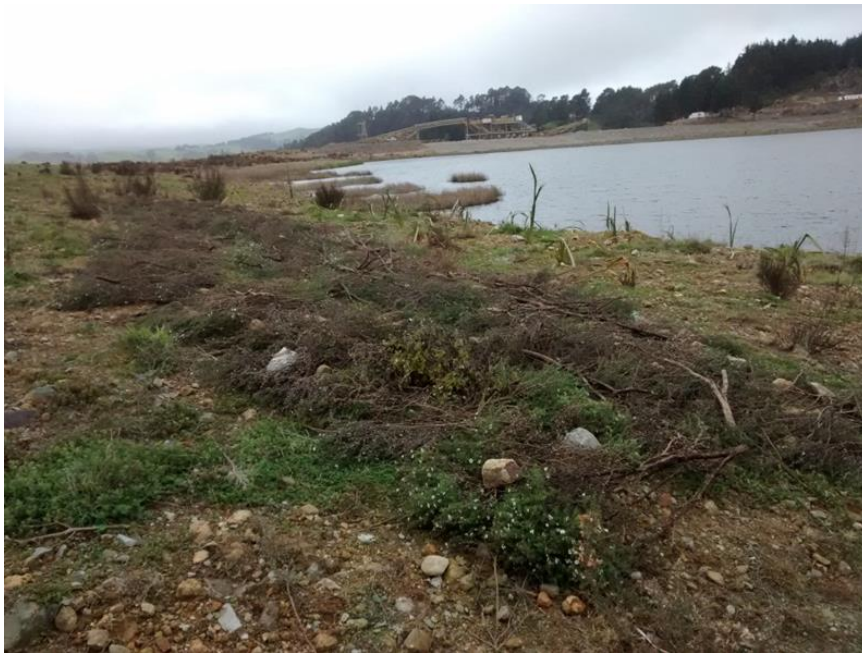
Figure 14 – Manuka Slash and Flax on Ignimbrite Capping

OGNZL is continuing to trial flax and manuka slash laid directly on the ignimbrite capping that overlies the tailings as potential revegetation options for this area (refer Figure 14 and 15). Manuka establishment on the capped area is slower than on bare ground within the open pit (due to grass competition), however the flax plants have established well.
