OceanaGold New Zealand Ltd  
Third Quarter Summary Report 2019  
Vibration Levels in Waihi

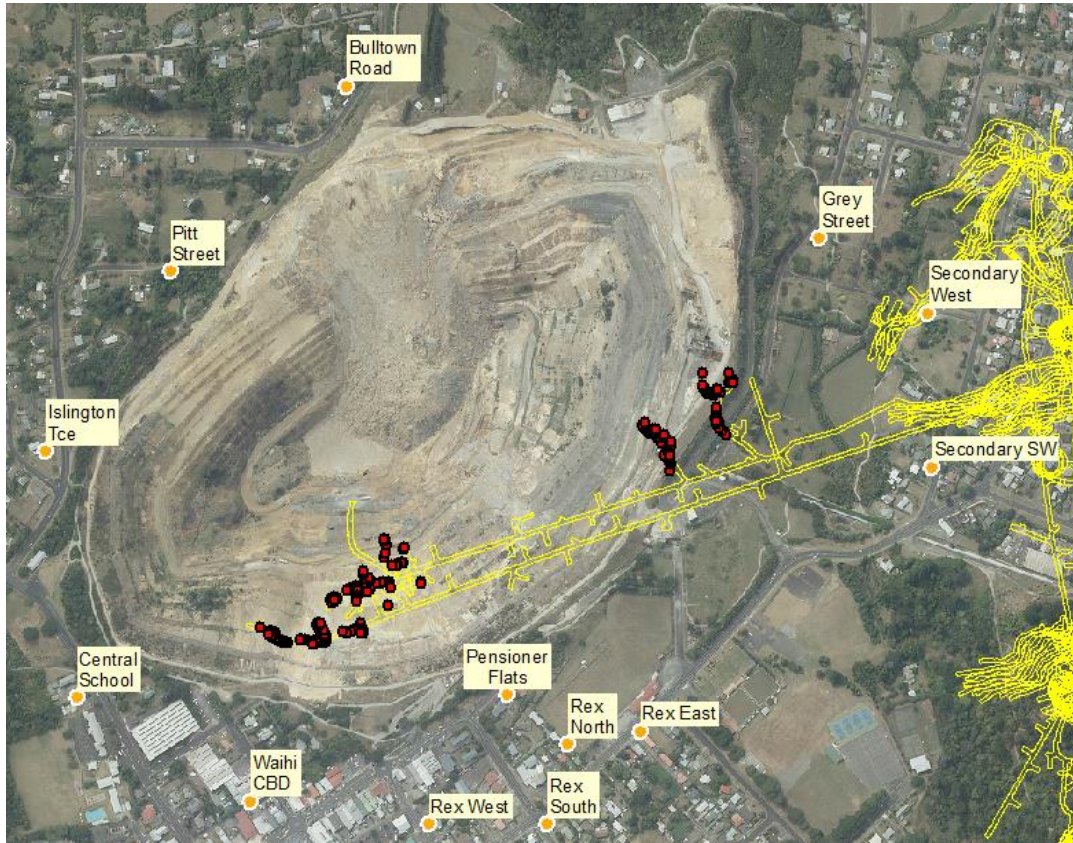
**Figure 1 VMS Monitor & Blast Locations – Project Martha**

In terms of vibration monitoring, the Project Martha network comprises 13 monitors (some shared with the Correnso network). These all have a trigger limit currently set at 0.75 mm/s. Any blasts fired during the period (highlighted in red) and the monitor locations are shown in Figure 1. (*nb: the ‘Rex’ monitors have not yet been installed, but will be prior to mining in that vicinity*)

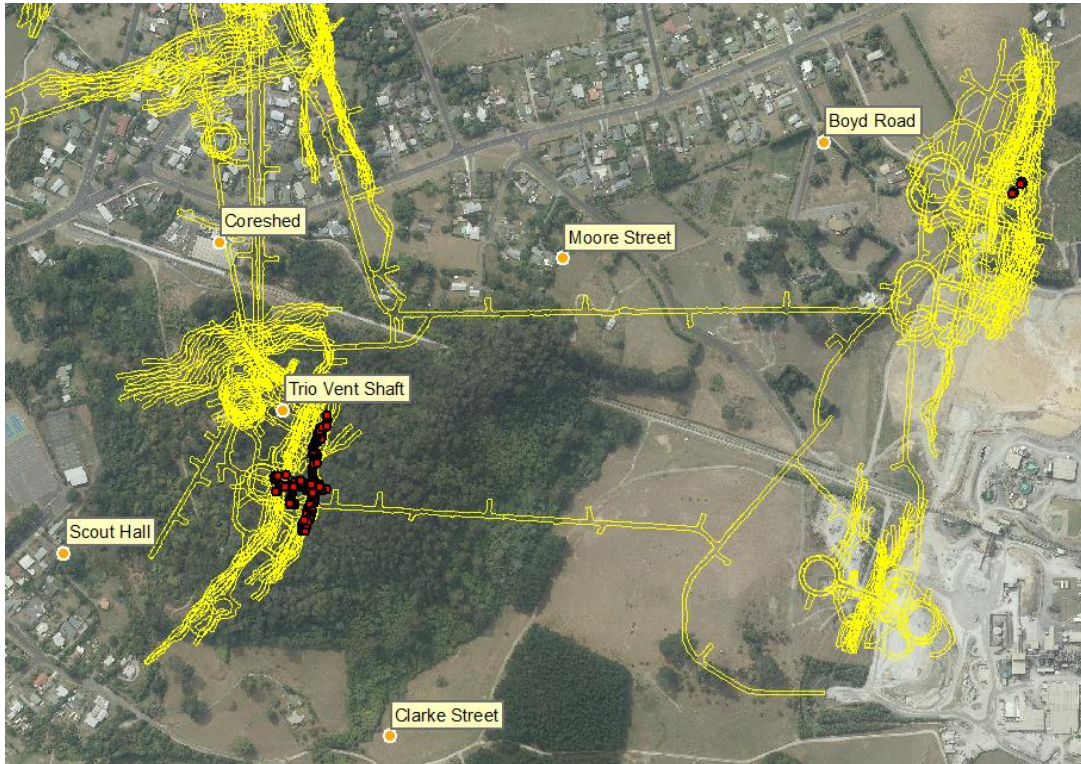
**Figure 2 VMS Monitor & Blast Locations – Underground Operations (Favona & Trio)**

The Trio Underground Operations have five compliance monitors situated at Boyd Rd, Moore St, Clarke St, the Coreshed (Barry Rd) and the Scout Hall (Baker St). In addition to these, one other monitor is located near the Trio vent shaft (Trio VS). This monitor acts as an ‘indicator’ for Blasthub, which allows correlation with the other monitors to report the compliance monitoring results directly onto Blasthub. The blasts fired during the period (highlighted in red) and monitor locations are shown in Figure 2.

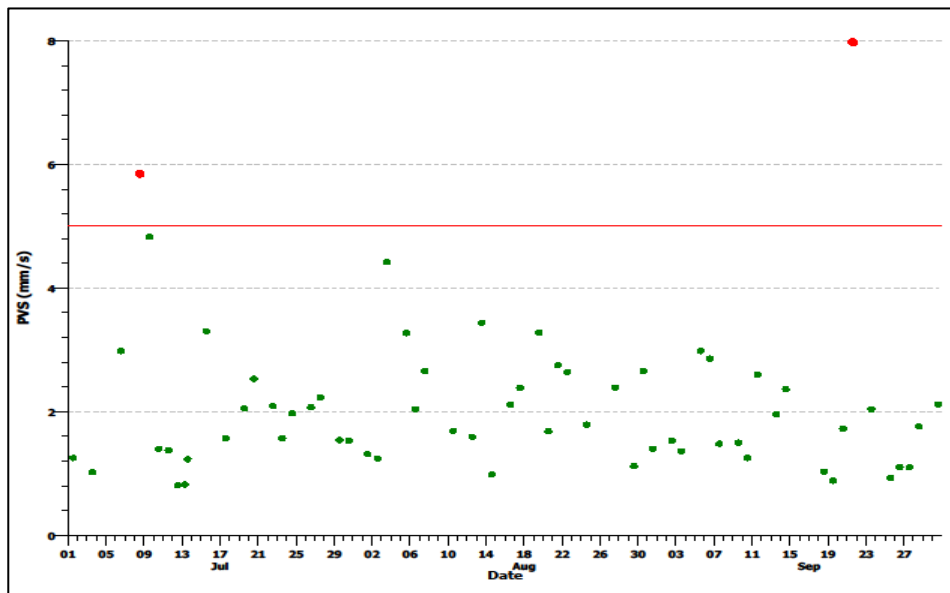
Figure 4: Peak Vibration Levels – Correnso/SUPA/MDDP Operations

During the third quarter of 2019, 287 blast events (cf. 168 in the previous quarter) occurred in the Correnso, SUPA, and MDDP projects. The blast locations are presented in Figure 3 above, with the relative locations indicated for development and production blasting. The peak vibration levels for the period are shown in Figure 4 below.

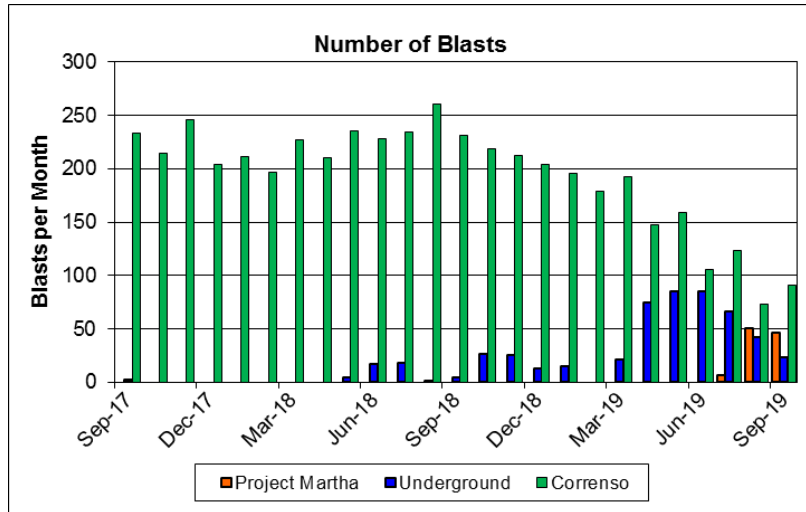
Figure 5: Number of Blasts (all operations)

Multiple blasts may be fired during the one blast event. There were 521 blasts in the third quarter of 2019, down significantly compared with 657 in the previous quarter (Figure 5). The fewer blasts were due primarily to a reduced equipment availability, with several machines out of action for significant periods. There is also an

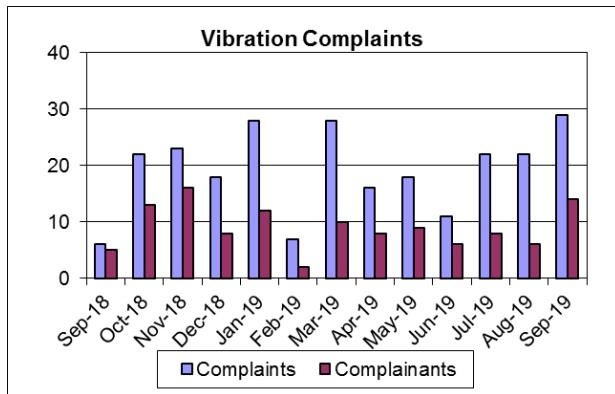
Figure 6: Number of Complaints & Complainants

73 vibration-related complaints were received during the reporting period, up from the 46 received in the previous quarter (Figures 6 & 7). The number of complainants also increased; 18 during the quarter cf. 14 in the previous period. These increases are considered due to several large deep blasts that generated multiple complaints (and therefore, complainants) per blast. 34 (47%) of the complaints were received from 2 residents. Table 2 provides a summary of the complaints received during the quarter.

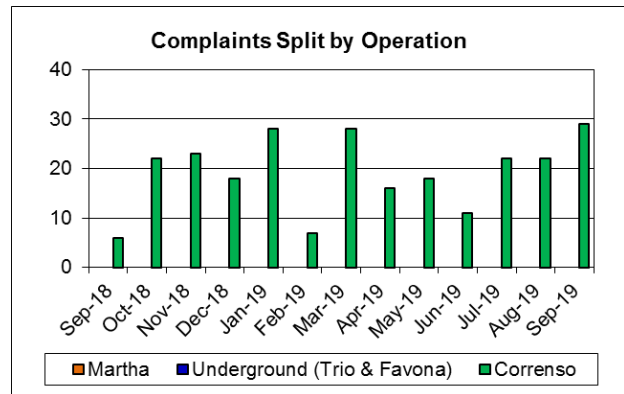
Figure 7: Complaints by Operation
