# Landscape Plan - Waihi 2019

WAI-200-PLN-017

**OCEANAGOLD WAIHI**  
**LANDSCAPE PLAN - WAIHI**  
**APRIL 2019**

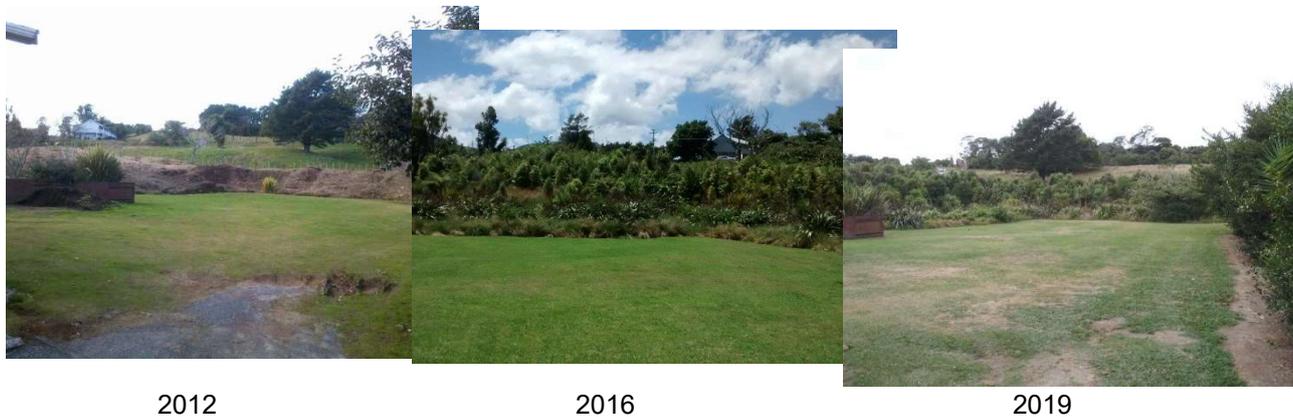
**Figure 3 – Rehabilitation (Mangatoetoe Stream)**

An example of a rehabilitated area is shown in Figure 3

OGNZL has already established riparian vegetation along the reach of the Mangatoetoe Stream where the lake outlet is planned to be constructed and discharge into (Figure 3). This outlet will be installed in accordance with the Waikato Regional Council consent AUTH139551.10.01. It is proposed that the currently retired area will be adjusted to incorporate the eventual outlet, with adequate stand-off area around any structures to allow for at least 10 m of screen planting.
