## Landscape Plan Waihi

Document ID: WAI-200-PLN-017

<b>Department</b>	<b>Sustainability</b>
<b>Location/Site</b>	Waihi

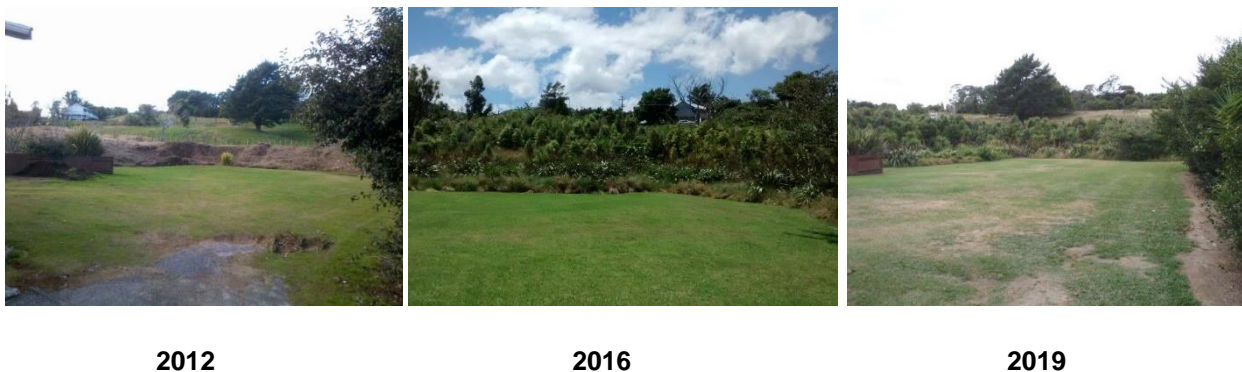
**Figure 1 – Rehabilitation (Mangatoetoe Stream)**

An example of a rehabilitated area is shown in Figure 3

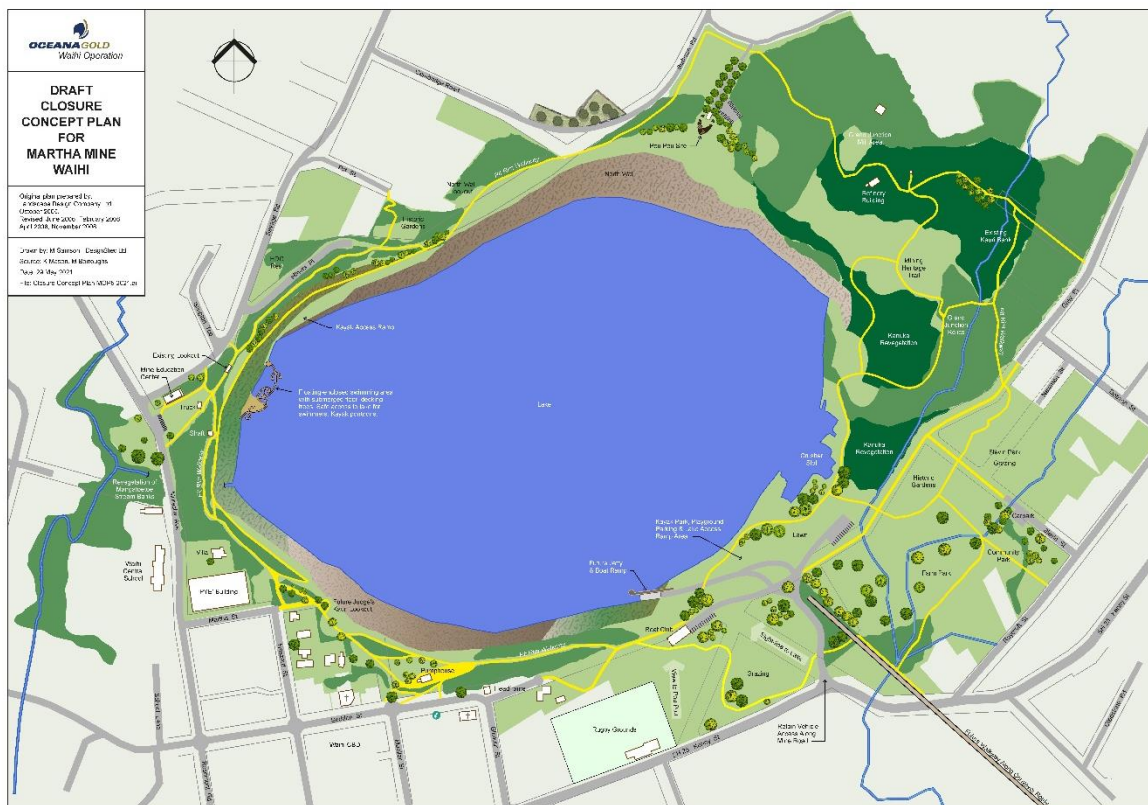
Figure 2: Martha Pit Concept Closure Plan

The Project Martha pit works will require the relocation of the pit rim walkway from its current position. The project will re-establish the walkway along the crest of the relocated noise bund, similar to the way the original pit rim walkway was created. Figure 2 shows the conceptual alignment of the pit rim walkway at closure. This will reinstate the separation between the walkway and public roads and will restore the views into the pit and across Waihi.

From a visual aspect, the key landscape implications of the project are the diversion of Cambridge Rd and the construction of a noise bund (topped by a noise wall) along the crest of the pit's north wall (Figure 3). The primary focus of the landscape mitigation plan by Boffa Miskell Ltd was to minimise the visual impact of these features (see Figure 2 for an indicative alignment).

OGNZL has already established riparian vegetation along the reach of the Mangatoetoe Stream where the lake outlet is planned to be constructed and discharge into (Figure 2). This outlet will be installed in accordance with the Waikato Regional Council consent AUTH139551.10.01. At least 10m of planting will be planted around outlet structures.
