WHO GIVES A DAM?

What is a tailings impoundment, and how is it different to a tailings dam?

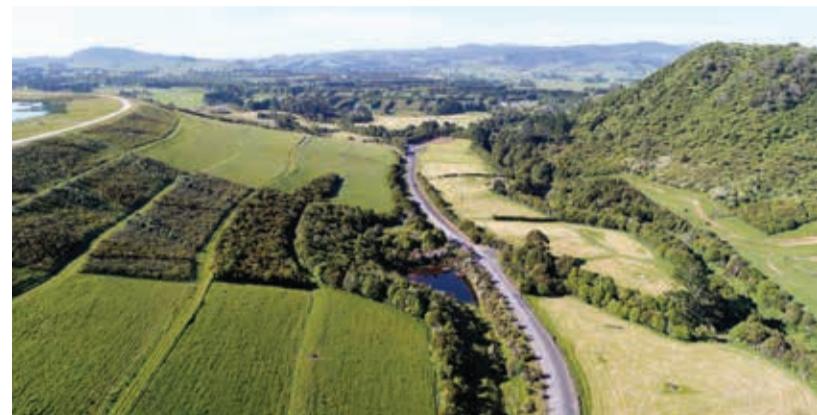
Our two tailings impoundments are carefully engineered structures constructed to precise specifications.

These are the structures we have seen fail on TV. The two tailings impoundments outside Waihi are not dams, and nor are they just piles of rock. They are carefully engineered structures made up of a series of zones, each constructed to precise engineering specifications for compaction, shear strength, rock geochemistry and structural integrity. They are constructed like a water dam, as if they are required to hold a large body of water rather than a slurry of tailings that settles and compresses over time.
